**HIGH RIVER ENERGY PROJECT  
ARTICLE 10 EXHIBIT 24**

**SIMULATIONS AND LINES OF SIGHT**

**ATTACHMENT 4**

High River Energy Center  
 Florida, New York  
 Visual Simulation of Project  
 August 2019

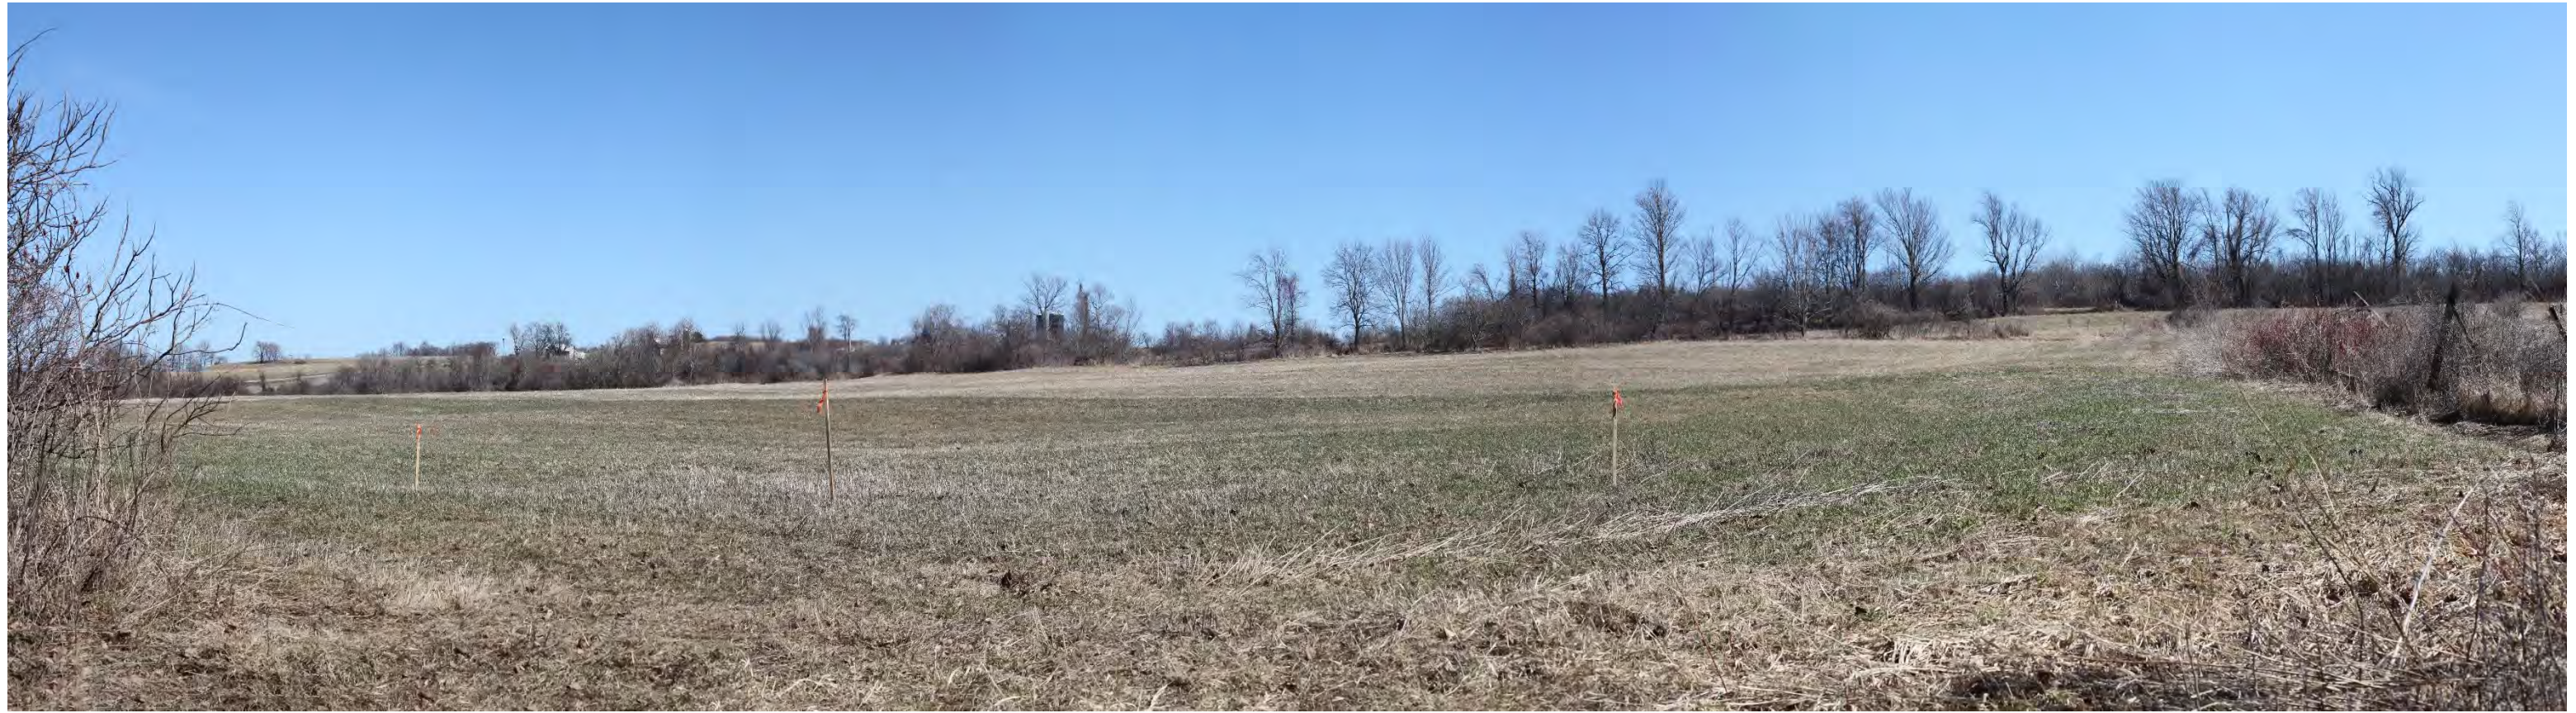
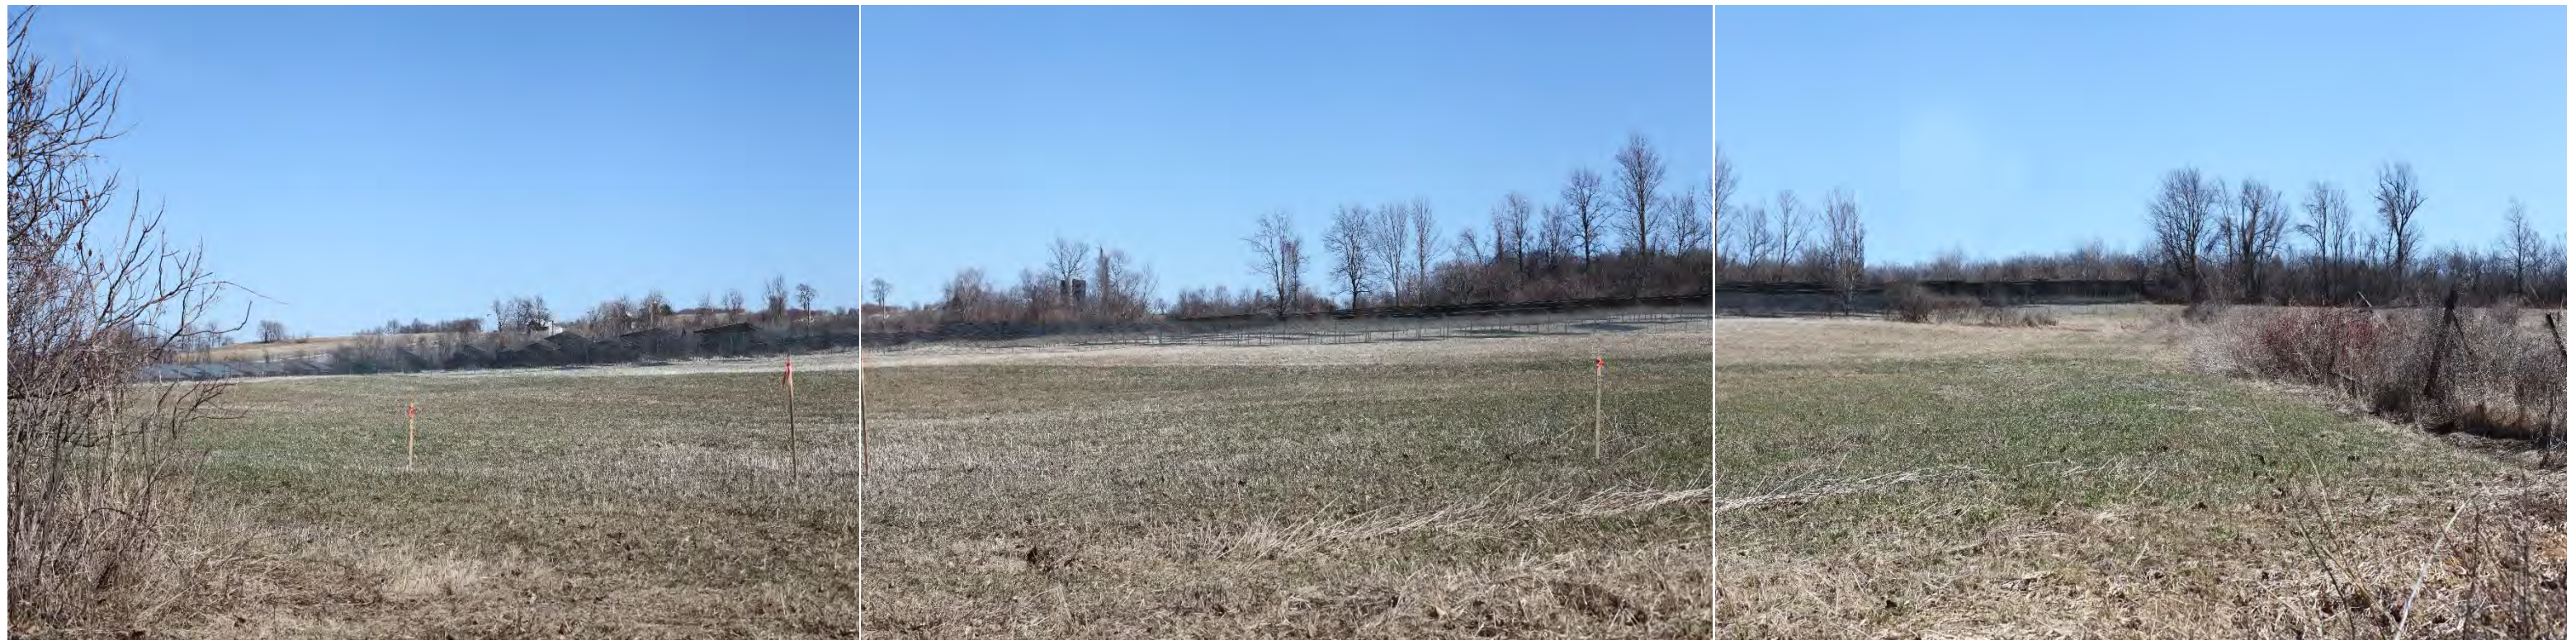
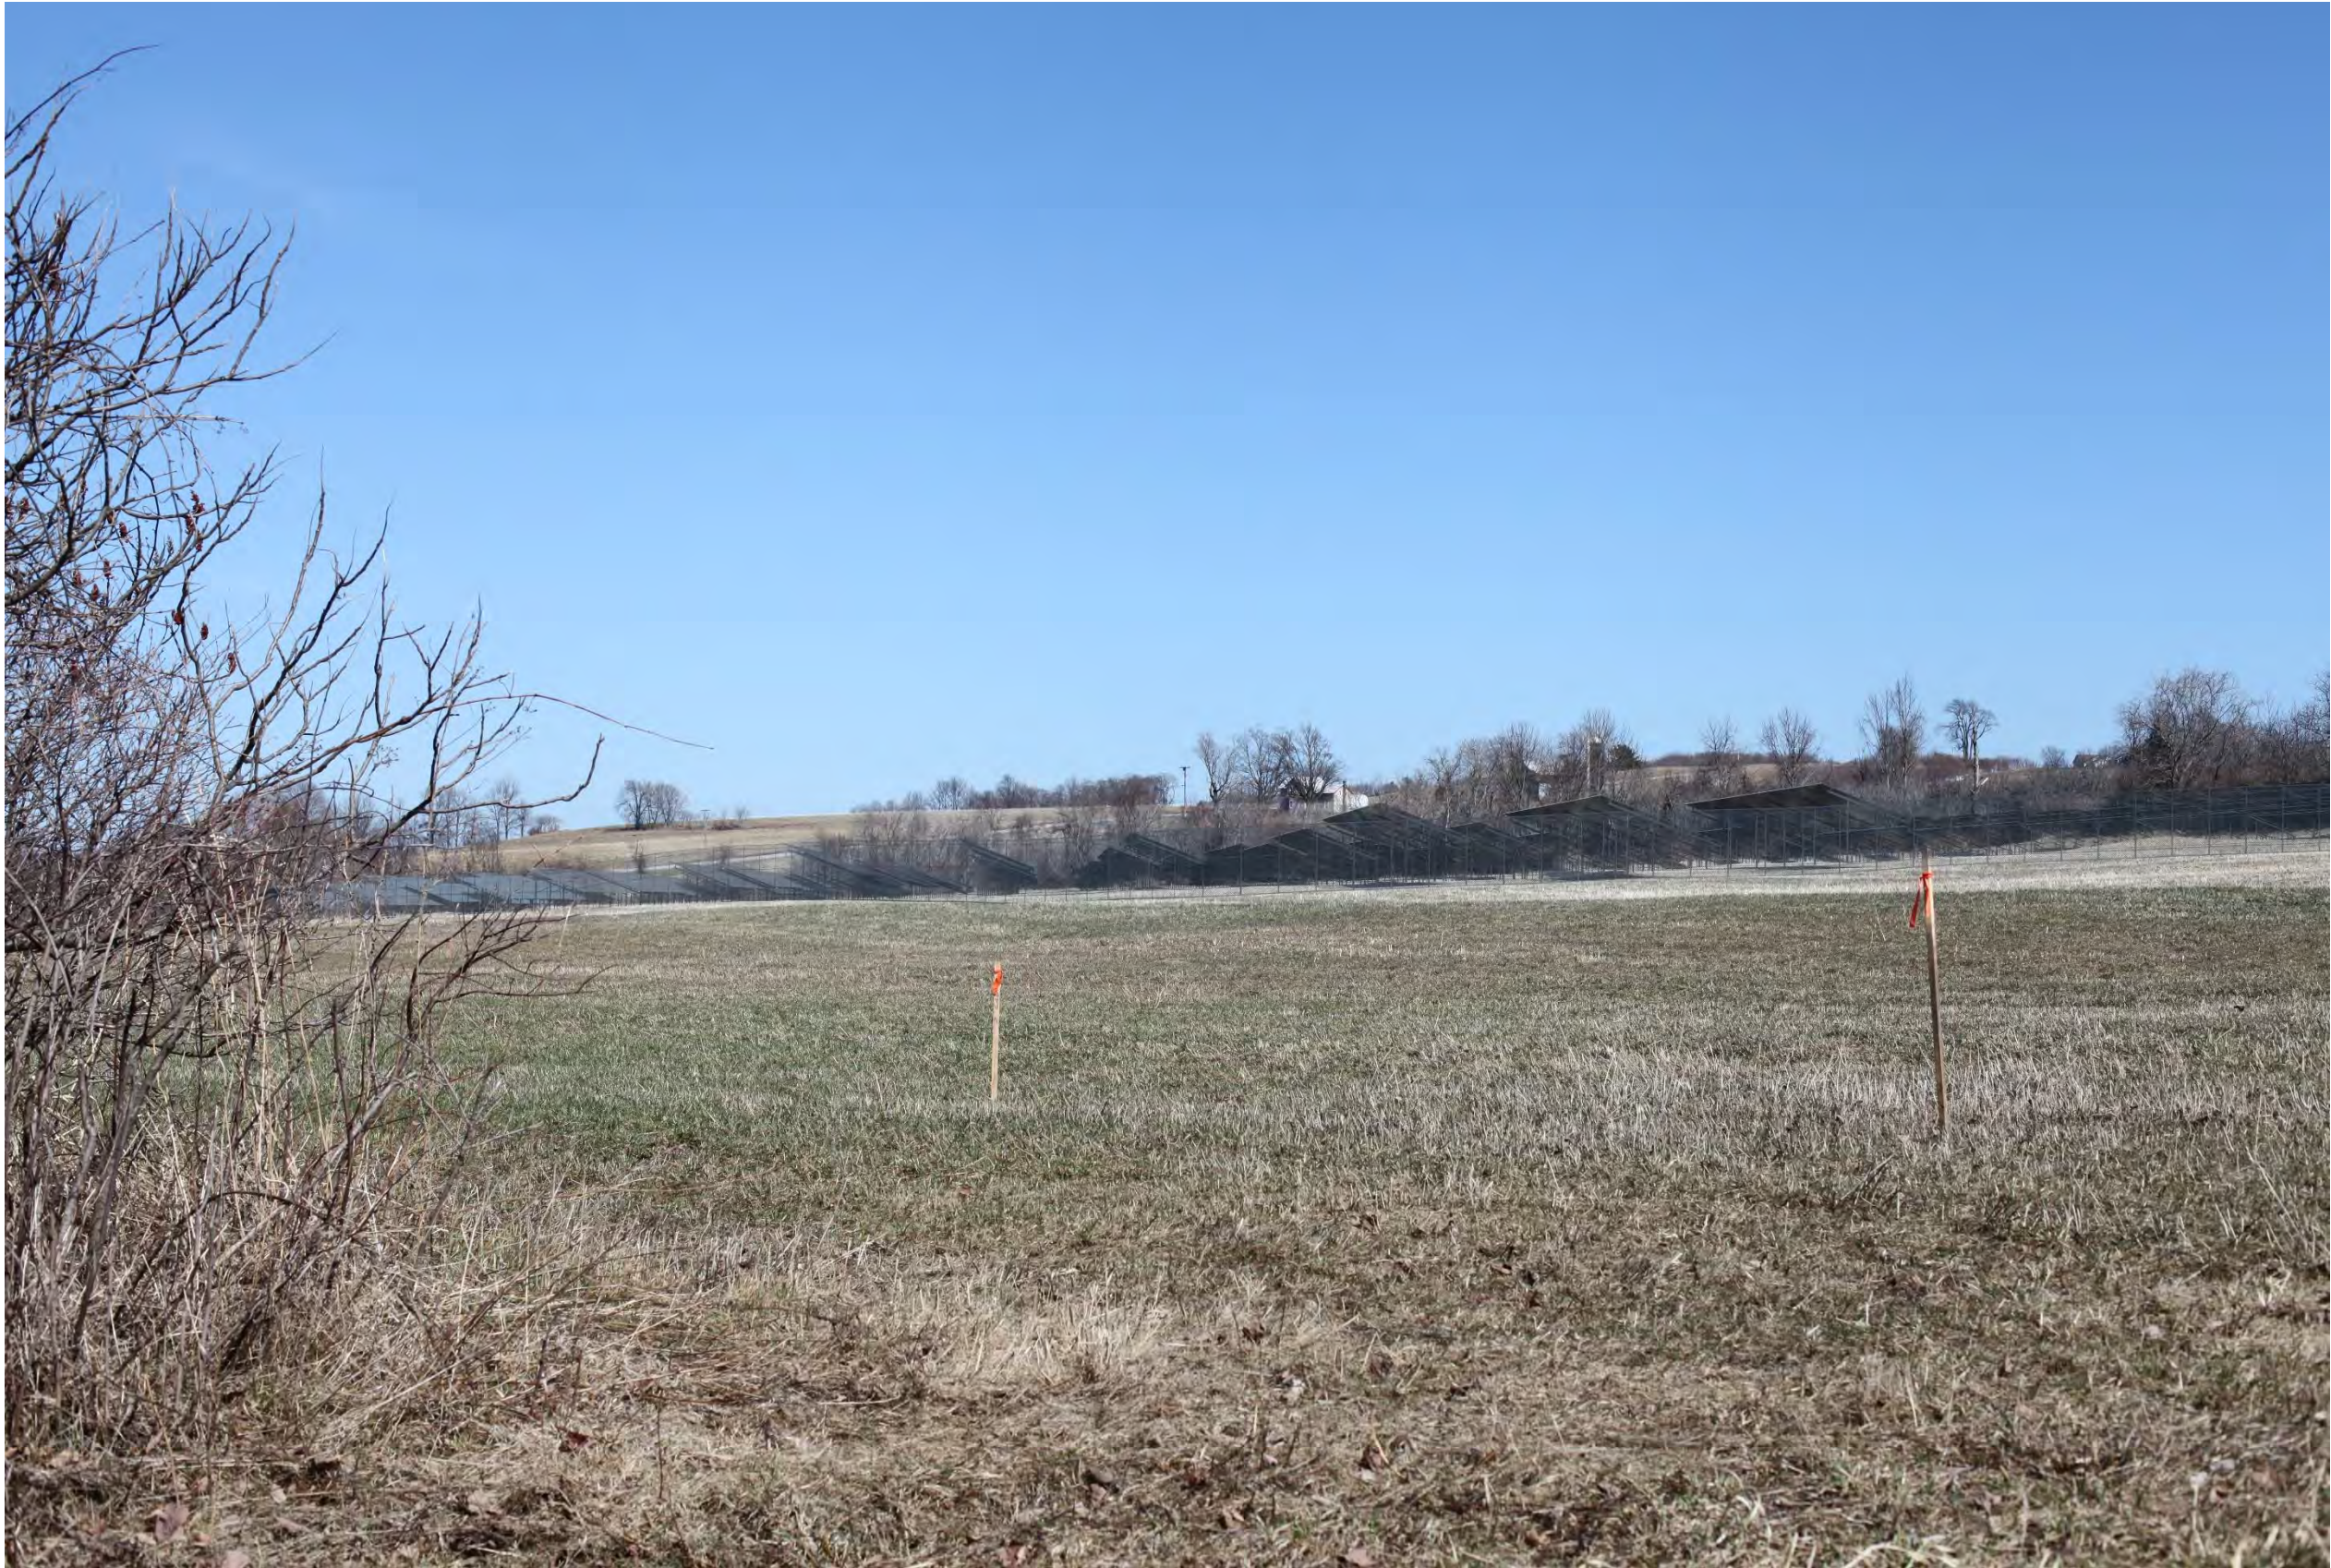
Note: Proposed mitigation not shown for clarity purposes.

Viewpoint Coordinates in	586187.4
NY State Plane East	1477778.3
Viewpoint Location	Bulls Head Rd
Viewer Elevation (ft msl)	816
Distance to Fenceline	380 feet
Direction of View	SE
Lens Setting	50 mm
Date/Time	4.23.2018/3:20 pm

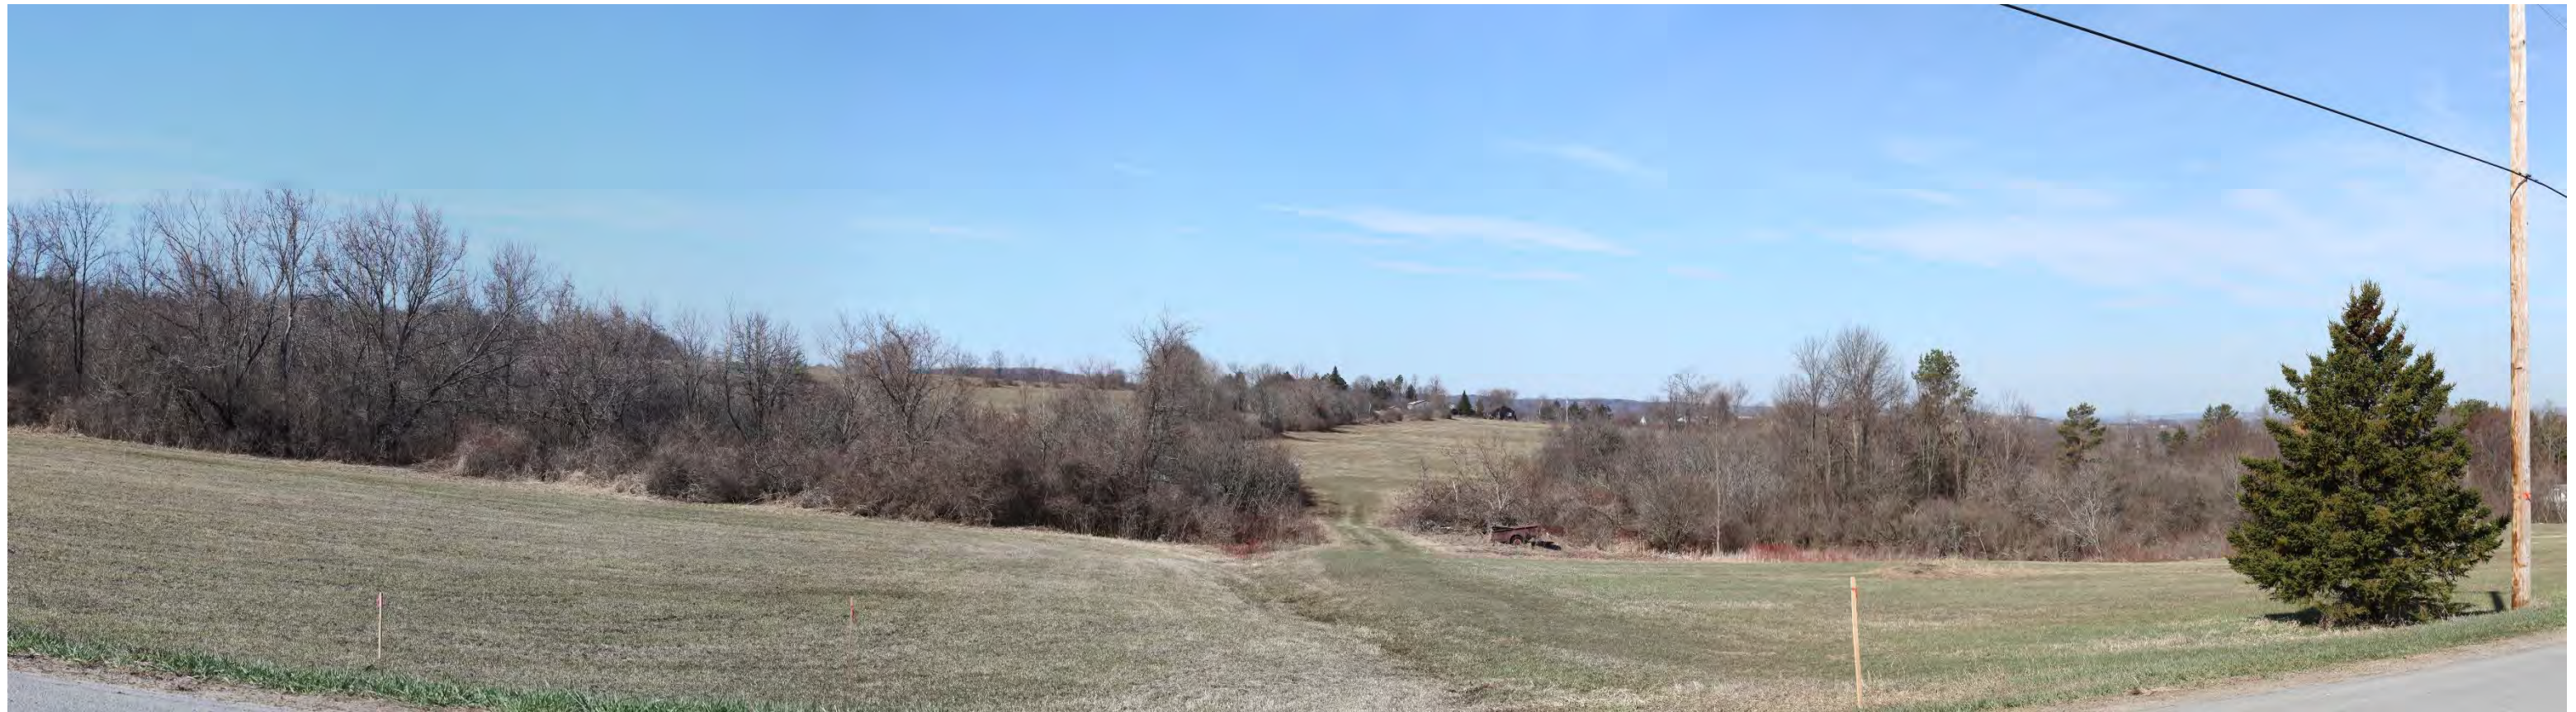
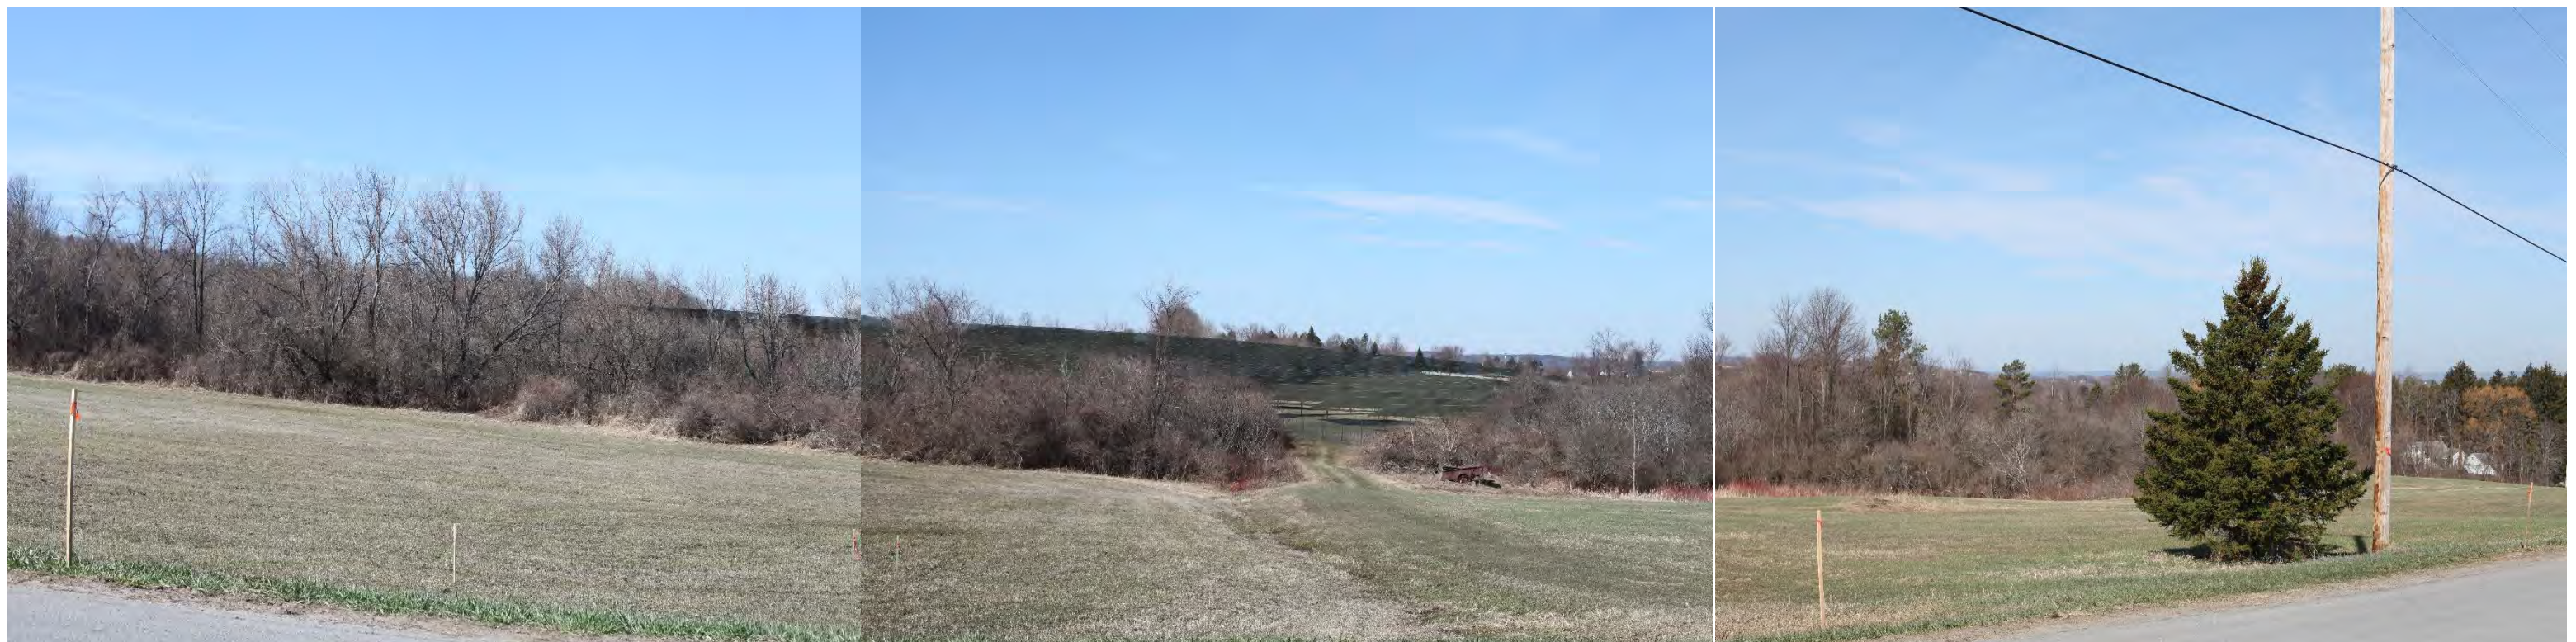
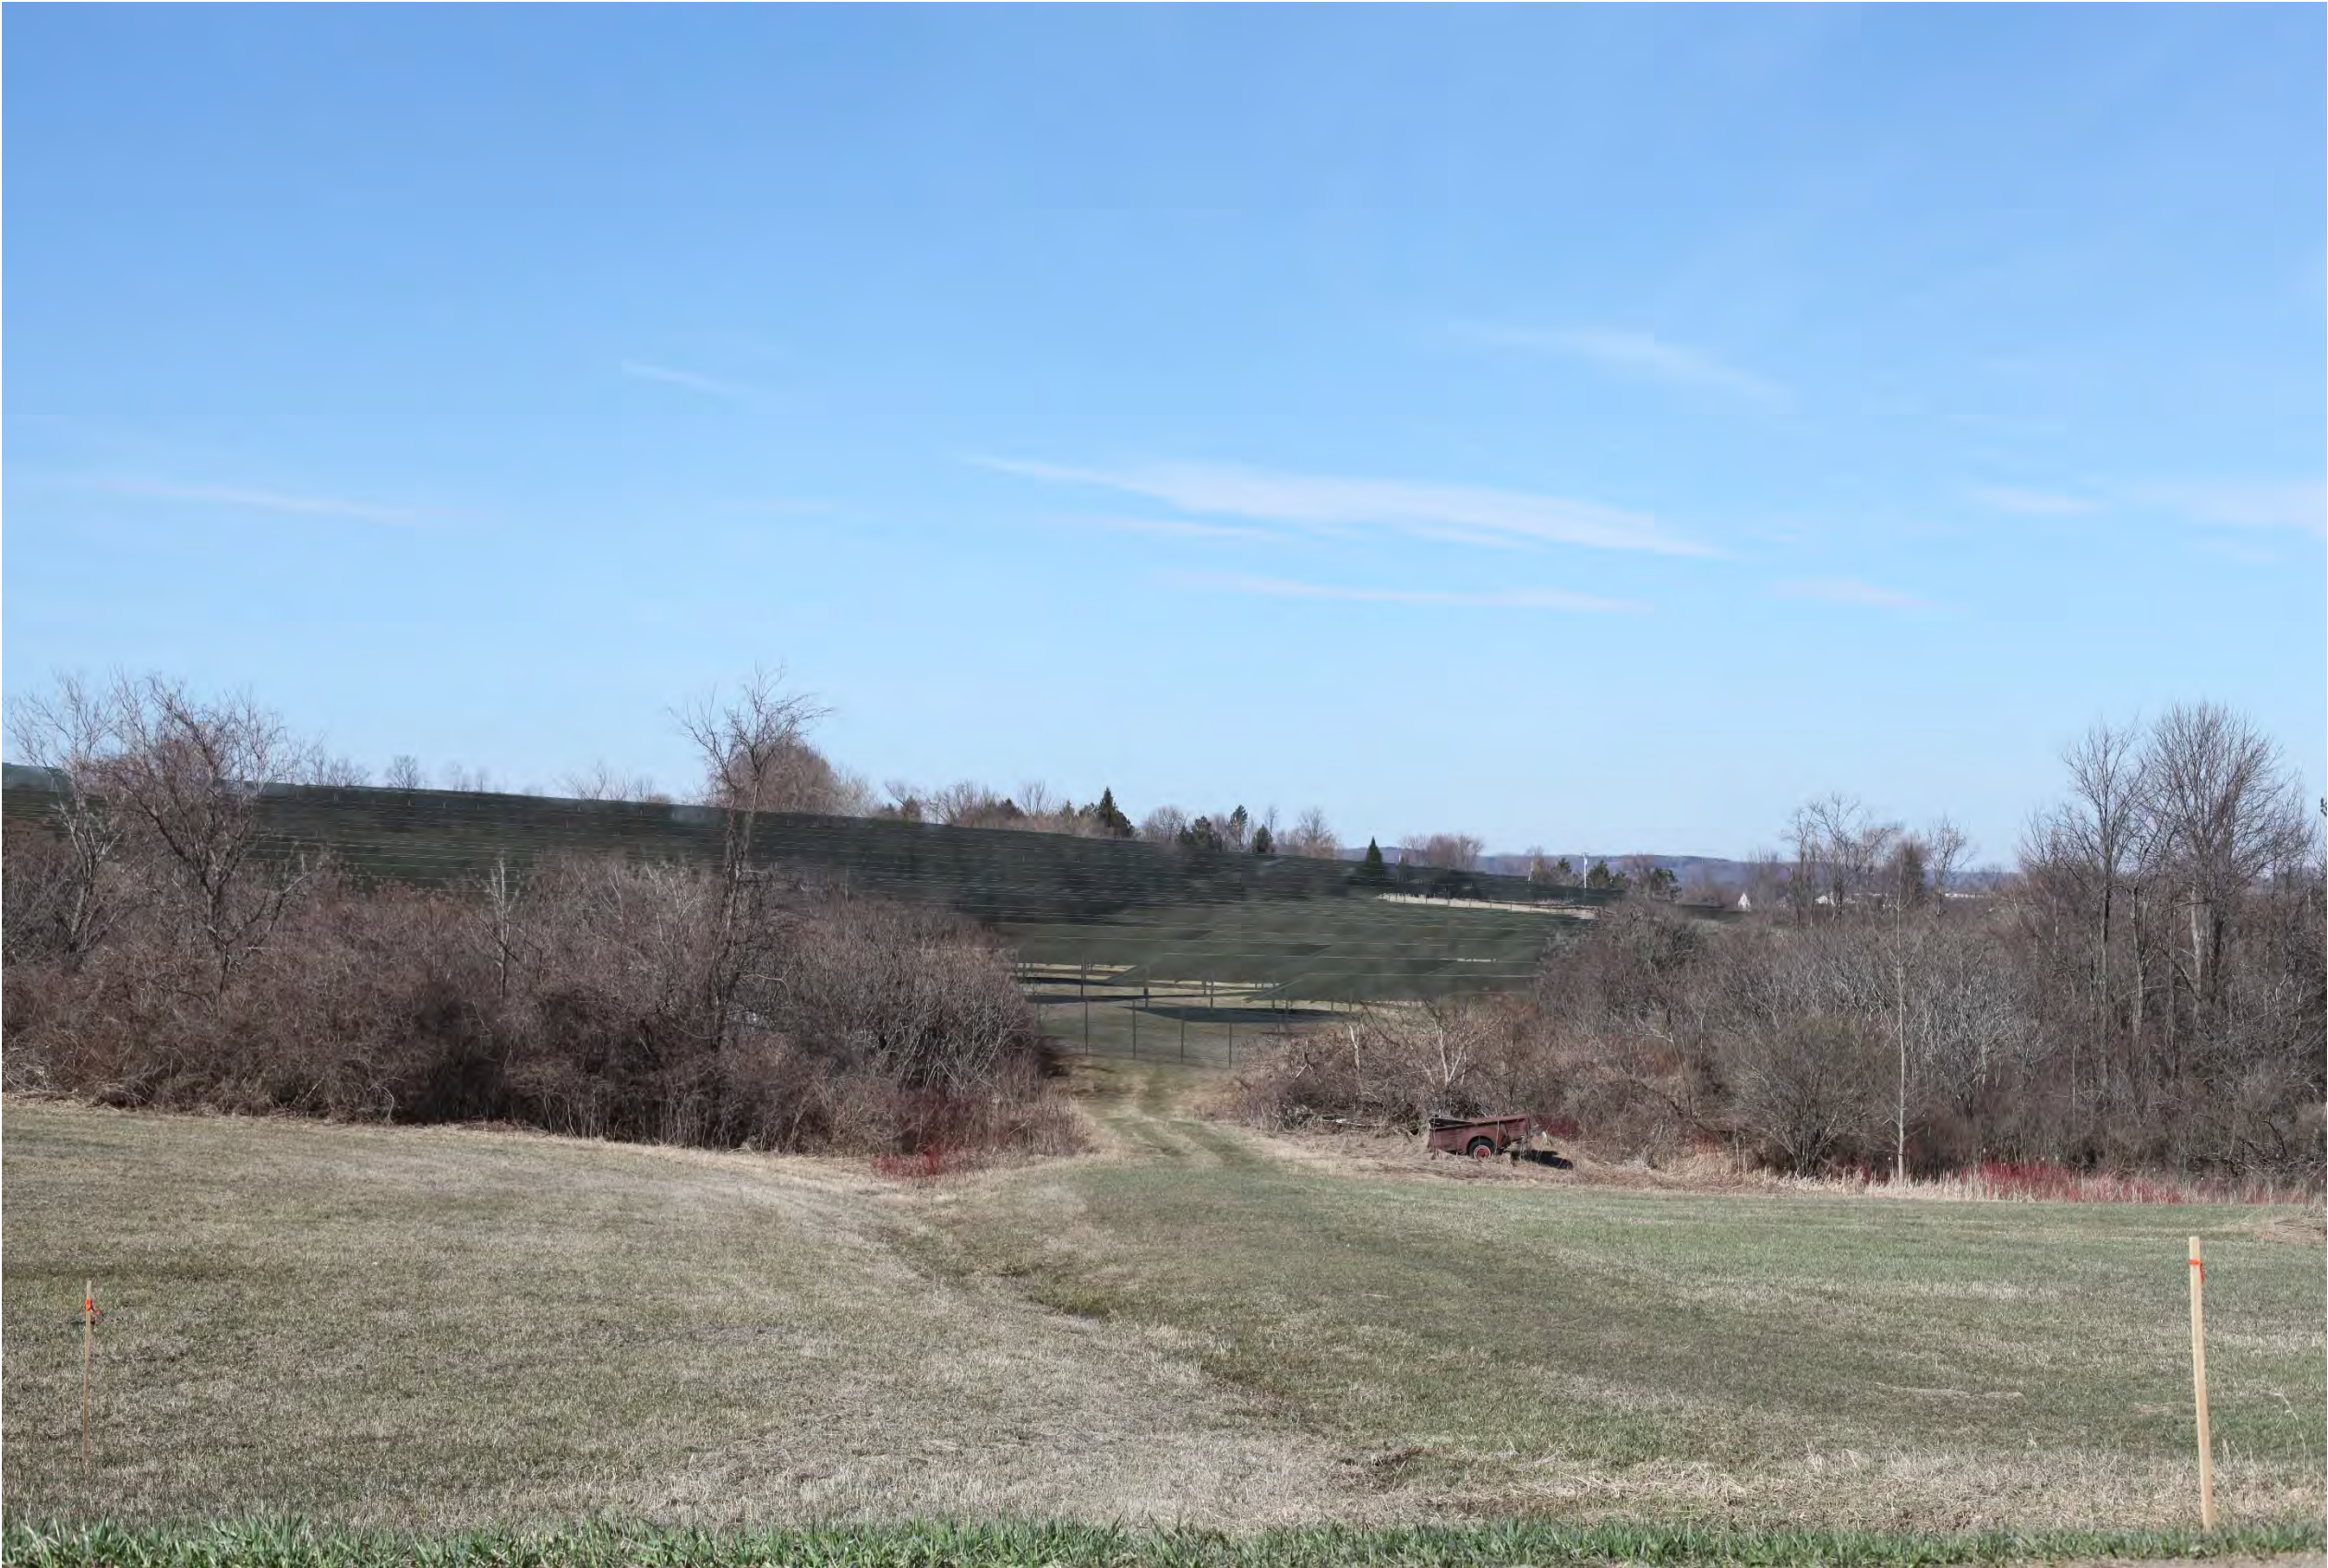
<i>Viewpoint Coordinates in</i>	588060.9
<i>NY State Plane East</i>	1478067.2
<i>Viewpoint Location</i>	Mohr Rd
<i>Viewer Elevation (ft msl)</i>	833
<i>Distance to Fenceline</i>	437 ft
<i>Direction of View</i>	W
<i>Lens Setting</i>	50 mm
<i>Date/Time</i>	4.25.2018/12:05 pm

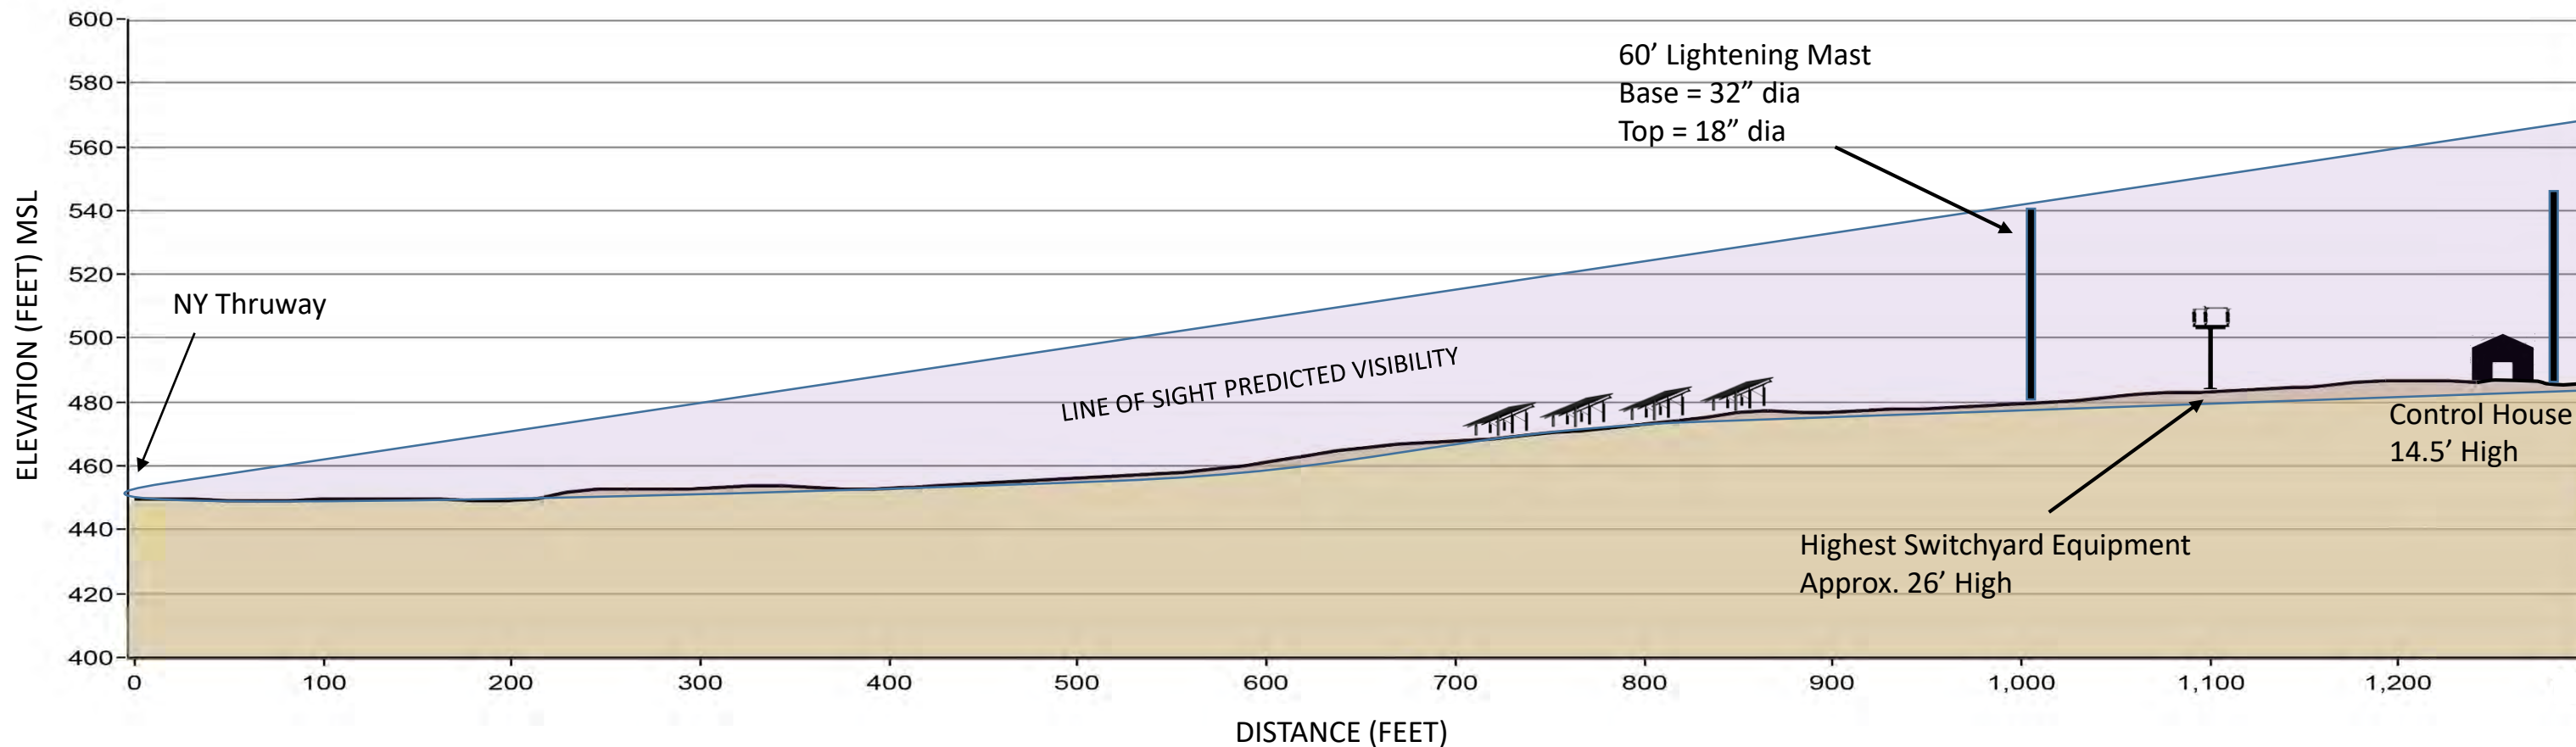
L1 - LINE OF SIGHT FROM THRUWAY TO COLLECTOR STATION

Viewpoint Coordinates in	592096.1
NY State Plane East	1482833.9
Viewpoint Location	NY Thruway
Distance to Object	710 ft
Direction of View	W

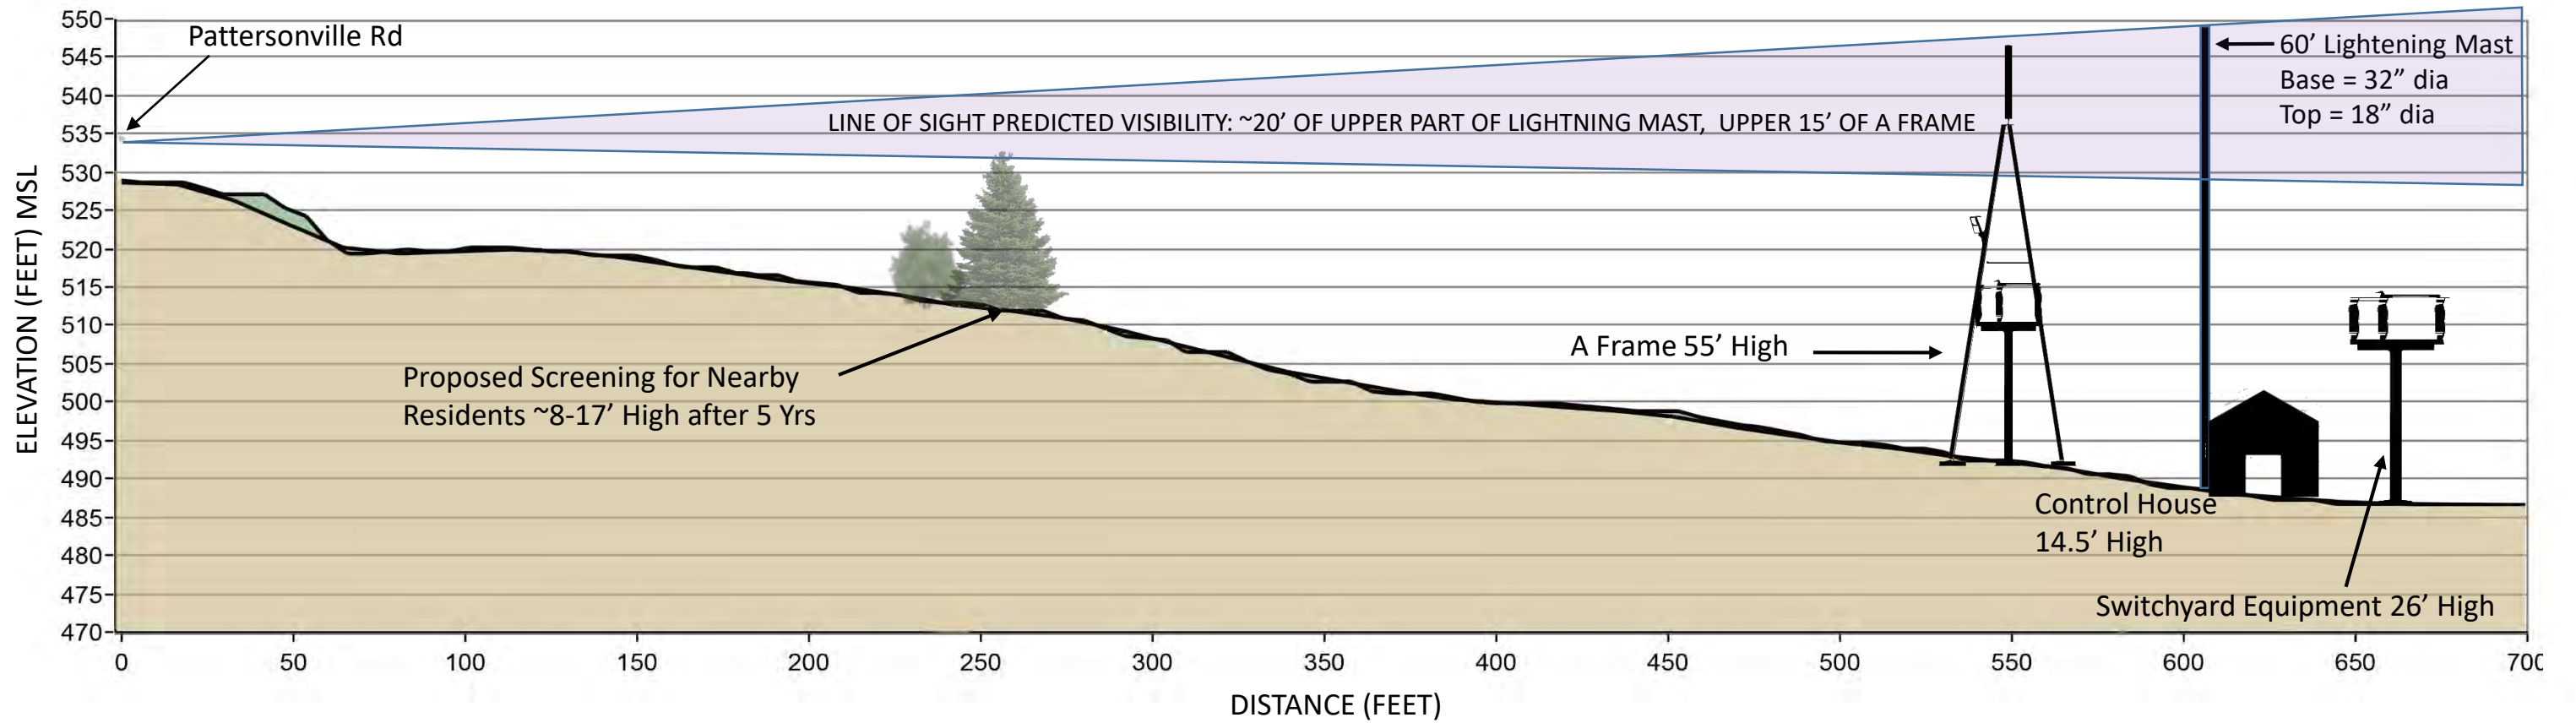
L2 - LINE OF SIGHT FROM PATTERSONVILLE ROAD TO COLLECTOR STATION

Viewpoint Coordinates in	590563.6
NY State Plane East	1482025.4
Viewpoint Location	Pattersonville Rd.
Distance to Object	~480 ft
Direction of View	NE

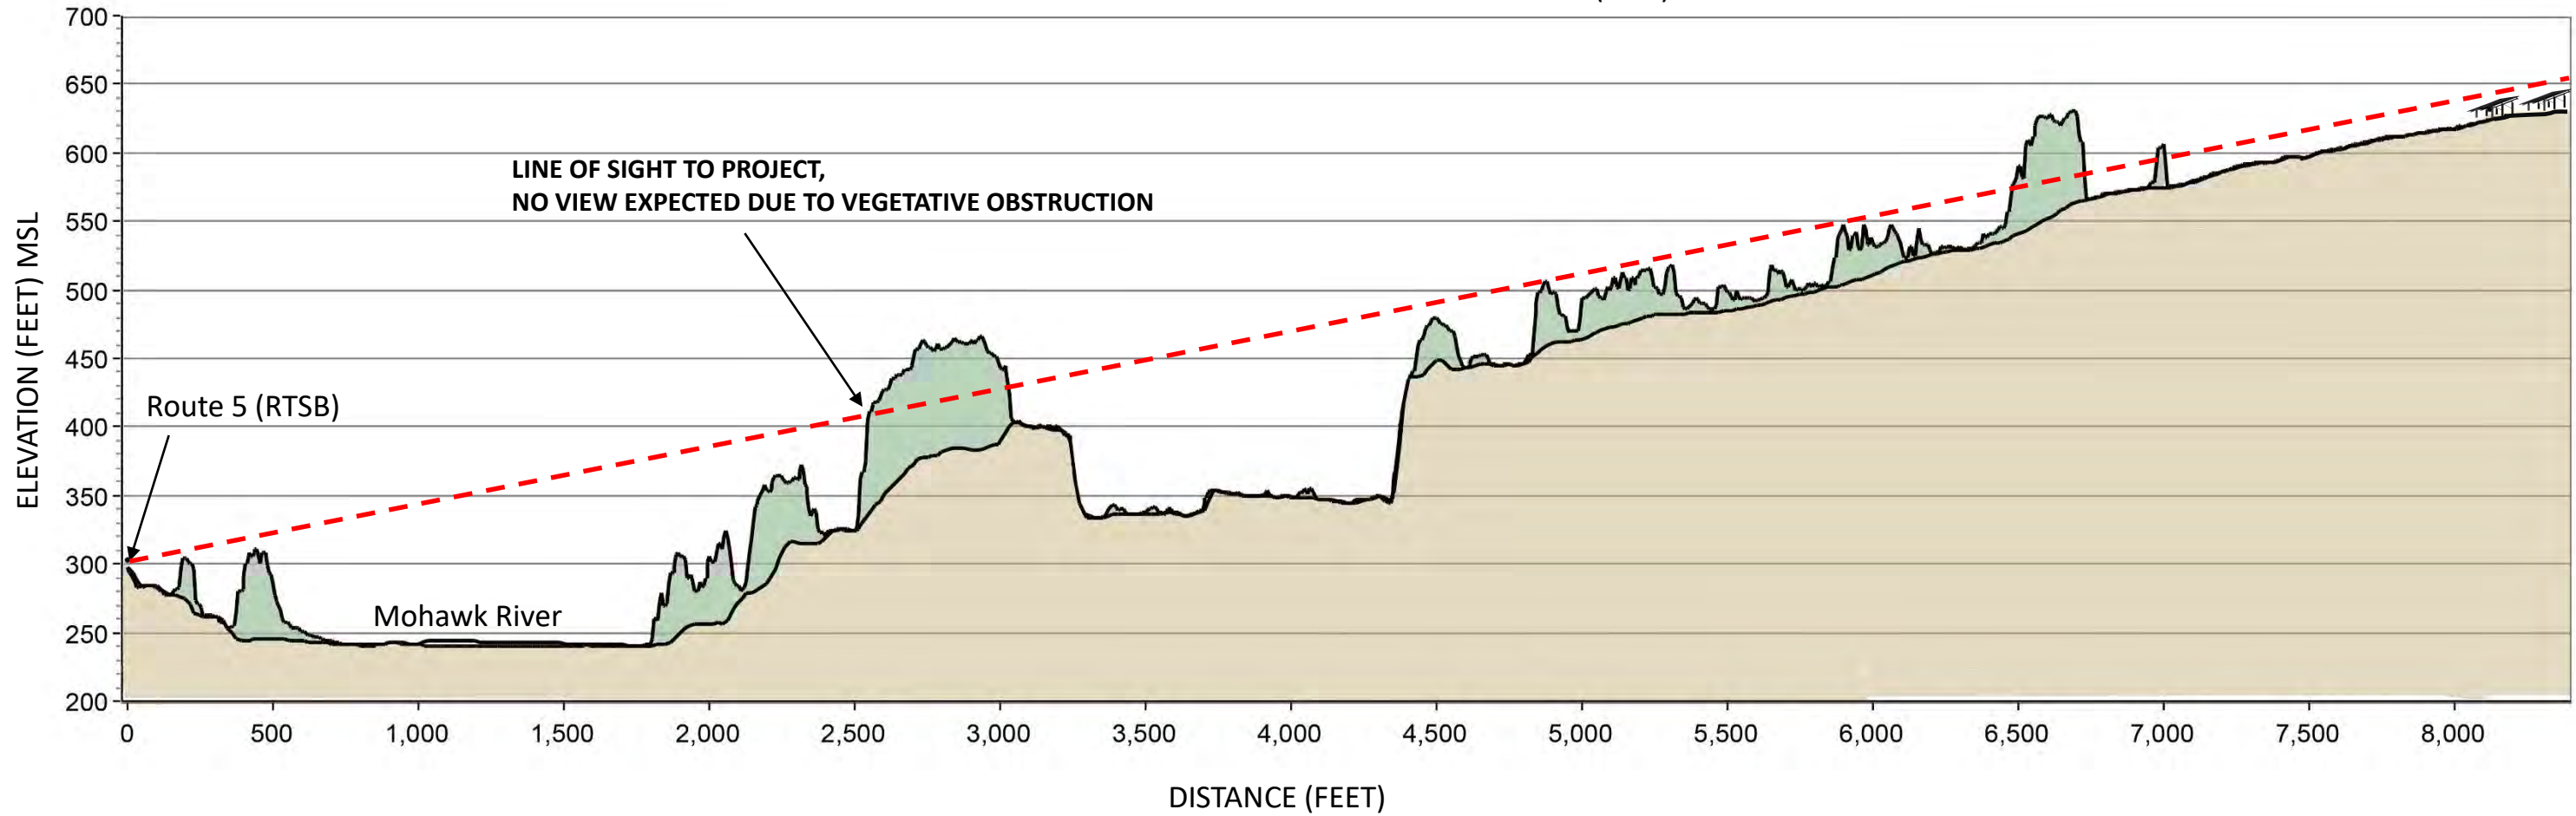
L3- LINE OF SIGHT FROM REVOLUTIONARY TRAIL SCENIC BYWAY (RT 5) TO SOLAR ARRAY

Viewpoint Coordinates in	598891.7
NY State Plane East	1484859.9
Viewpoint Location	Route 5N
Distance to Object	1.5 miles
Direction of View	SW

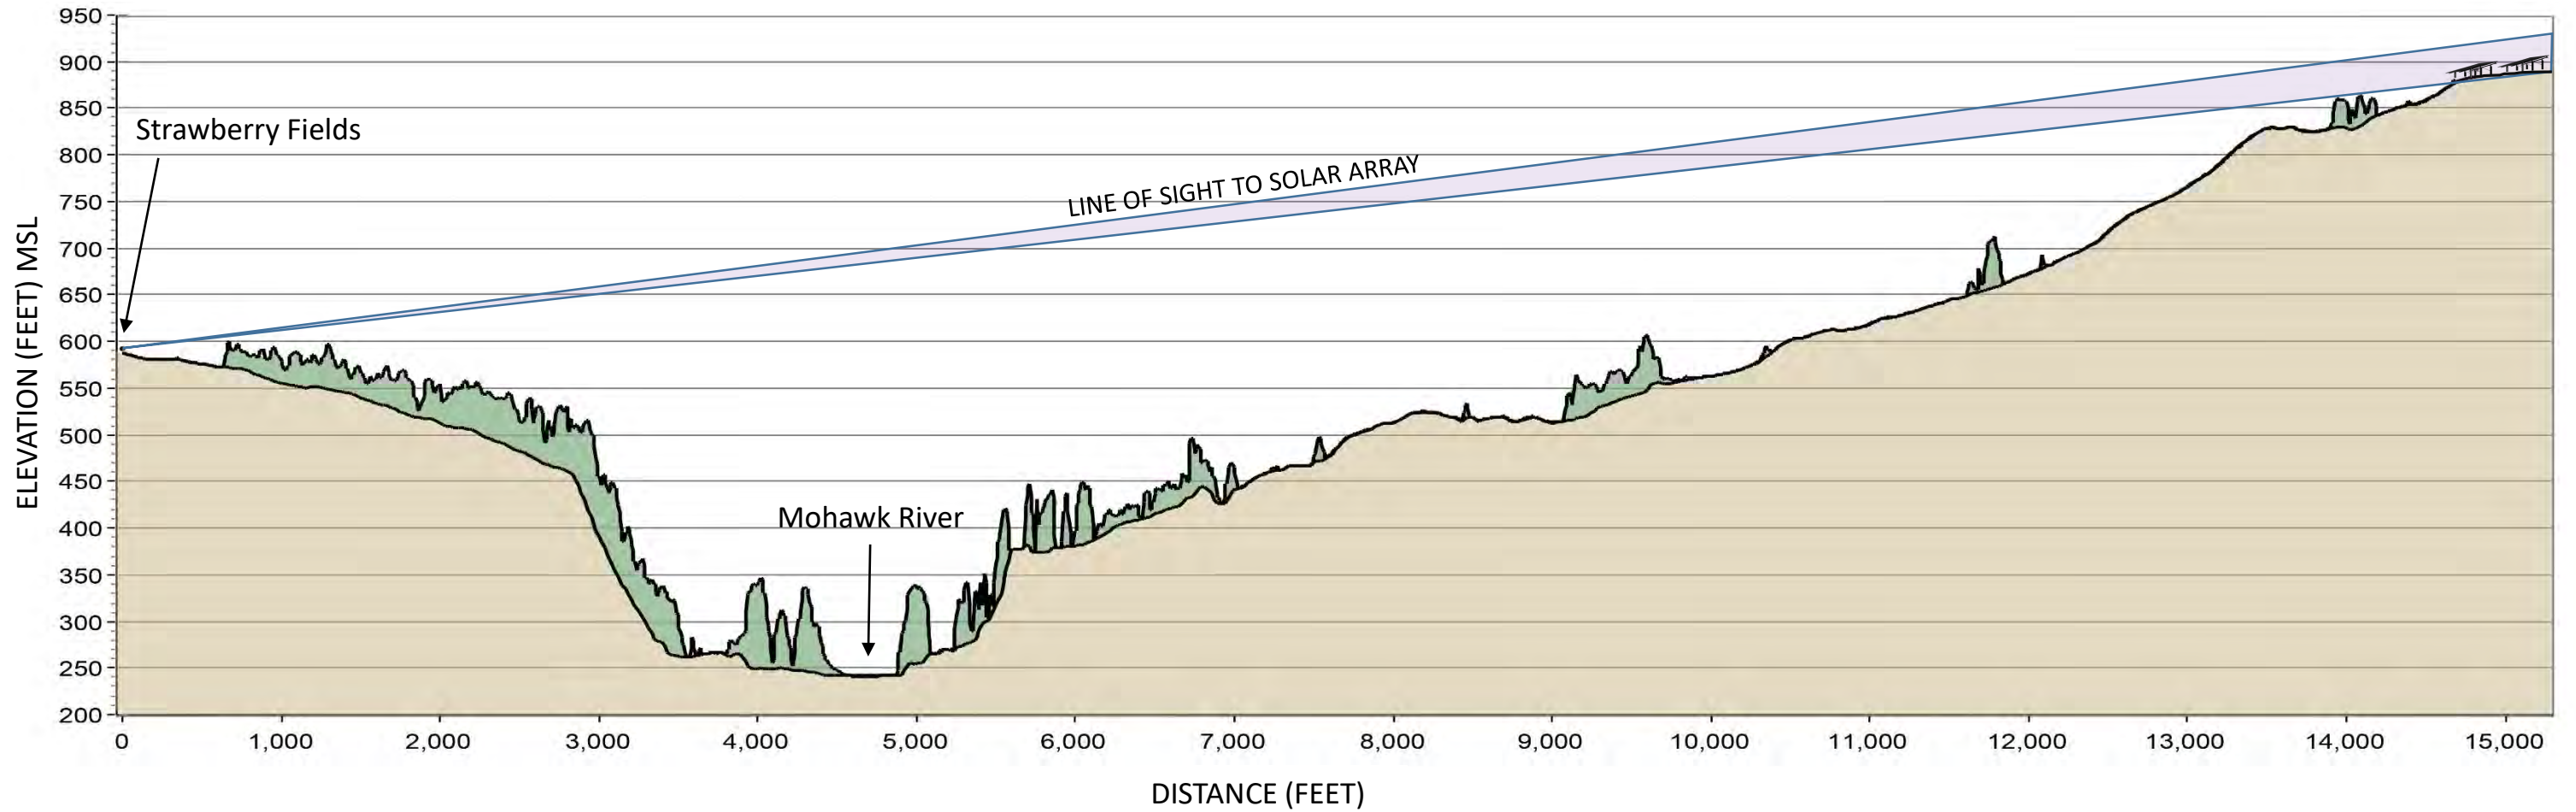
L4- LINE OF SIGHT FROM STRAWBERRY FIELDS NATURE PRESERVE VALLEY VIEW TRAIL TO SOLAR ARRAY

Viewpoint Coordinates in	593227.2
NY State Plane East	1490701
Viewpoint Location	Strawberry Fields Prsv
Distance to Object	2.8 miles
Direction of View	SW
