**HIGH RIVER ENERGY PROJECT  
ARTICLE 10 EXHIBIT 24**

**SIMULATIONS AND LINES OF SIGHT**

**ATTACHMENT 4**

High River Energy Center  
 Florida, New York  
 Visual Simulation of Project  
 August 2019

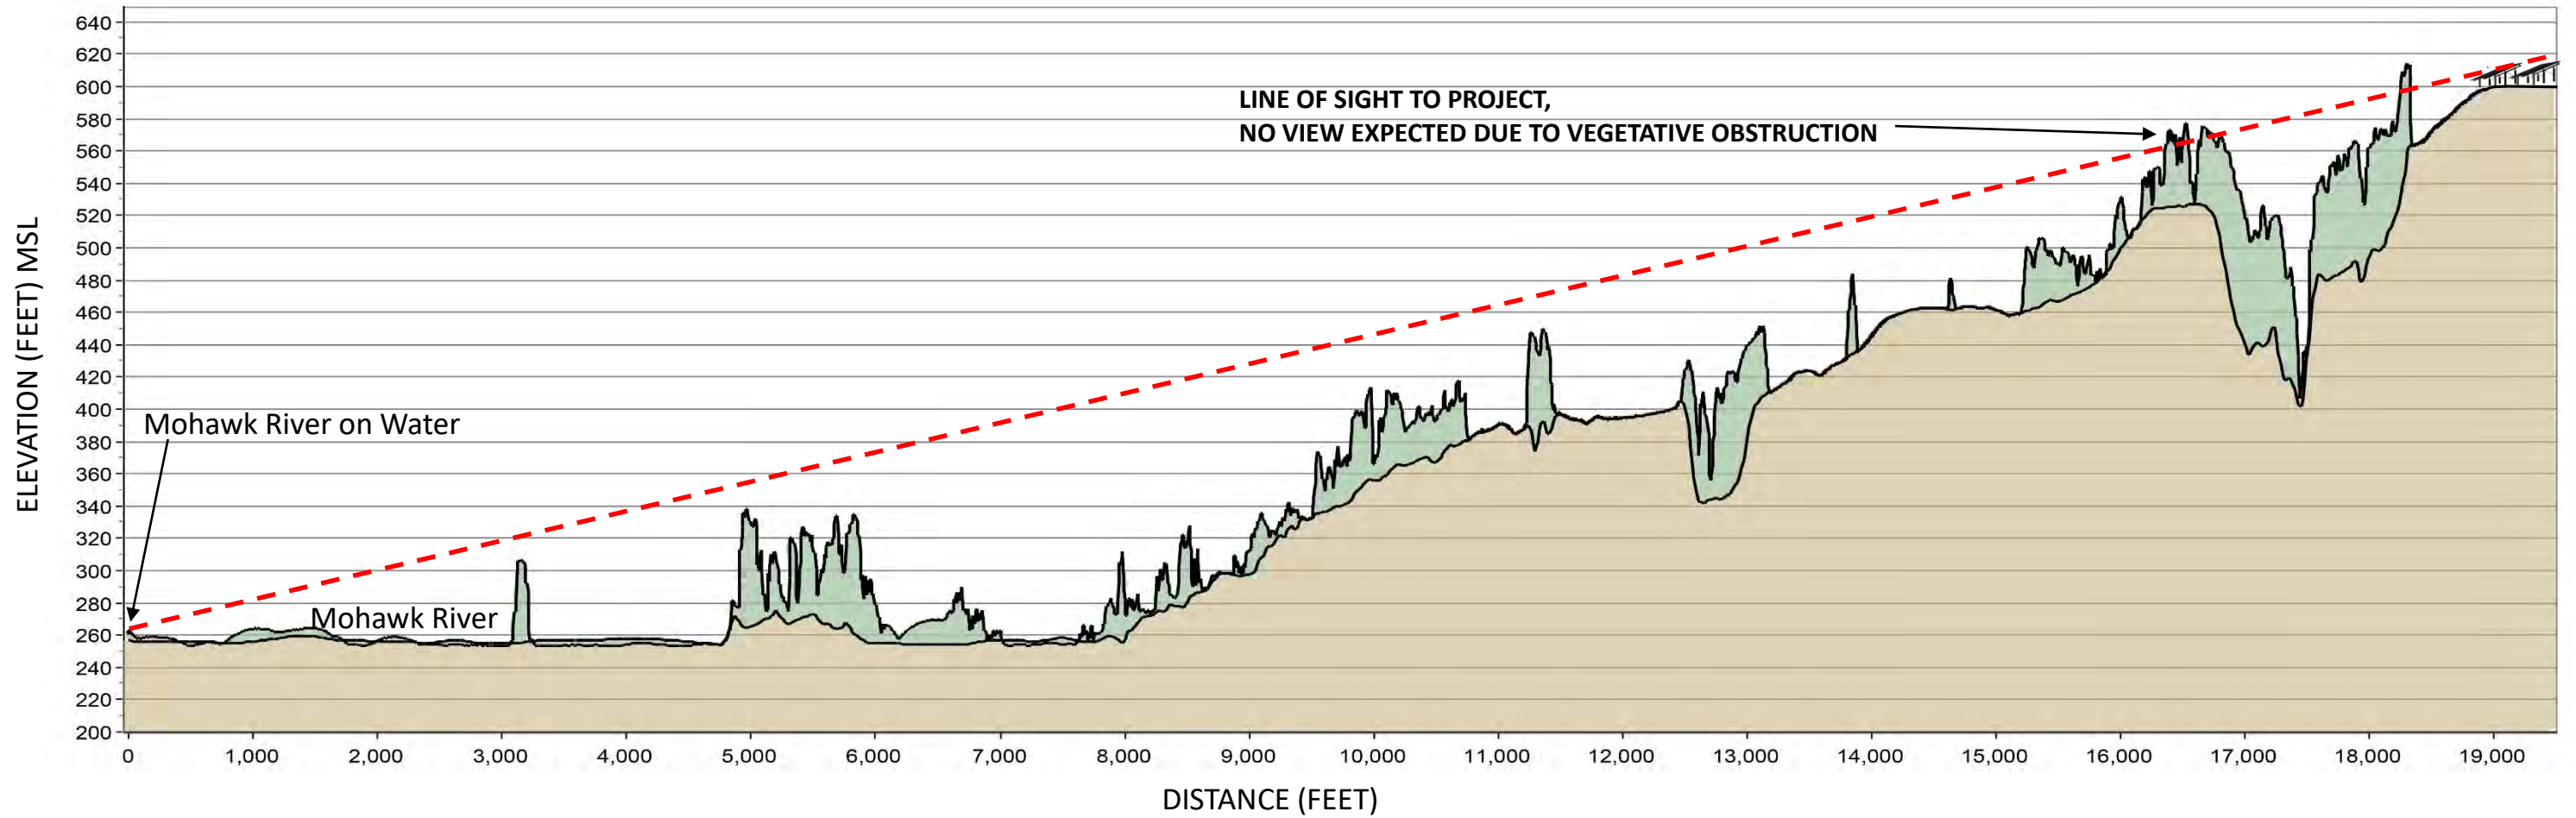
L5- LINE OF SIGHT FROM MOHAWK RIVER NEAR CITY OF AMSTERDAM TO SOLAR ARRAY

Viewpoint Coordinates in	572064.9
NY State Plane East	1496546.1
Viewpoint Location	Mohawk River
Distance to Object	3.6 miles
Direction of View	SE

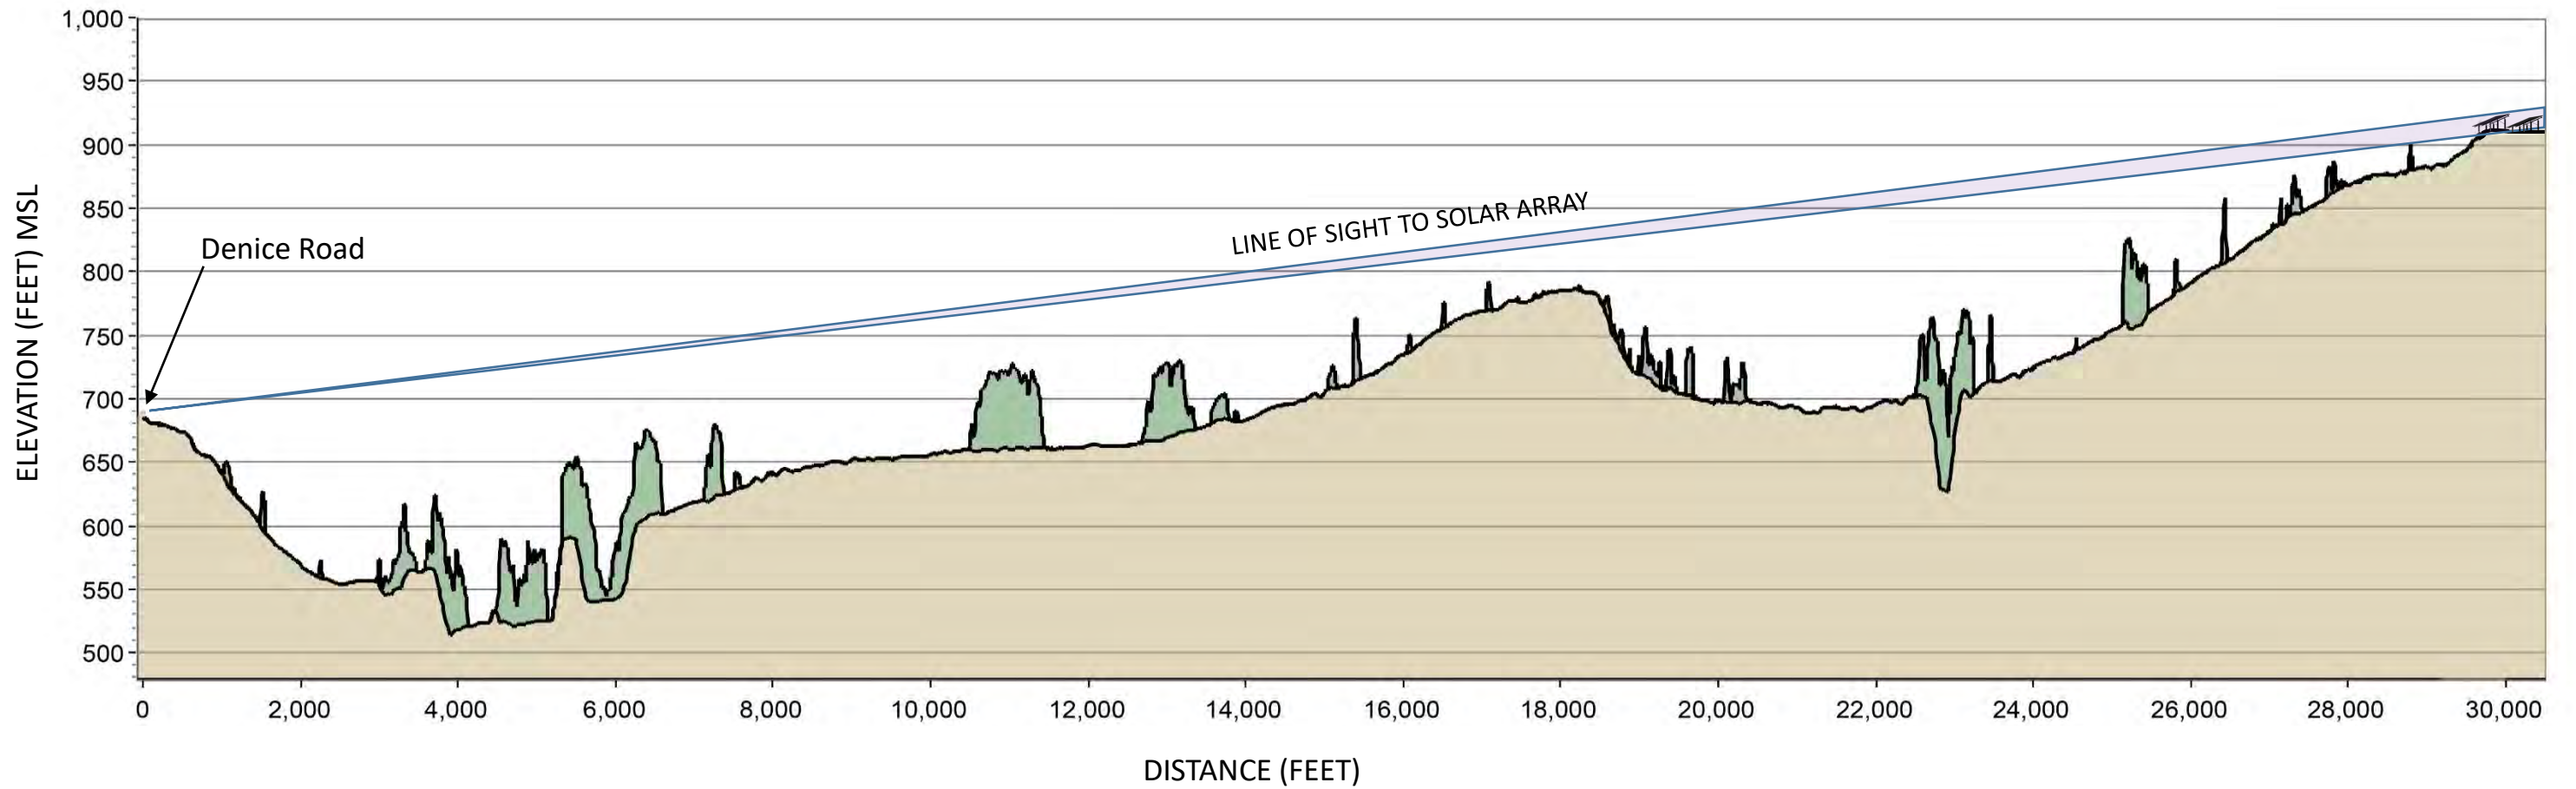
L6- LINE OF SIGHT FROM DENICE ROAD TO SOLAR ARRAY

Viewpoint Coordinates in	558984.8
NY State Plane East	1481162.4
Viewpoint Location	Denice Rd
Distance to Object	5.6 miles
Direction of View	E

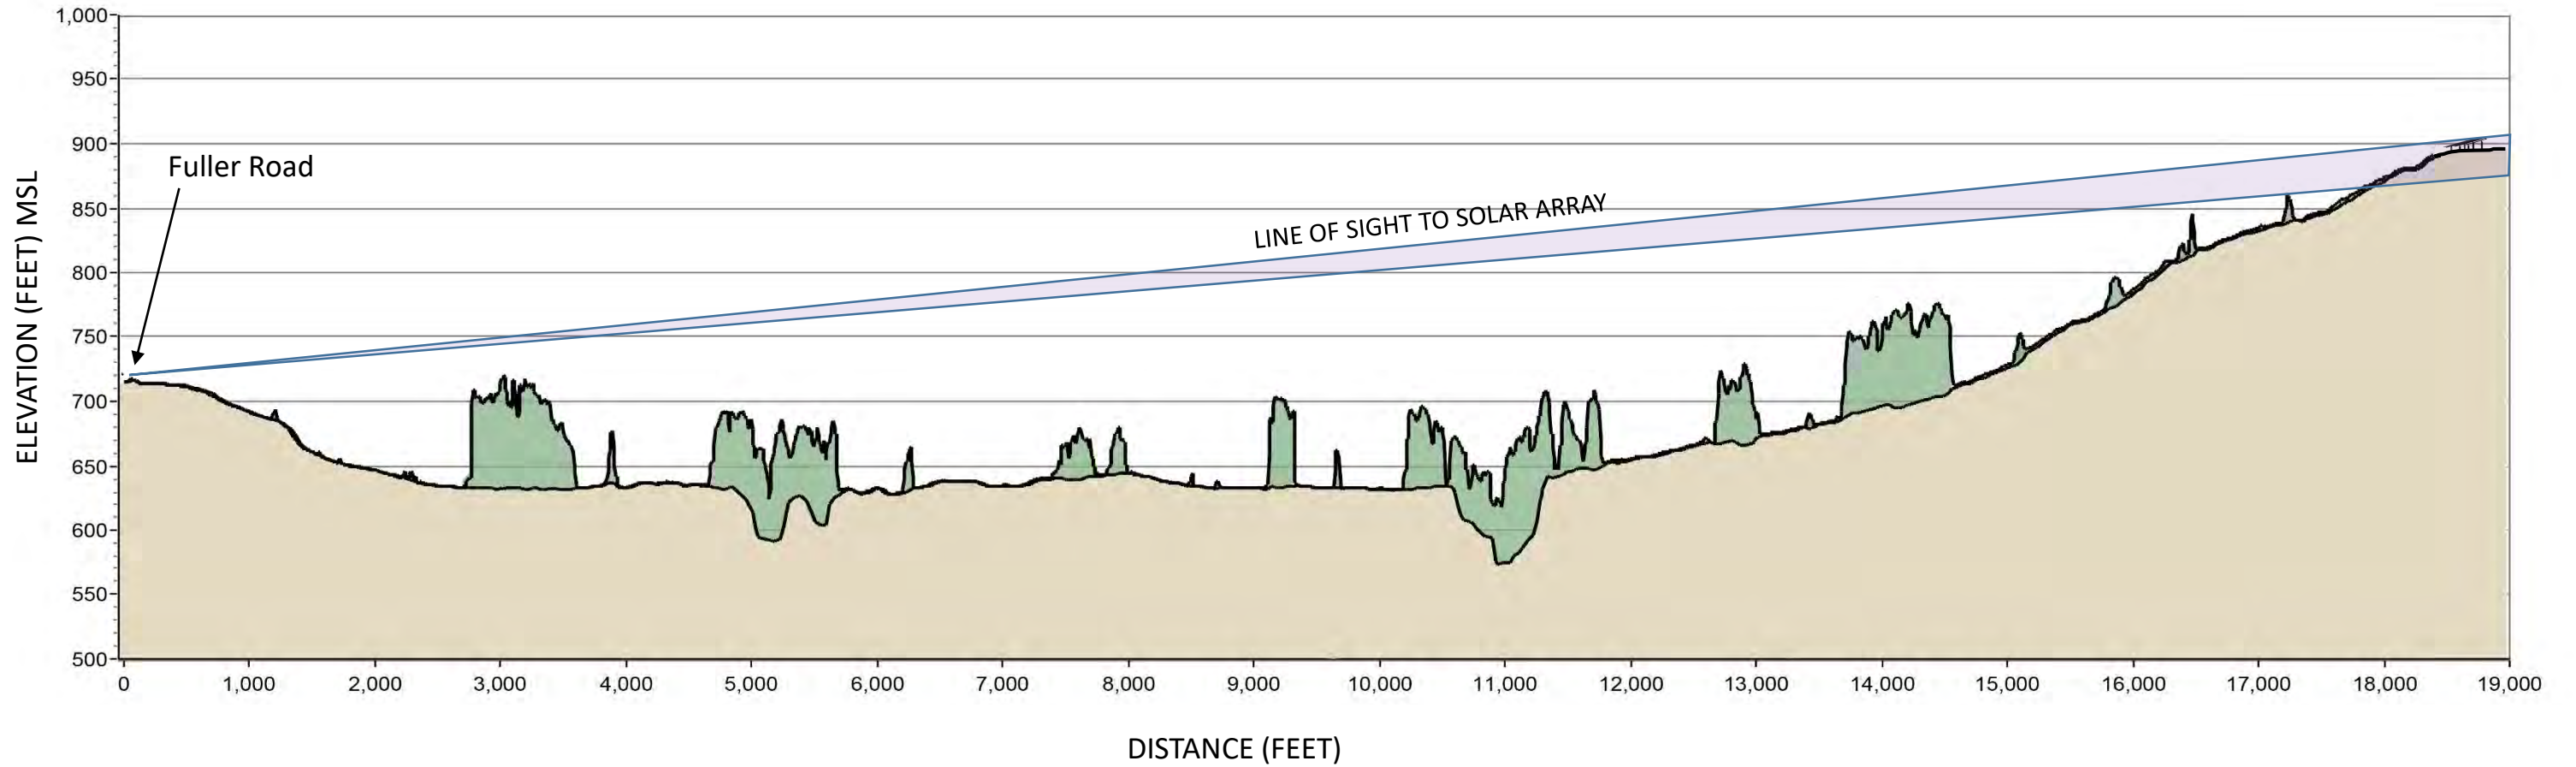
L7- LINE OF SIGHT FROM FULLER ROAD TO SOLAR ARRAY

Viewpoint Coordinates in	571478
NY State Plane East	1484957.6
Viewpoint Location	Fuller Rd
Distance to Object	3.5 miles
Direction of View	SE

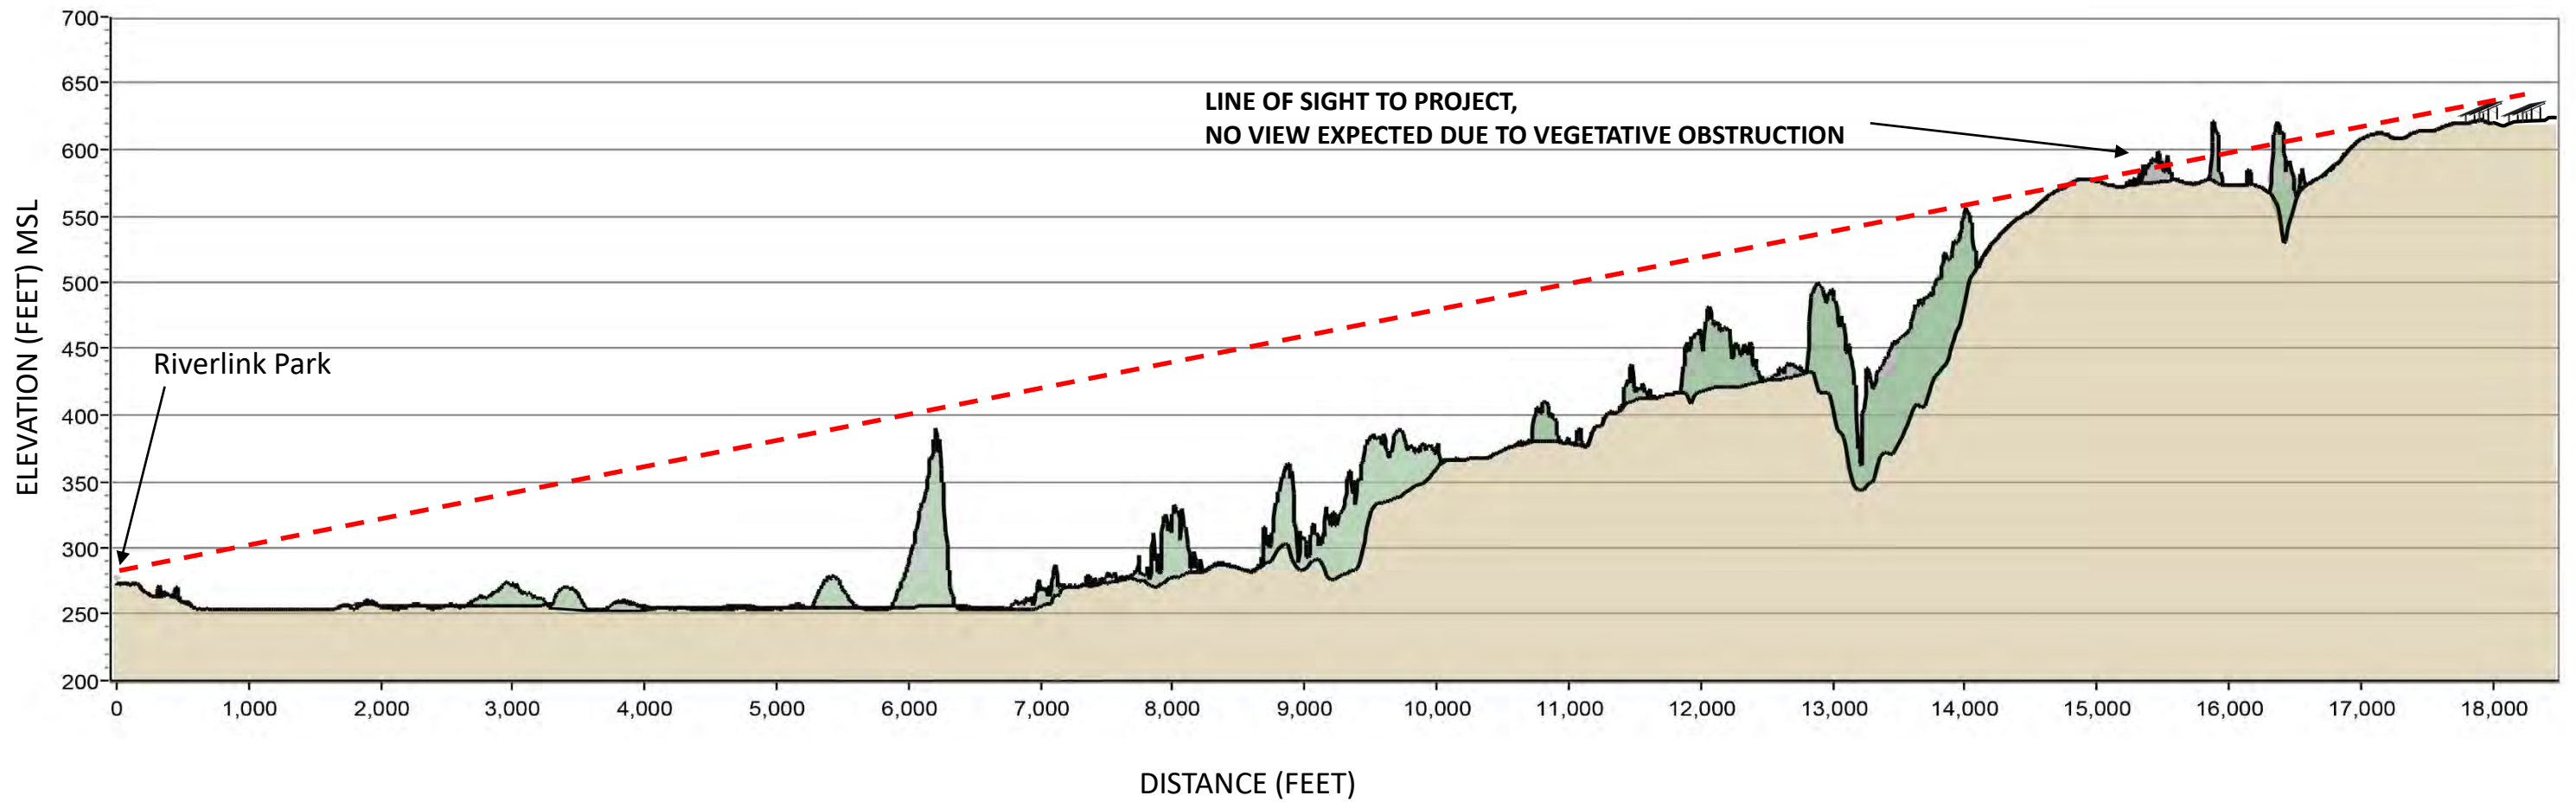
L8- LINE OF SIGHT FROM RIVERLINK PARK TO SOLAR ARRAY

Viewpoint Coordinates in	574506.4
NY State Plane East	1494277.3
Viewpoint Location	Riverlink Park,
Distance to Object	3.4 miles
Direction of View	SE

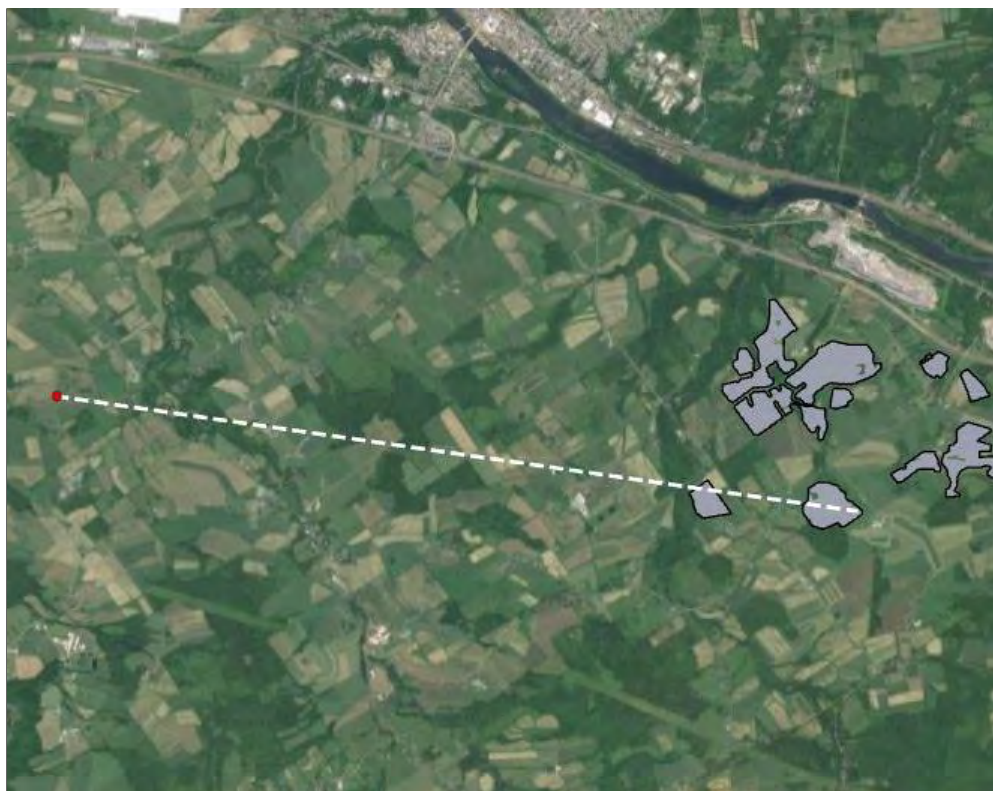
Viewpoint Location Aerial

Viewpoint Coordinates in	558984.8
NY State Plane East	1481162.4
Viewpoint Location	Denice Rd
Distance to Object	5.6 miles
Direction of View	E

High River Energy Center  
 Florida, New York  
 Line of Sight  
 September 2019

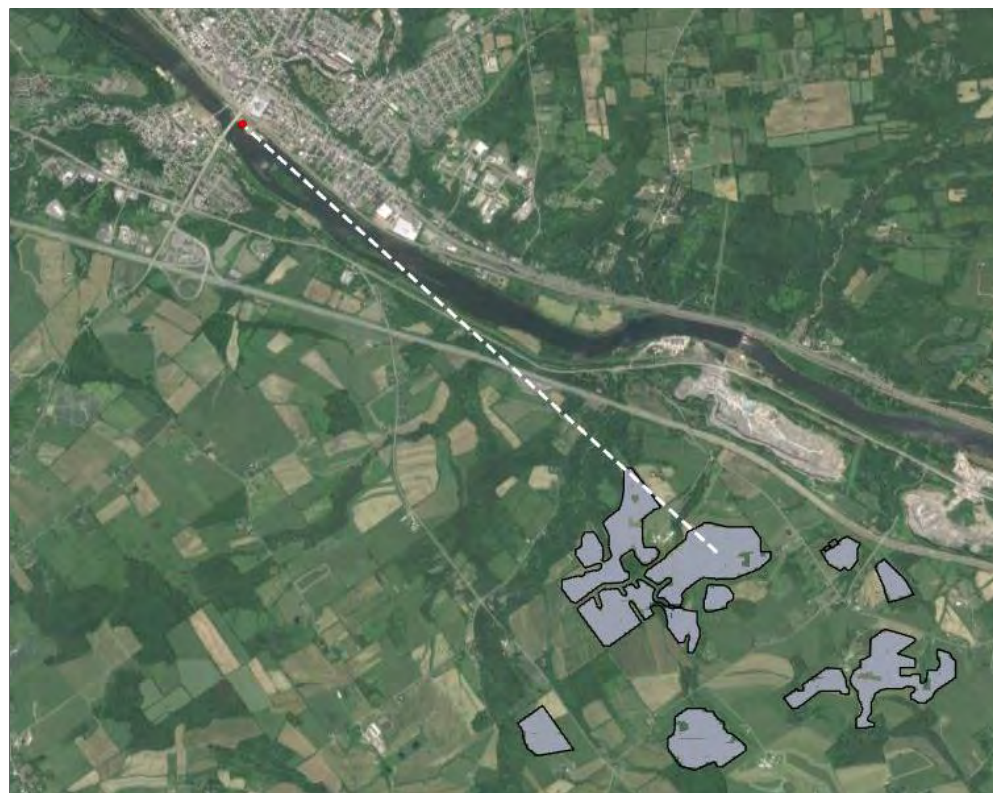
Viewpoint Location Aerial

Viewpoint Coordinates in	574506.4
NY State Plane East	1494277.3
Viewpoint Location	Riverlink Park,
Distance to Object	3.4 miles
Direction of View	SE

High River Energy Center  
 Florida, New York  
 Line of Sight  
 September 2019
