Visual Impact Assessment Update for Alternative Layout

May 2020

High River Energy Center
Town of Florida, New York

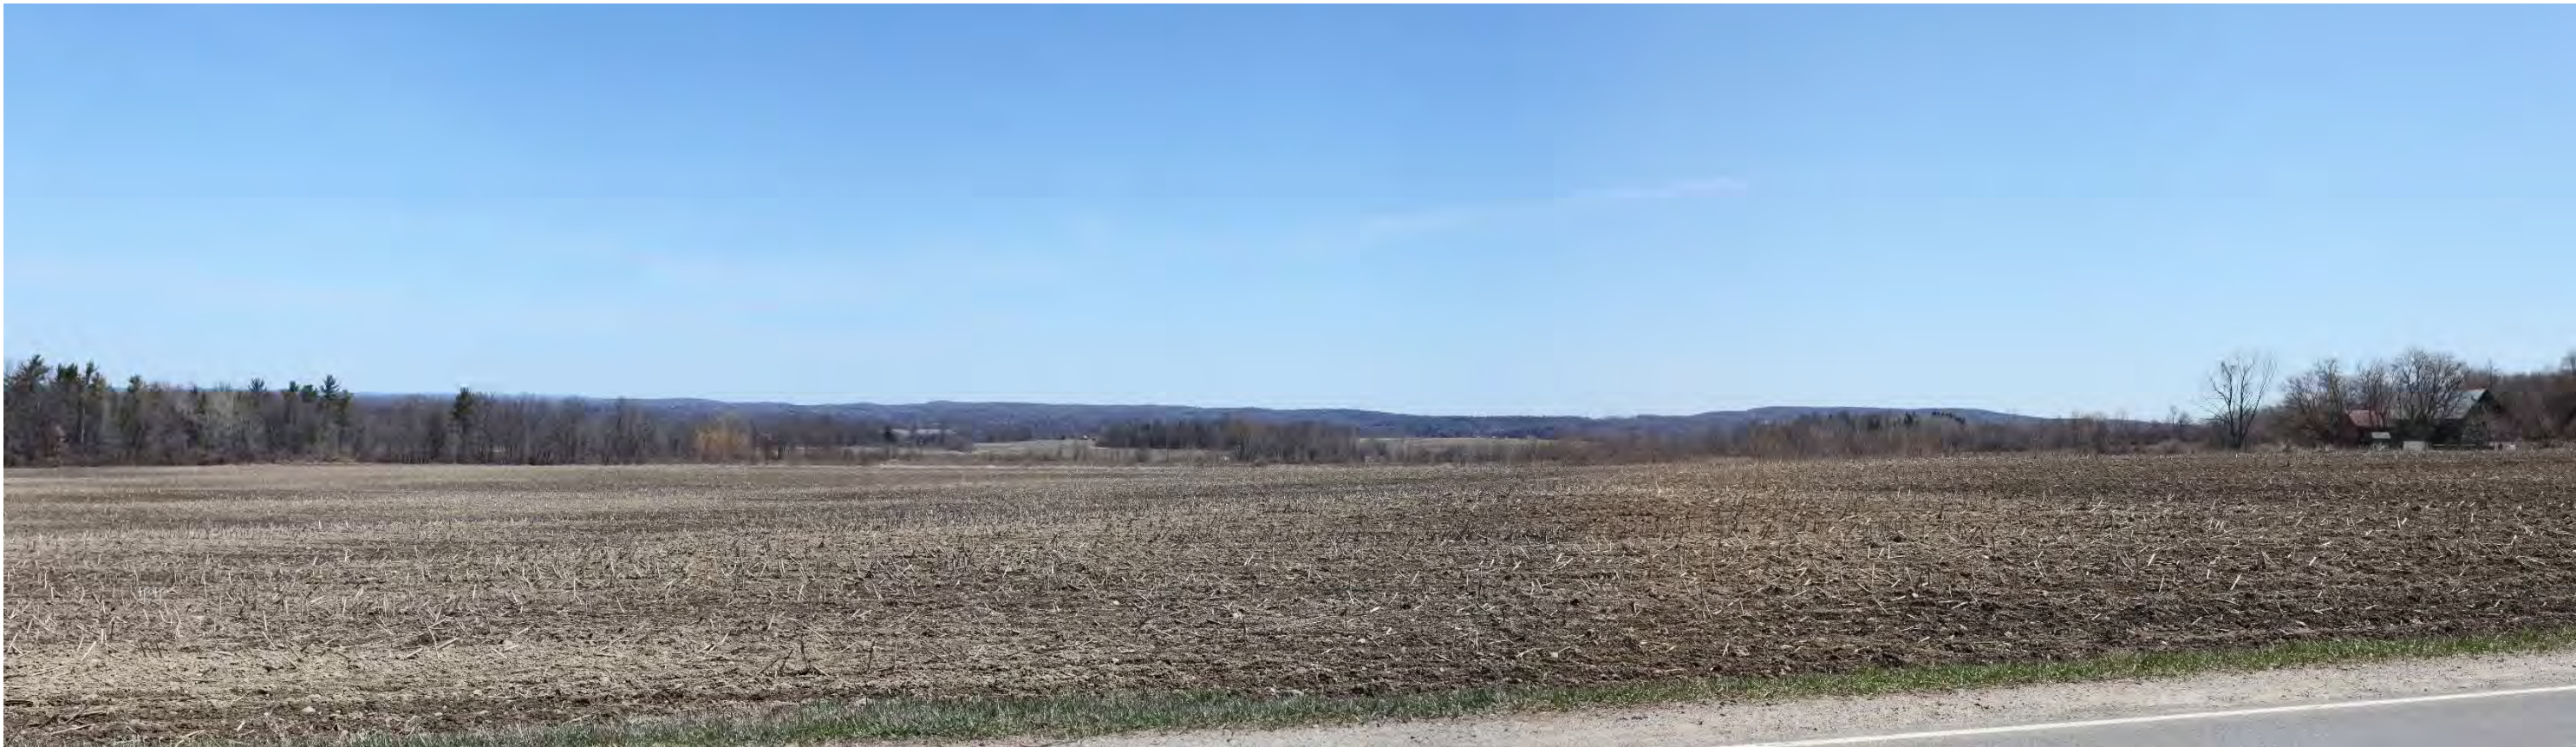
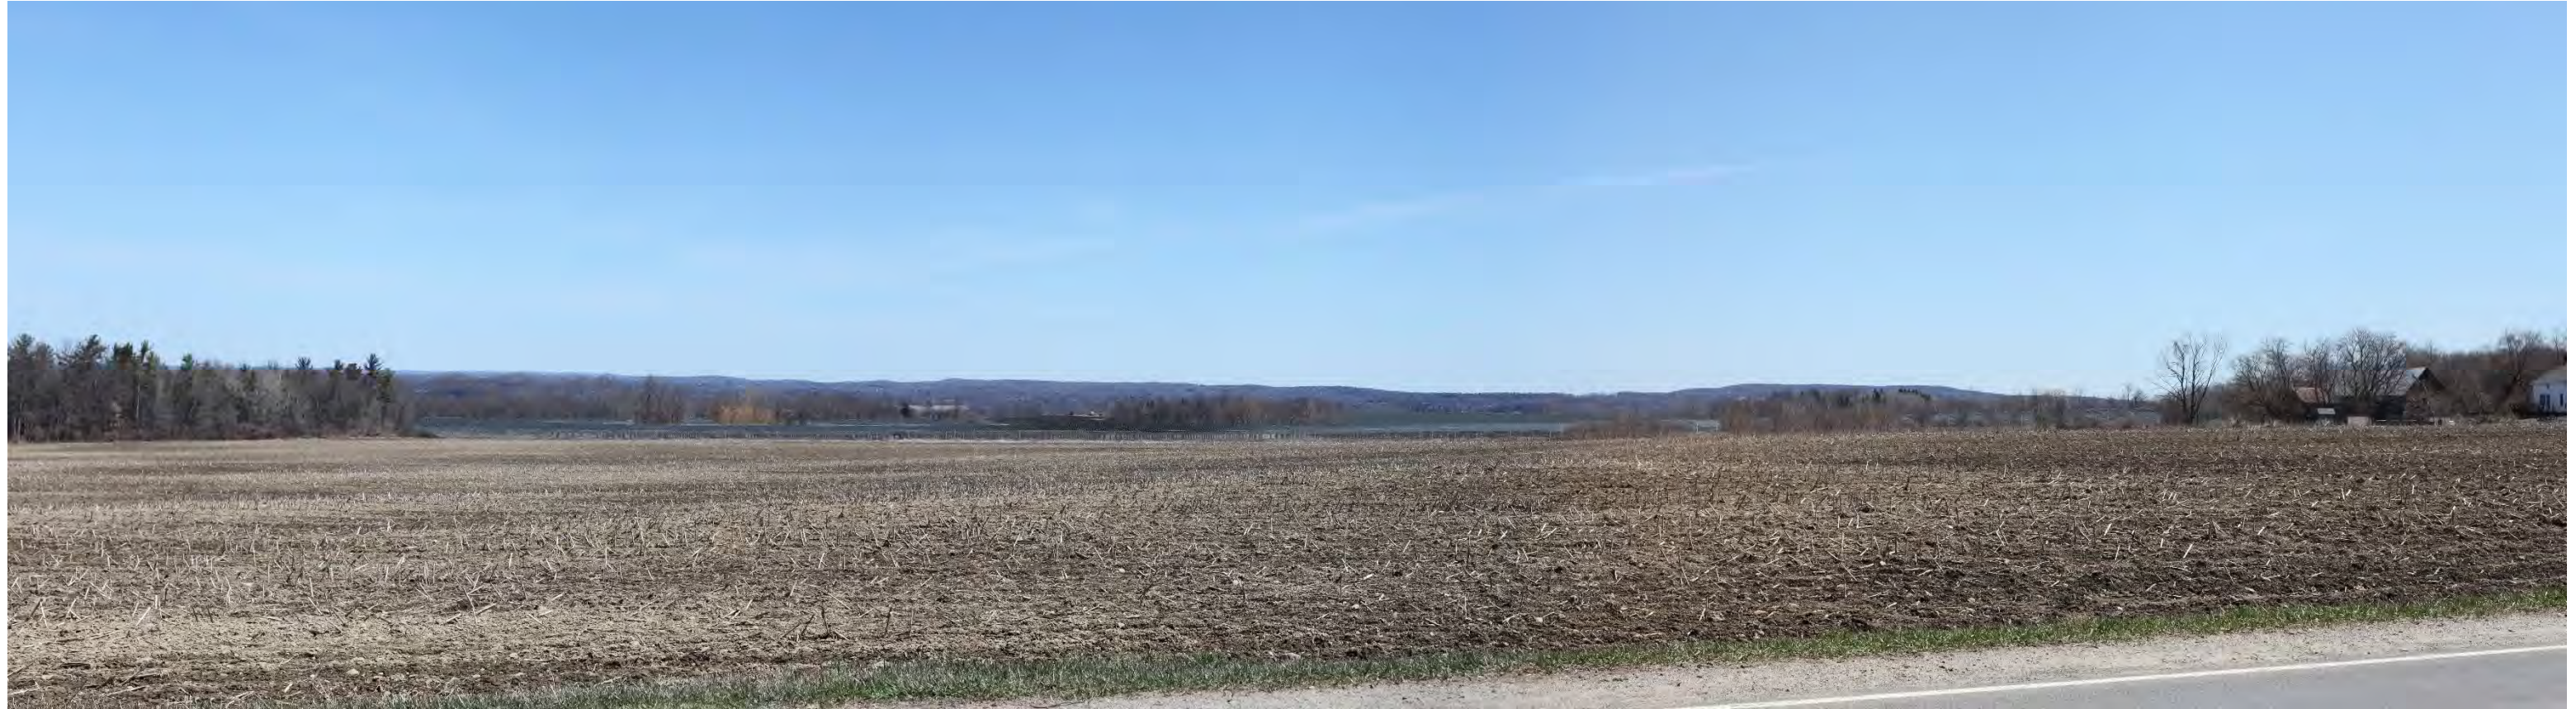
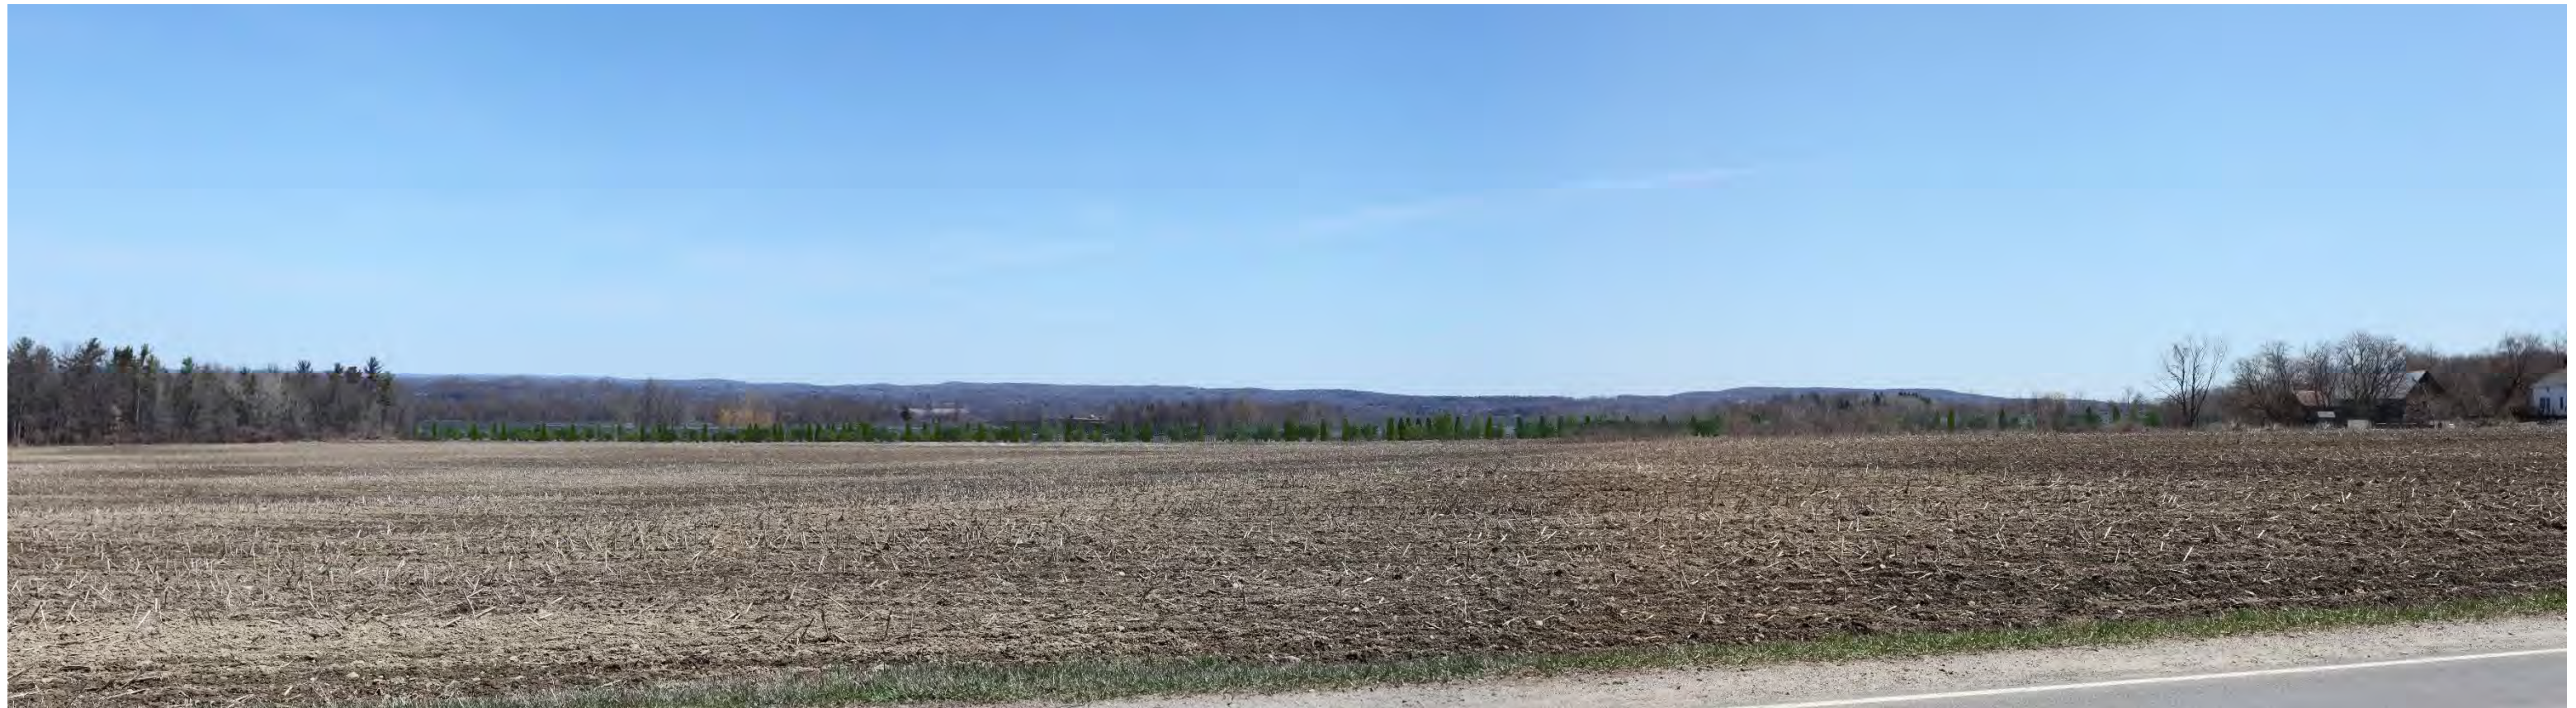
Proposed Conditions

Proposed Conditions – Mitigation at 5 Years

Project: High River Energy Center	Date: 5/14/2020	
Viewpoint Number: 5	Preparer: J.Bartos	
Viewpoint Location: Florida		
Viewpoint Description: view from Thayer Road, view east		
Landscape Similarity Zone: Agricultural/Open		
Viewer Type (check all that apply): <input checked="" type="checkbox"/> Resident <input type="checkbox"/> Commuter/Traveler <input checked="" type="checkbox"/> Local Motorist <input type="checkbox"/> Recreational <input type="checkbox"/> Worker		
Seasonal Condition: <input type="checkbox"/> Leaf On <input checked="" type="checkbox"/> Leaf Off		
Visual Rating Element	Rating	Notes
Part 1 Visual Contrast Rating		
Form Contrast	1.5	Lateral breadth of project introduces one new large form that is apparent but is similar to larger shapes in landscape.
Line Contrast	0.5	Similar to existing lines in scape. Project undulates parallel to existing topography
Texture Contrast	0.5	Texture not discernible but what is visible is similar to what is in view

Color Contrast	1.5	Color contrast is low to moderate because project blends in with similar colors that comprise the middleground and background trees.
Project Scale Contrast/Spatial Dominance	1.5	Low profile arrays is subordinate in view. The project is not high but there is lateral breadth.
Broken Horizon Line	0	None.
Visual Acuity	1.5	Project can be seen but low discernible detail.
Amount of Project Clearing Seen	1	Middleground trees removed
Screening/Mitigation Needed	1	Project can be seen but colors blend in with background and there are some trees in front that block views.
Total	9	
Part 2 Viewpoint Sensitivity Rating		
Within a Visual Resource*	0	
View of Other Visual Resource with Project*	0	
A Listed/Known Scenic Resource of Visual Quality*	0	
Number of Viewers (Low or High Use Activity)	2	Local road.
Duration of View	1.5	Short duration views from road travel. A couple houses in vicinity
Presence of Existing Development	0.5	Residence in view

Project: High River Energy Center	Date: 5/14/20	
Viewpoint Number: 5	Preparer: Michael Ross	
Viewpoint Location: Florida		
Viewpoint Description: view from Thayer Road, view east		
Landscape Similarity Zone: Agricultural/Open, Developed Road, and Residential		
Viewer Type (check all that apply): <input checked="" type="checkbox"/> Resident <input type="checkbox"/> Commuter/Traveler <input checked="" type="checkbox"/> Local Motorist <input type="checkbox"/> Recreational <input type="checkbox"/> Worker		
Seasonal Condition: <input type="checkbox"/> Leaf On <input checked="" type="checkbox"/> Leaf Off		
Visual Rating Element	Rating	Notes
Part 1 Visual Contrast Rating		
Form Contrast	1	The panels are located away in the distance, in a relatively low-lying area creating a horizontal line that mimics the existing terrain quite well.
Line Contrast	.5	The layout and configuration and location of the array fields allows for minimum contrast to occur by following the existing surface terrain and ground line configuration.

Texture Contrast	1	Distance softens the impact of size and hard surfaces somewhat, allowing for less contrast between the existing texture conditions of the farm field and vegetation present.
Color Contrast	1	The darker greys of the arrays blend in somewhat with the background but, contrast some with the existing farm field in the foreground.
Project Scale Contrast/Spatial Dominance	1	The solar array fields are obviously quite large however, the patterns of the arrays do not dominate the landscape but, are foreign in appearance.
Broken Horizon Line	0	The horizon line is not broken in this view by the solar arrays.
Visual Acuity	.5	Little to no detail is present in this view with regards to the solar arrays.
Amount of Project Clearing Seen	1.5	Some clearing can be discerned.
Screening/Mitigation Needed	2	Strategically placed plantings can mitigate potential future views of the solar arrays and have been provided.

Project: High River Energy Center	Date: 5/15/2020	
Viewpoint Number: 5	Preparer: Heather Vaillant	
Viewpoint Location: Florida		
Viewpoint Description: view from Thayer Rd, view east		
Landscape Similarity Zone: Agricultural/Open, Developed Road		
Viewer Type (check all that apply): <input checked="" type="checkbox"/> Resident <input type="checkbox"/> Commuter/Traveler <input checked="" type="checkbox"/> Local Motorist <input type="checkbox"/> Recreational <input type="checkbox"/> Worker		
Seasonal Condition: <input type="checkbox"/> Leaf On <input checked="" type="checkbox"/> Leaf Off		
Visual Rating Element	Rating	Notes
Part 1 Visual Contrast Rating		
Form Contrast	1	New form in landscape but it is a small part of the view
Line Contrast	0.5	
Texture Contrast	1	Panels contrast with the field they are placed in, but are difficult to see
Color Contrast	1	Contrasts with field
Project Scale Contrast/Spatial Dominance	1

Broken Horizon Line	0	Horizon not broken
Visual Acuity	0.5	Difficult to see the panels
Amount of Project Clearing Seen	1.5	Clearing visible
Screening/Mitigation Needed	2	
Total	8.5	
Part 2 Viewpoint Sensitivity Rating		
Within a Visual Resource*	0	
View of Other Visual Resource with Project*	0	
A Listed/Known Scenic Resource of Visual Quality*	0	
Number of Viewers (Low or High Use Activity)	1	Local road, residences near viewpoint
Duration of View	1.5	Short duration from road but long-term views from residences
Presence of Existing Development	1.5	Minimal development present within view
Uniqueness of Landscape Compared to Region	2	
Presence of Water	0	
Total	6	
Part 3 Scenic Quality		
General Scenic Quality of the View	2

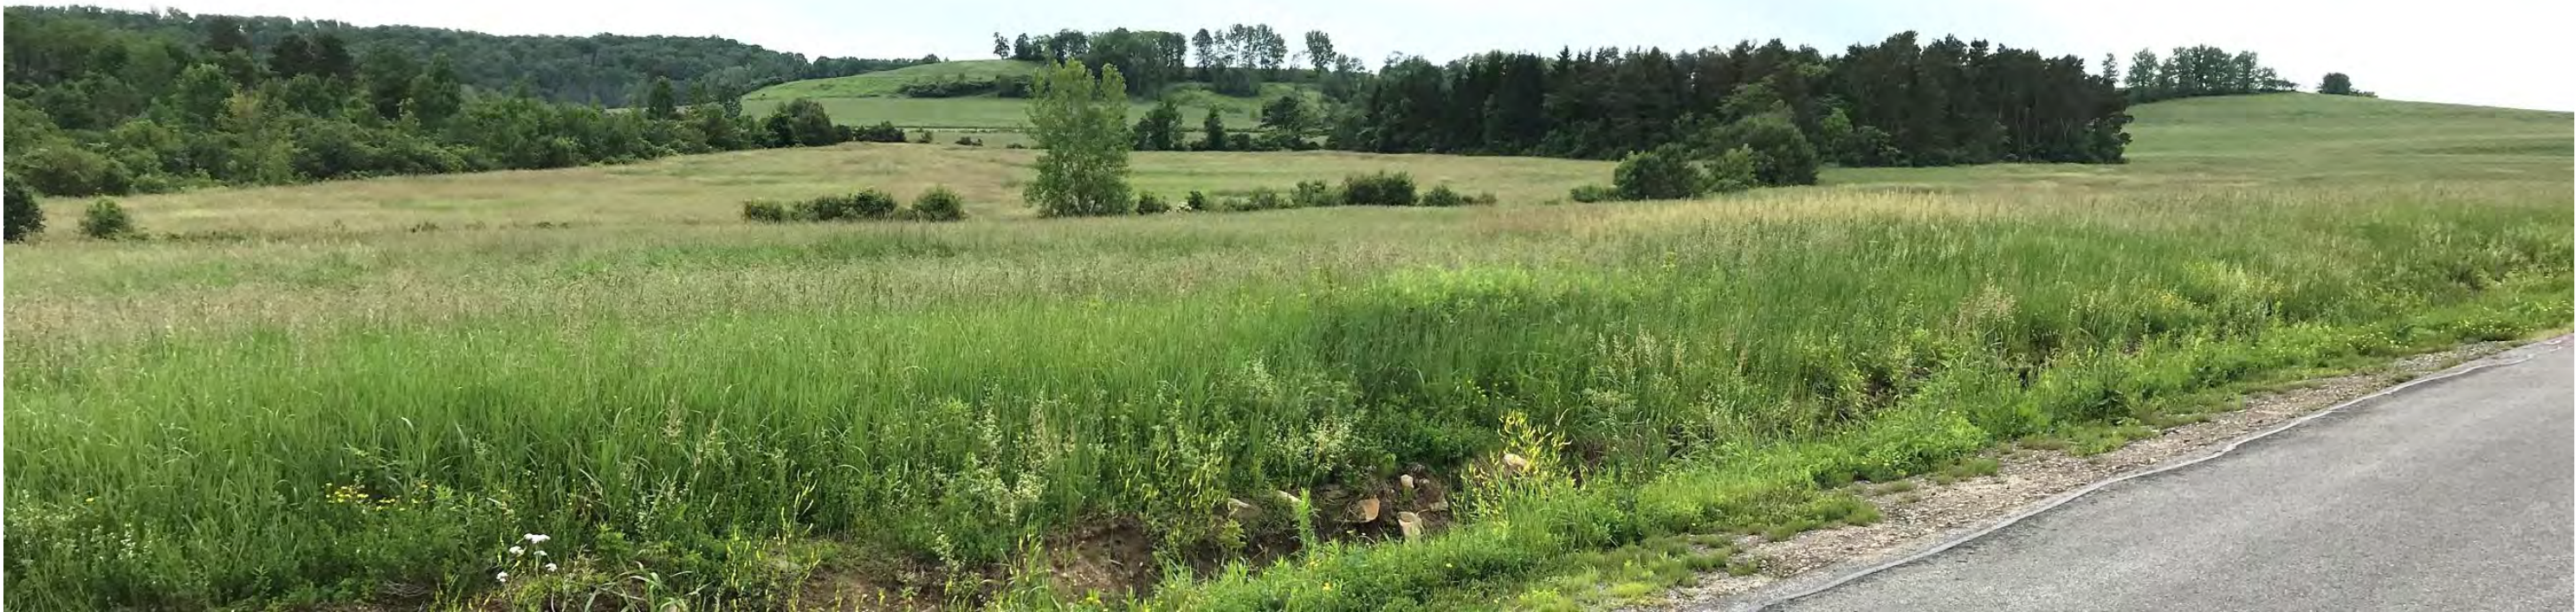
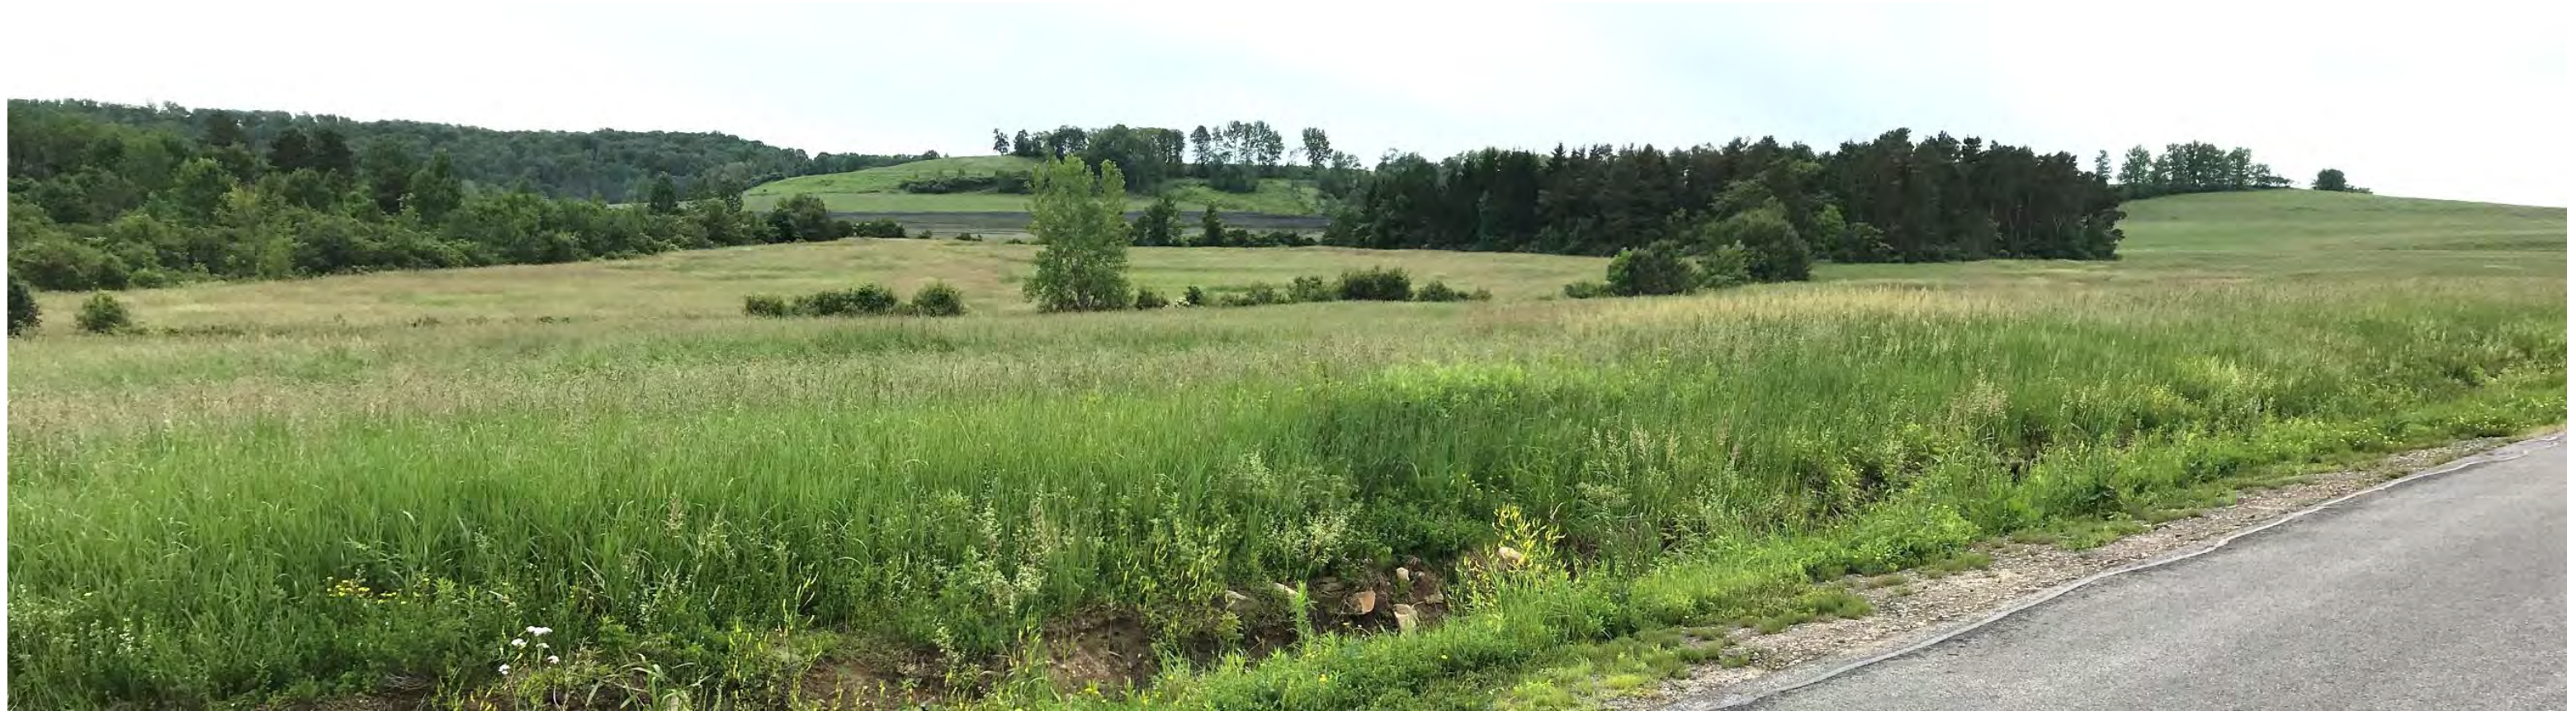
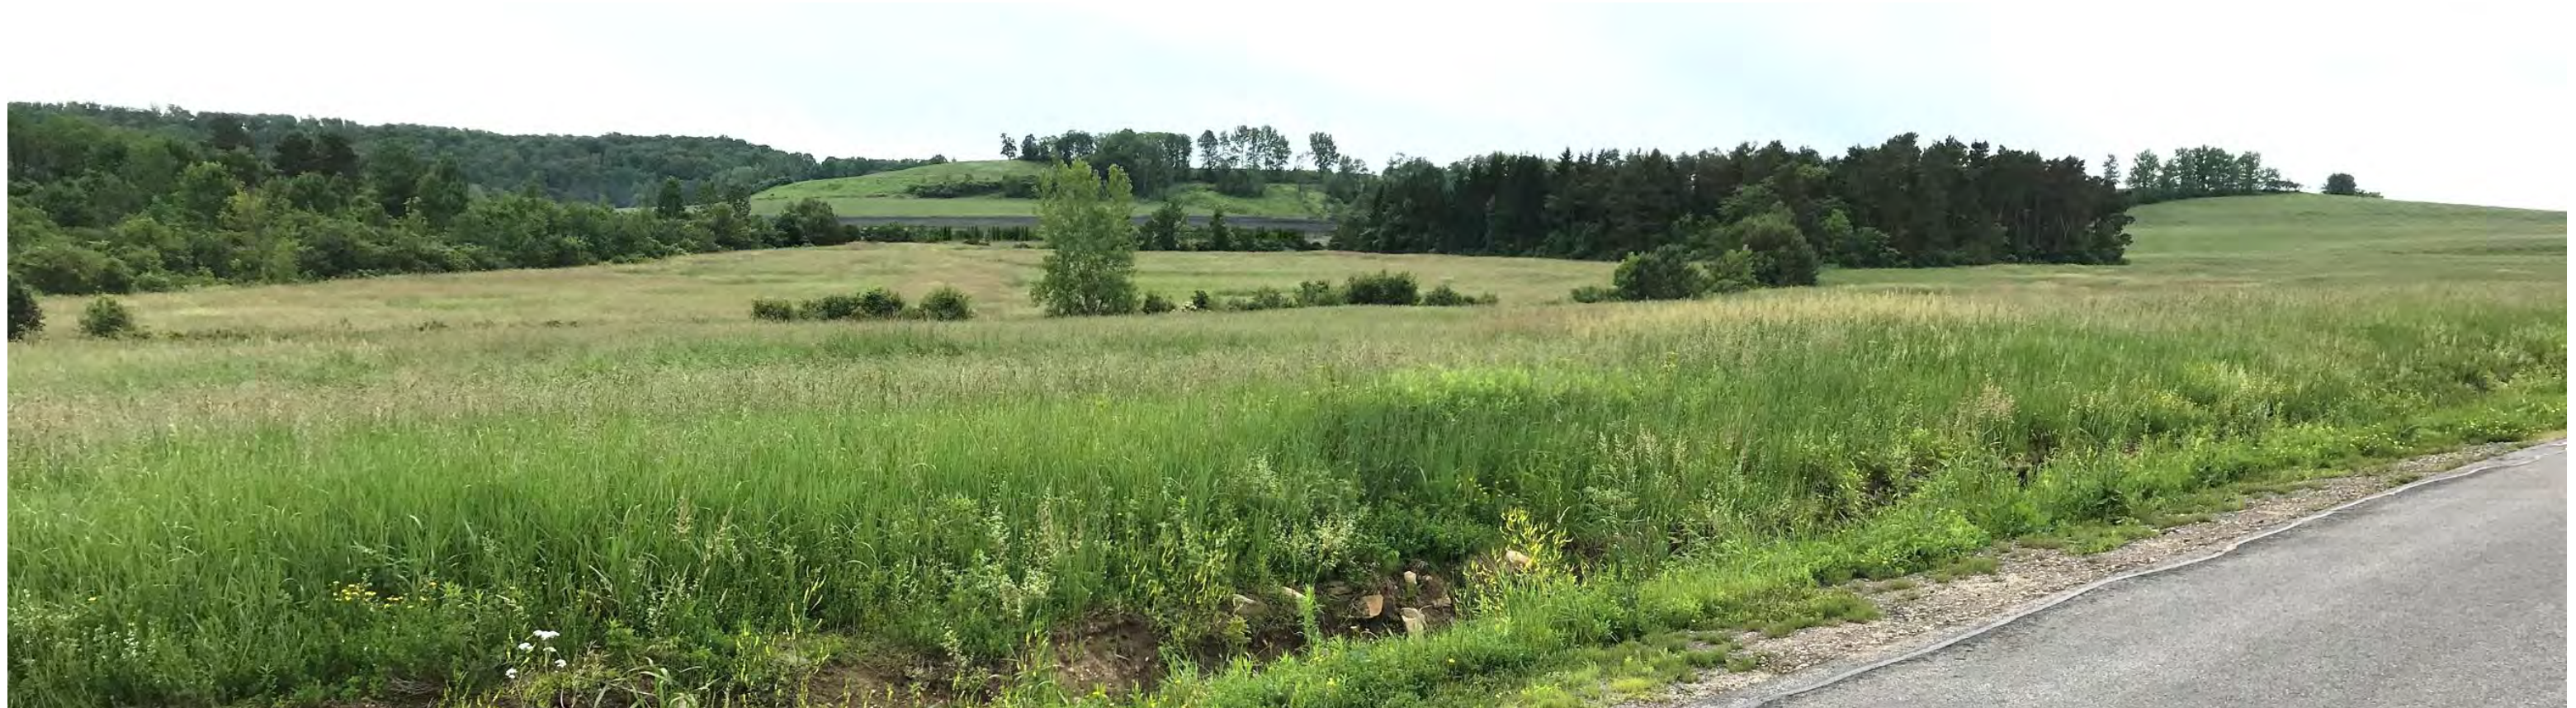
VP31 is provided as a request from the Town of Florida to show an additional view farther north along Bulls Head Road in the vicinity of a residence. As noted in the simulation, much of the Project is behind existing distant trees but lower on a slope. This location was chosen as it shows a portion of the Project through an available gap in the tree line looking south. The arrays that are visible provides some visual contrast with new form, line, and color introduced into the environmental. However, the partial views of the panels at this location are subordinate in the view due to proximal distance and blocked sight lines.

Proposed Conditions

Proposed Conditions – Mitigation at 5 Years

Project: High River Energy Center	Date: 5/14/2020	
Viewpoint Number: 31	Preparer: J.Bartos	
Viewpoint Location: Florida		
Viewpoint Description: view from Bulls Head Road, view south		
Landscape Similarity Zone: Agricultural/Open		
Viewer Type (check all that apply): <input checked="" type="checkbox"/> Resident <input type="checkbox"/> Commuter/Traveler <input checked="" type="checkbox"/> Local Motorist <input type="checkbox"/> Recreational <input type="checkbox"/> Worker		
Seasonal Condition: <input checked="" type="checkbox"/> Leaf On <input type="checkbox"/> Leaf Off		
Visual Rating Element	Rating	Notes
Part 1 Visual Contrast Rating		
Form Contrast	1.5	Limited view of similar horizontal forms found in landscape
Line Contrast	1.5	Horizontal line of project fairly consistent with ground features but also contrasts a bit with vertical trees
Texture Contrast	0.5	Texture not discernible but similar to what is seen at distance.

Color Contrast	2.0	New darker colors introduced compared to existing conditions and offers moderate contrast.
Project Scale Contrast/Spatial Dominance	1	Subordinate in the view
Broken Horizon Line	0	
Visual Acuity	1	Panels can be seen between tree gaps but view is limited and distant
Amount of Project Clearing Seen	0	
Screening/Mitigation Needed	0.5	Much of the Project is already mitigation by existing vegetation
Total	8	
Part 2 Viewpoint Sensitivity Rating		
Within a Visual Resource*	0	
View of Other Visual Resource with Project*	0	
A Listed/Known Scenic Resource of Visual Quality*	0	
Number of Viewers (Low or High Use Activity)	1.5	Local rural road view with residences nearby
Duration of View	2	Intermittent and short duration along a low traveled road but longer duration view for nearby residents
Presence of Existing Development	1	Not within the view but there are few residences in area
Uniqueness of Landscape Compared to Region	1	Typical of open field views in the area

Project: High River Energy Center	Date: 5/14/20	
Viewpoint Number: 31	Preparer: Michael Ross	
Viewpoint Location: Florida		
Viewpoint Description: view from Bulls Head Road, view south		
Landscape Similarity Zone: Agricultural/Open, Developed Road, and Residential		
Viewer Type (check all that apply): <input checked="" type="checkbox"/> Resident <input type="checkbox"/> Commuter/Traveler <input checked="" type="checkbox"/> Local Motorist <input type="checkbox"/> Recreational <input type="checkbox"/> Worker		
Seasonal Condition: <input checked="" type="checkbox"/> Leaf On <input type="checkbox"/> Leaf Off		
Visual Rating Element	Rating	Notes
Part 1 Visual Contrast Rating		
Form Contrast	1.5	The panels are located somewhat in the distance, at the base of a hill creating a distinct horizontal band.
Line Contrast	1	The banding effect and location of the array field allows for some contrast to occur with the surround existing terrain and ground line configuration.

Texture Contrast	1	Distance softens the impact of size and hard surfaces somewhat, allowing for less contrast between the existing texture conditions of the grassy fields and other vegetation present.
Color Contrast	1	The darker greys of the arrays contrast somewhat with the greens of the grassy fields and other existing vegetation.
Project Scale Contrast/Spatial Dominance	1	The solar array field is quite large however, the overall area and type of terrain captured in this view diminishes impact.
Broken Horizon Line	0	The horizon line is not broken in this view by the solar arrays.
Visual Acuity	.5	Little to no detail is present in this view with regards to the solar arrays.
Amount of Project Clearing Seen	.5	Minimal clearing can be discerned.
Screening/Mitigation Needed	2	Strategically placed plantings can help mitigate potential future views of the solar arrays and have been provided.
Total	8.5

Project: High River Energy Center		Date: 5/15/2020
Viewpoint Number: 31		Preparer: Heather Vaillant
Viewpoint Location: Florida		
Viewpoint Description: view from Bulls Head Rd, view south		
Landscape Similarity Zone: Agricultural/Open, Developed Road		
Viewer Type (check all that apply): <input checked="" type="checkbox"/> Resident <input type="checkbox"/> Commuter/Traveler <input checked="" type="checkbox"/> Local Motorist <input type="checkbox"/> Recreational <input type="checkbox"/> Worker		
Seasonal Condition: <input checked="" type="checkbox"/> Leaf On <input type="checkbox"/> Leaf Off		
Visual Rating Element	Rating	Notes
Part 1 Visual Contrast Rating		
Form Contrast	1.5	New form in landscape but it is a small part of the view
Line Contrast	1	New horizontal band in landscape
Texture Contrast	1.5	Panels contrast with the field they are placed in, but are difficult to see
Color Contrast	1.5	Contrasts with fields, but small part of view

Project Scale Contrast/Spatial Dominance	1	
Broken Horizon Line	0	Horizon not broken
Visual Acuity	0.5	Minimal detail visible in array
Amount of Project Clearing Seen	0.5	Minimal clearing visible
Screening/Mitigation Needed	2	
Total	9.5	
Part 2 Viewpoint Sensitivity Rating		
Within a Visual Resource*	0	
View of Other Visual Resource with Project*	0	
A Listed/Known Scenic Resource of Visual Quality*	0	
Number of Viewers (Low or High Use Activity)	1	Local road, residences near viewpoint
Duration of View	1.5	Short duration from road but long-term views from residences
Presence of Existing Development	1.5	Minimal development present within view
Uniqueness of Landscape Compared to Region	2	
Presence of Water	0	
Total	6	
Part 3 Scenic Quality		
General Scenic Quality of the View	2

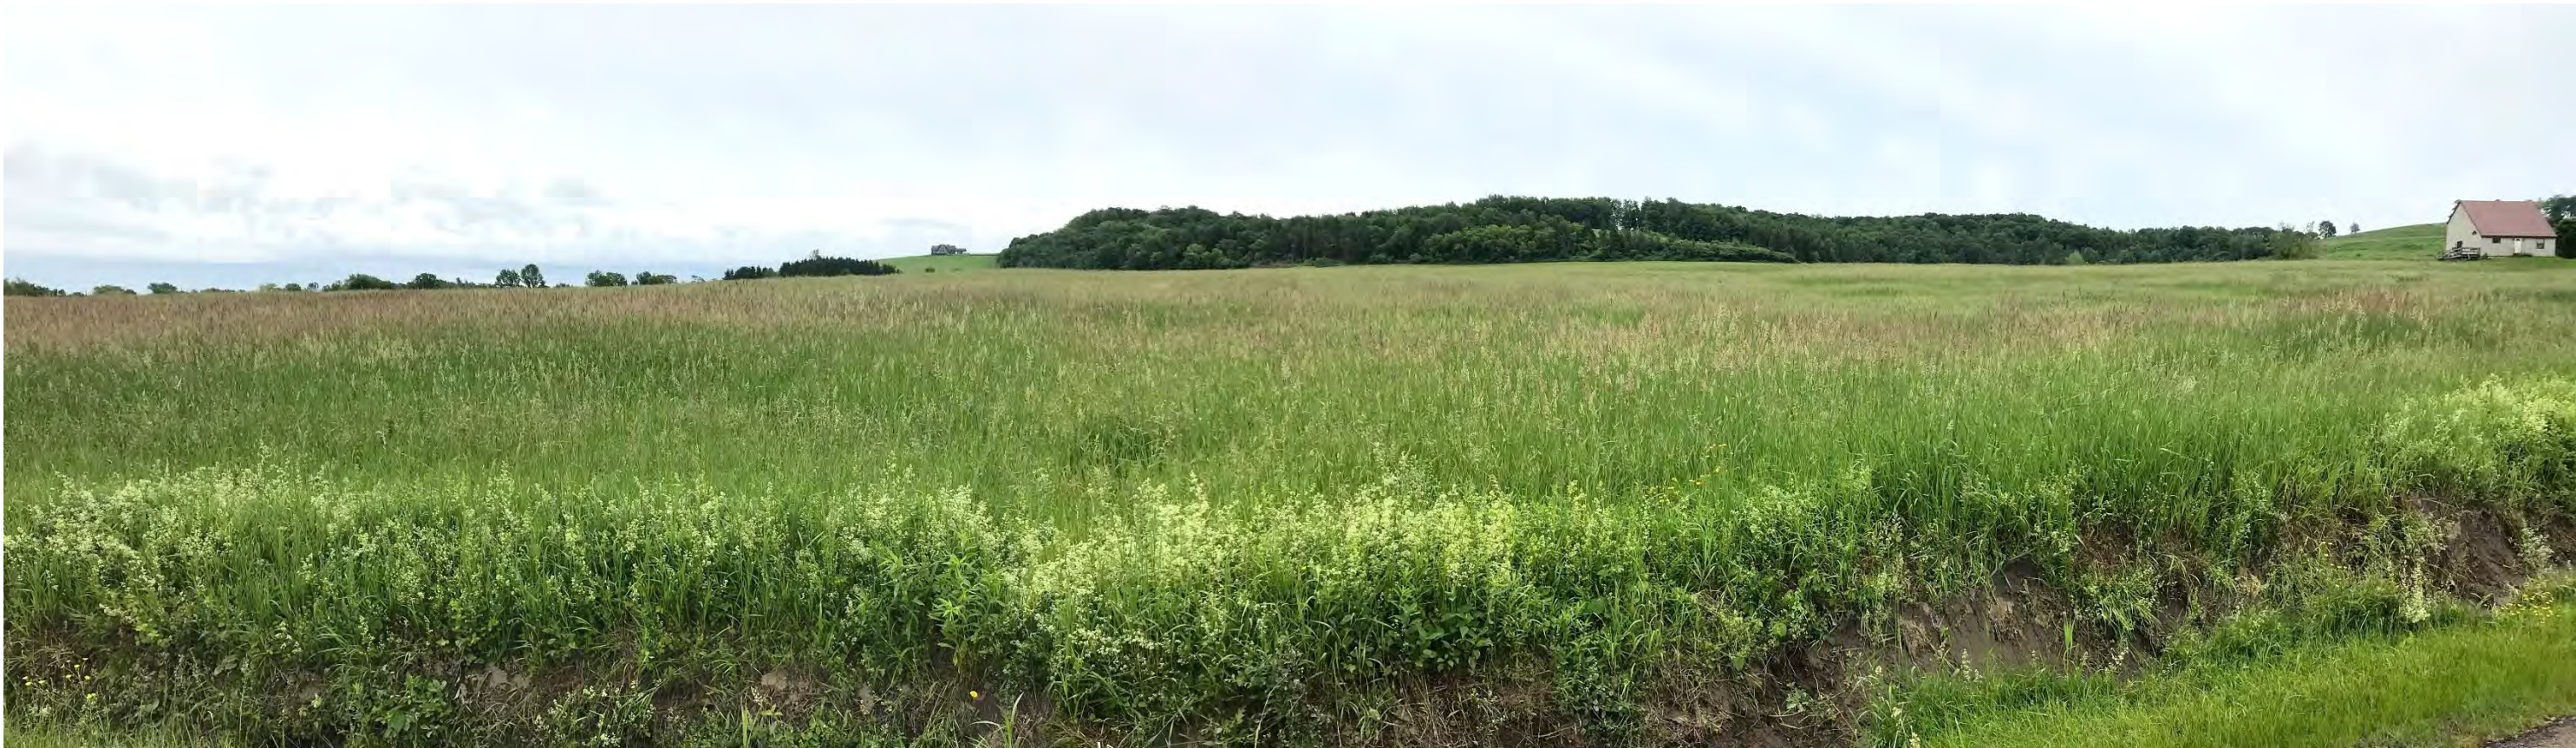
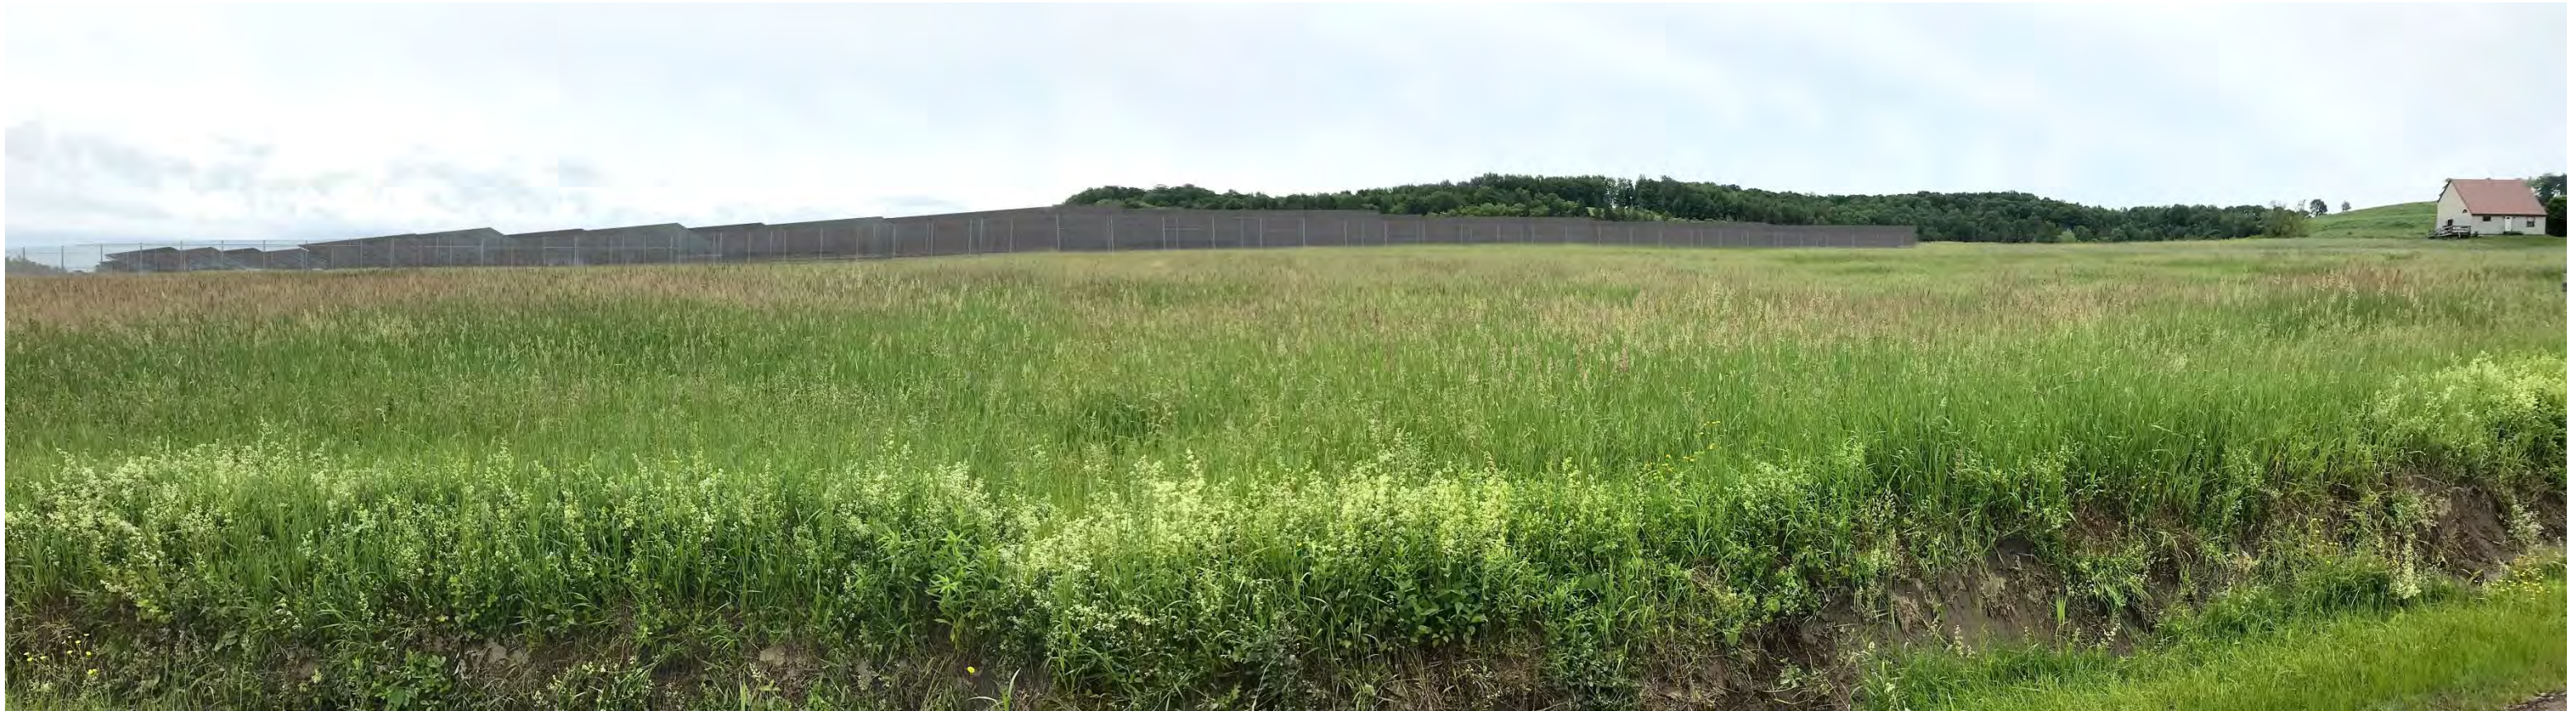
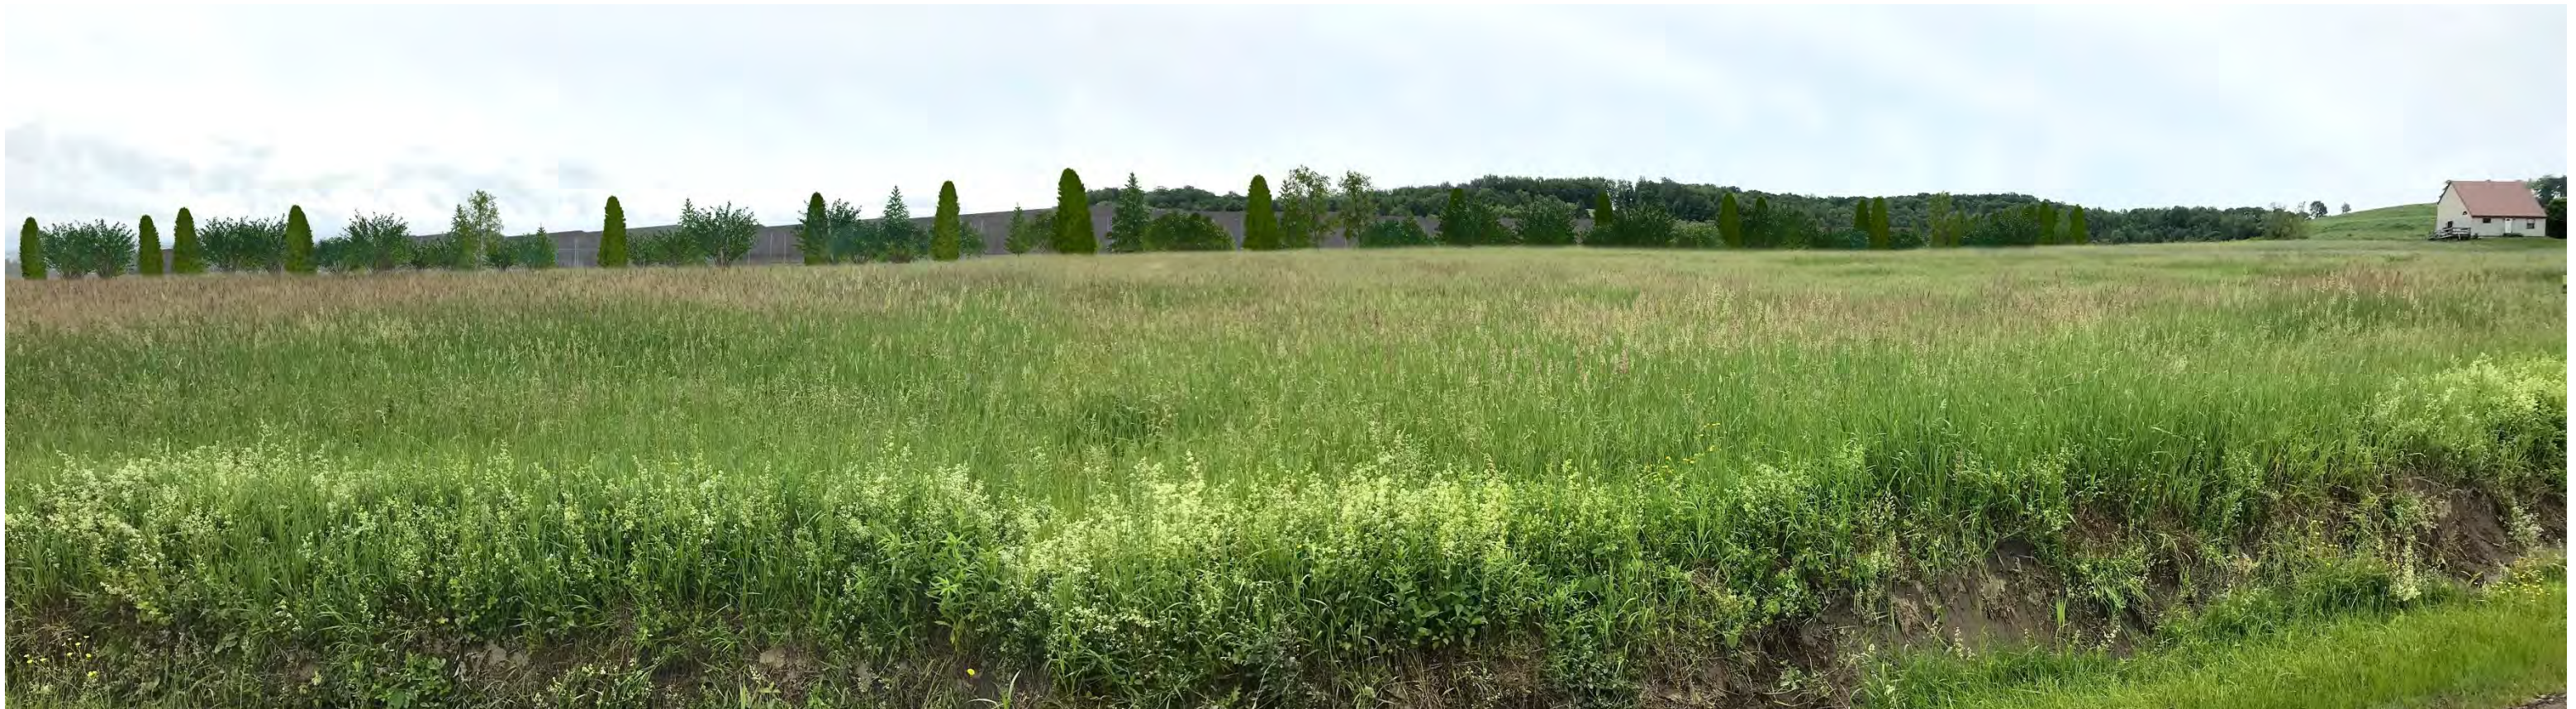
VP32 photo is provided as a request from the Town of Florida to show a view from Persons Road. The view faces south to an open field and the viewer is approximately 312 feet from the fence line. Existing conditions shows large homogeneous uninterrupted simple shapes of horizontal field or distant forest. The sight lines under proposed conditions without mitigation show uninterrupted views of solar panels. The arrays hold a shape and pattern similar to the horizontal sweep of the foreground as well as background vegetation. Due to proximity, the Project is apparent as a new element in the landscape but it has a low profile. A few of the arrays interrupt the horizon line in the left part of the simulation. Color contrast is moderate against the summer vegetation.

Proposed Conditions

Proposed Conditions – Mitigation at 5 Years

Project: High River Energy Center		Date: 5.14.2020
Viewpoint Number: 32		Preparer: J Bartos
Viewpoint Location: Florida		
Viewpoint Description: view from Persons Road		
Landscape Similarity Zone: Agricultural/Open, Developed Road		
Viewer Type (check all that apply): <input checked="" type="checkbox"/> Resident <input type="checkbox"/> Commuter/Traveler <input type="checkbox"/> Local Motorist <input type="checkbox"/> Recreational <input type="checkbox"/> Worker		
Seasonal Condition: <input checked="" type="checkbox"/> Leaf On <input type="checkbox"/> Leaf Off		
Visual Rating Element	Rating	Notes
Part 1 Visual Contrast Rating		
Form Contrast	2.5	New forms compared to existing
Line Contrast	2.5	New line elements compared to existing
Texture Contrast	2.5	New textures introduced compared to existing
Color Contrast	2.5	New color compared to existing with contrast only somewhat moderated by existing colors in view.

Project Scale Contrast/Spatial Dominance	2.5	Although vertical elements are not too great the Project is dominant in view because of proximity
Broken Horizon Line	1	Partially interrupt horizon in left of photo
Visual Acuity	2.5	Proximity to panels gives detail.
Amount of Project Clearing Seen	0	
Screening/Mitigation Needed	2.0	Depends. Not all parts of road here may need screening because of extremely limited amount of residents.
Total	18	
Part 2 Viewpoint Sensitivity Rating		
Within a Visual Resource*	0	
View of Other Visual Resource with Project*	0	
A Listed/Known Scenic Resource of Visual Quality*	0	
Number of Viewers (Low or High Use Activity)	0.5	Only 2 or 3 residents on entire dead end road
Duration of View	2.5	Long duration view for resident
Presence of Existing Development	0	
Uniqueness of Landscape Compared to Region	1	Typical for this area.
Presence of Water	0	
Total	4	
Part 3 Scenic Quality		
General Scenic Quality of the View	1.5	Pretty and pastoral.

Project: High River Energy Center	Date: 5/14/20	
Viewpoint Number: 32	Preparer: Michael Ross	
Viewpoint Location: Florida		
Viewpoint Description: view from Persons Road, view southeast		
Landscape Similarity Zone: Agricultural/Open, Developed Road, and Residential		
Viewer Type (check all that apply): <input checked="" type="checkbox"/> Resident <input type="checkbox"/> Commuter/Traveler <input type="checkbox"/> Local Motorist <input type="checkbox"/> Recreational <input type="checkbox"/> Worker		
Seasonal Condition: <input checked="" type="checkbox"/> Leaf On <input type="checkbox"/> Leaf Off		
Visual Rating Element	Rating	Notes
Part 1 Visual Contrast Rating		
Form Contrast	2.5	The panels are located somewhat close in this view, in an open grassy field and somewhat natural setting creating contrast.
Line Contrast	2.5	The perimeter delineation created by the array field creates an unnatural line and contrast in the landscape.

Texture Contrast	2	Due to the close proximity of the array field in this view, texture of fencing and array outline of panels is present creating contrast in the naturalized surrounding of the existing vegetation.
Color Contrast	2	The darker greys of the arrays and fence line contrast with the greens of the grassy fields and other existing vegetation.
Project Scale Contrast/Spatial Dominance	2	The solar array field is quite large in the overall area of this view and type of terrain promotes scale impact.
Broken Horizon Line	1.5	Approximately 50% of the horizon line is broken in this view by the solar arrays.
Visual Acuity	1.5	Some detail is present in this view with regards to the solar array panels and fence line.
Amount of Project Clearing Seen	0	No actual clearing can be discerned.
Screening/Mitigation Needed	3	Screening mitigation plantings will be needed to help mitigate potential future views of the solar arrays and have been provided.

Project: High River Energy Center		Date: 5/15/2020
Viewpoint Number: 32		Preparer: Heather Vaillant
Viewpoint Location: Florida		
Viewpoint Description: view from Persons Rd, view south		
Landscape Similarity Zone: Agricultural/Open, Developed Road		
Viewer Type (check all that apply): <input checked="" type="checkbox"/> Resident <input type="checkbox"/> Commuter/Traveler <input type="checkbox"/> Local Motorist <input type="checkbox"/> Recreational <input type="checkbox"/> Worker		
Seasonal Condition: <input checked="" type="checkbox"/> Leaf On <input type="checkbox"/> Leaf Off		
Visual Rating Element	Rating	Notes
Part 1 Visual Contrast Rating		
Form Contrast	2	New form in landscape but it is a small part of the view
Line Contrast	2	New, large horizontal band in landscape
Texture Contrast	2	Panels contrast with the surrounding vegetation
Color Contrast	2	Contrasts with fields, but small part of view
Project Scale Contrast/Spatial Dominance	2	Dominant in landscape

Broken Horizon Line	1.5	Horizon broken in left hand side of photo
Visual Acuity	1.5	
Amount of Project Clearing Seen	0	No clearing visible
Screening/Mitigation Needed	3	
Total	16	
Part 2 Viewpoint Sensitivity Rating		
Within a Visual Resource*	0	
View of Other Visual Resource with Project*	0	
A Listed/Known Scenic Resource of Visual Quality*	0	
Number of Viewers (Low or High Use Activity)	1	Local road, residences near viewpoint
Duration of View	1.5	Short duration from road but long-term views from residences
Presence of Existing Development	1.5	Minimal development present within view
Uniqueness of Landscape Compared to Region	1.5	
Presence of Water	0	
Total	5.5	
Part 3 Scenic Quality		
General Scenic Quality of the View	1.5

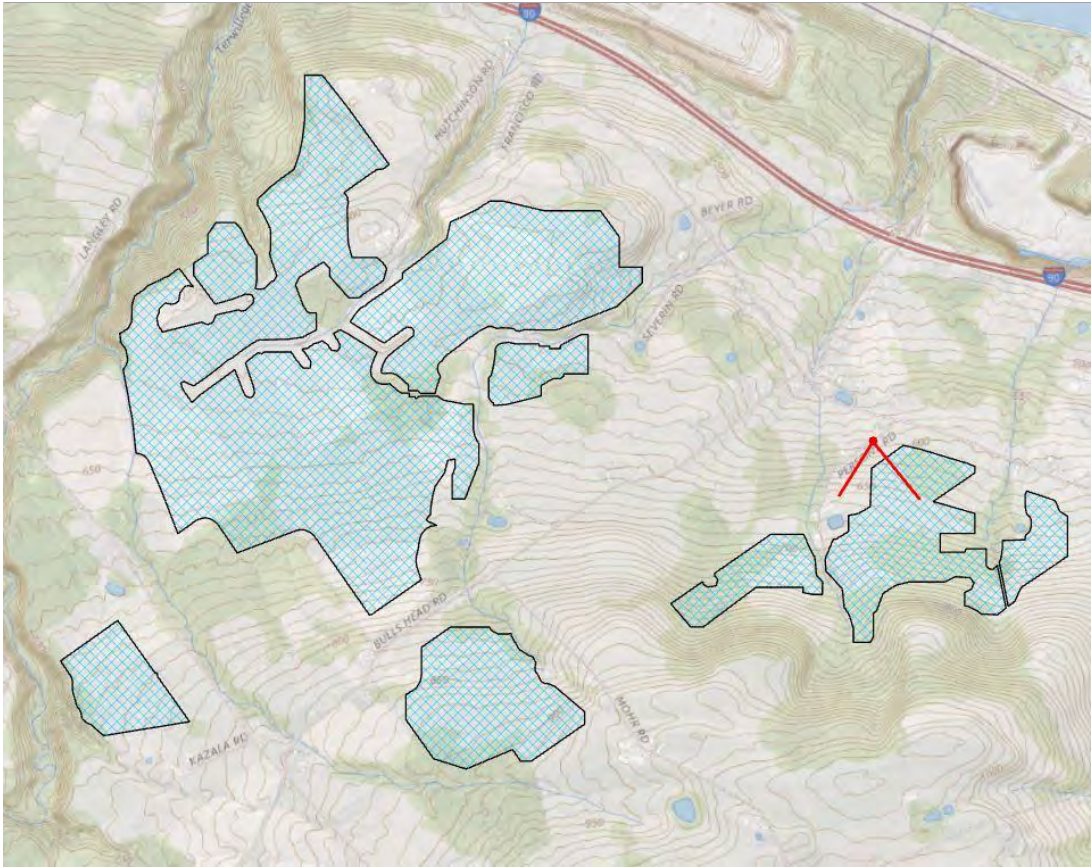
Viewpoint Coordinates in	592043.1 E
NY State Plane East	1480265.9 N
Viewpoint Location	Persons Rd
Viewer Elevation (ft msl)	593 feet
Distance to Fenceline	275 feet
Direction of View	S
Date	6.18.2019
Time	12:52 pm
High River Energy Center Update for Alternative Layout Florida, New York Visual Simulation of Project May 2020
