Visual Impact Assessment Update for Alternative Layout

May 2020

High River Energy Center
Town of Florida, New York

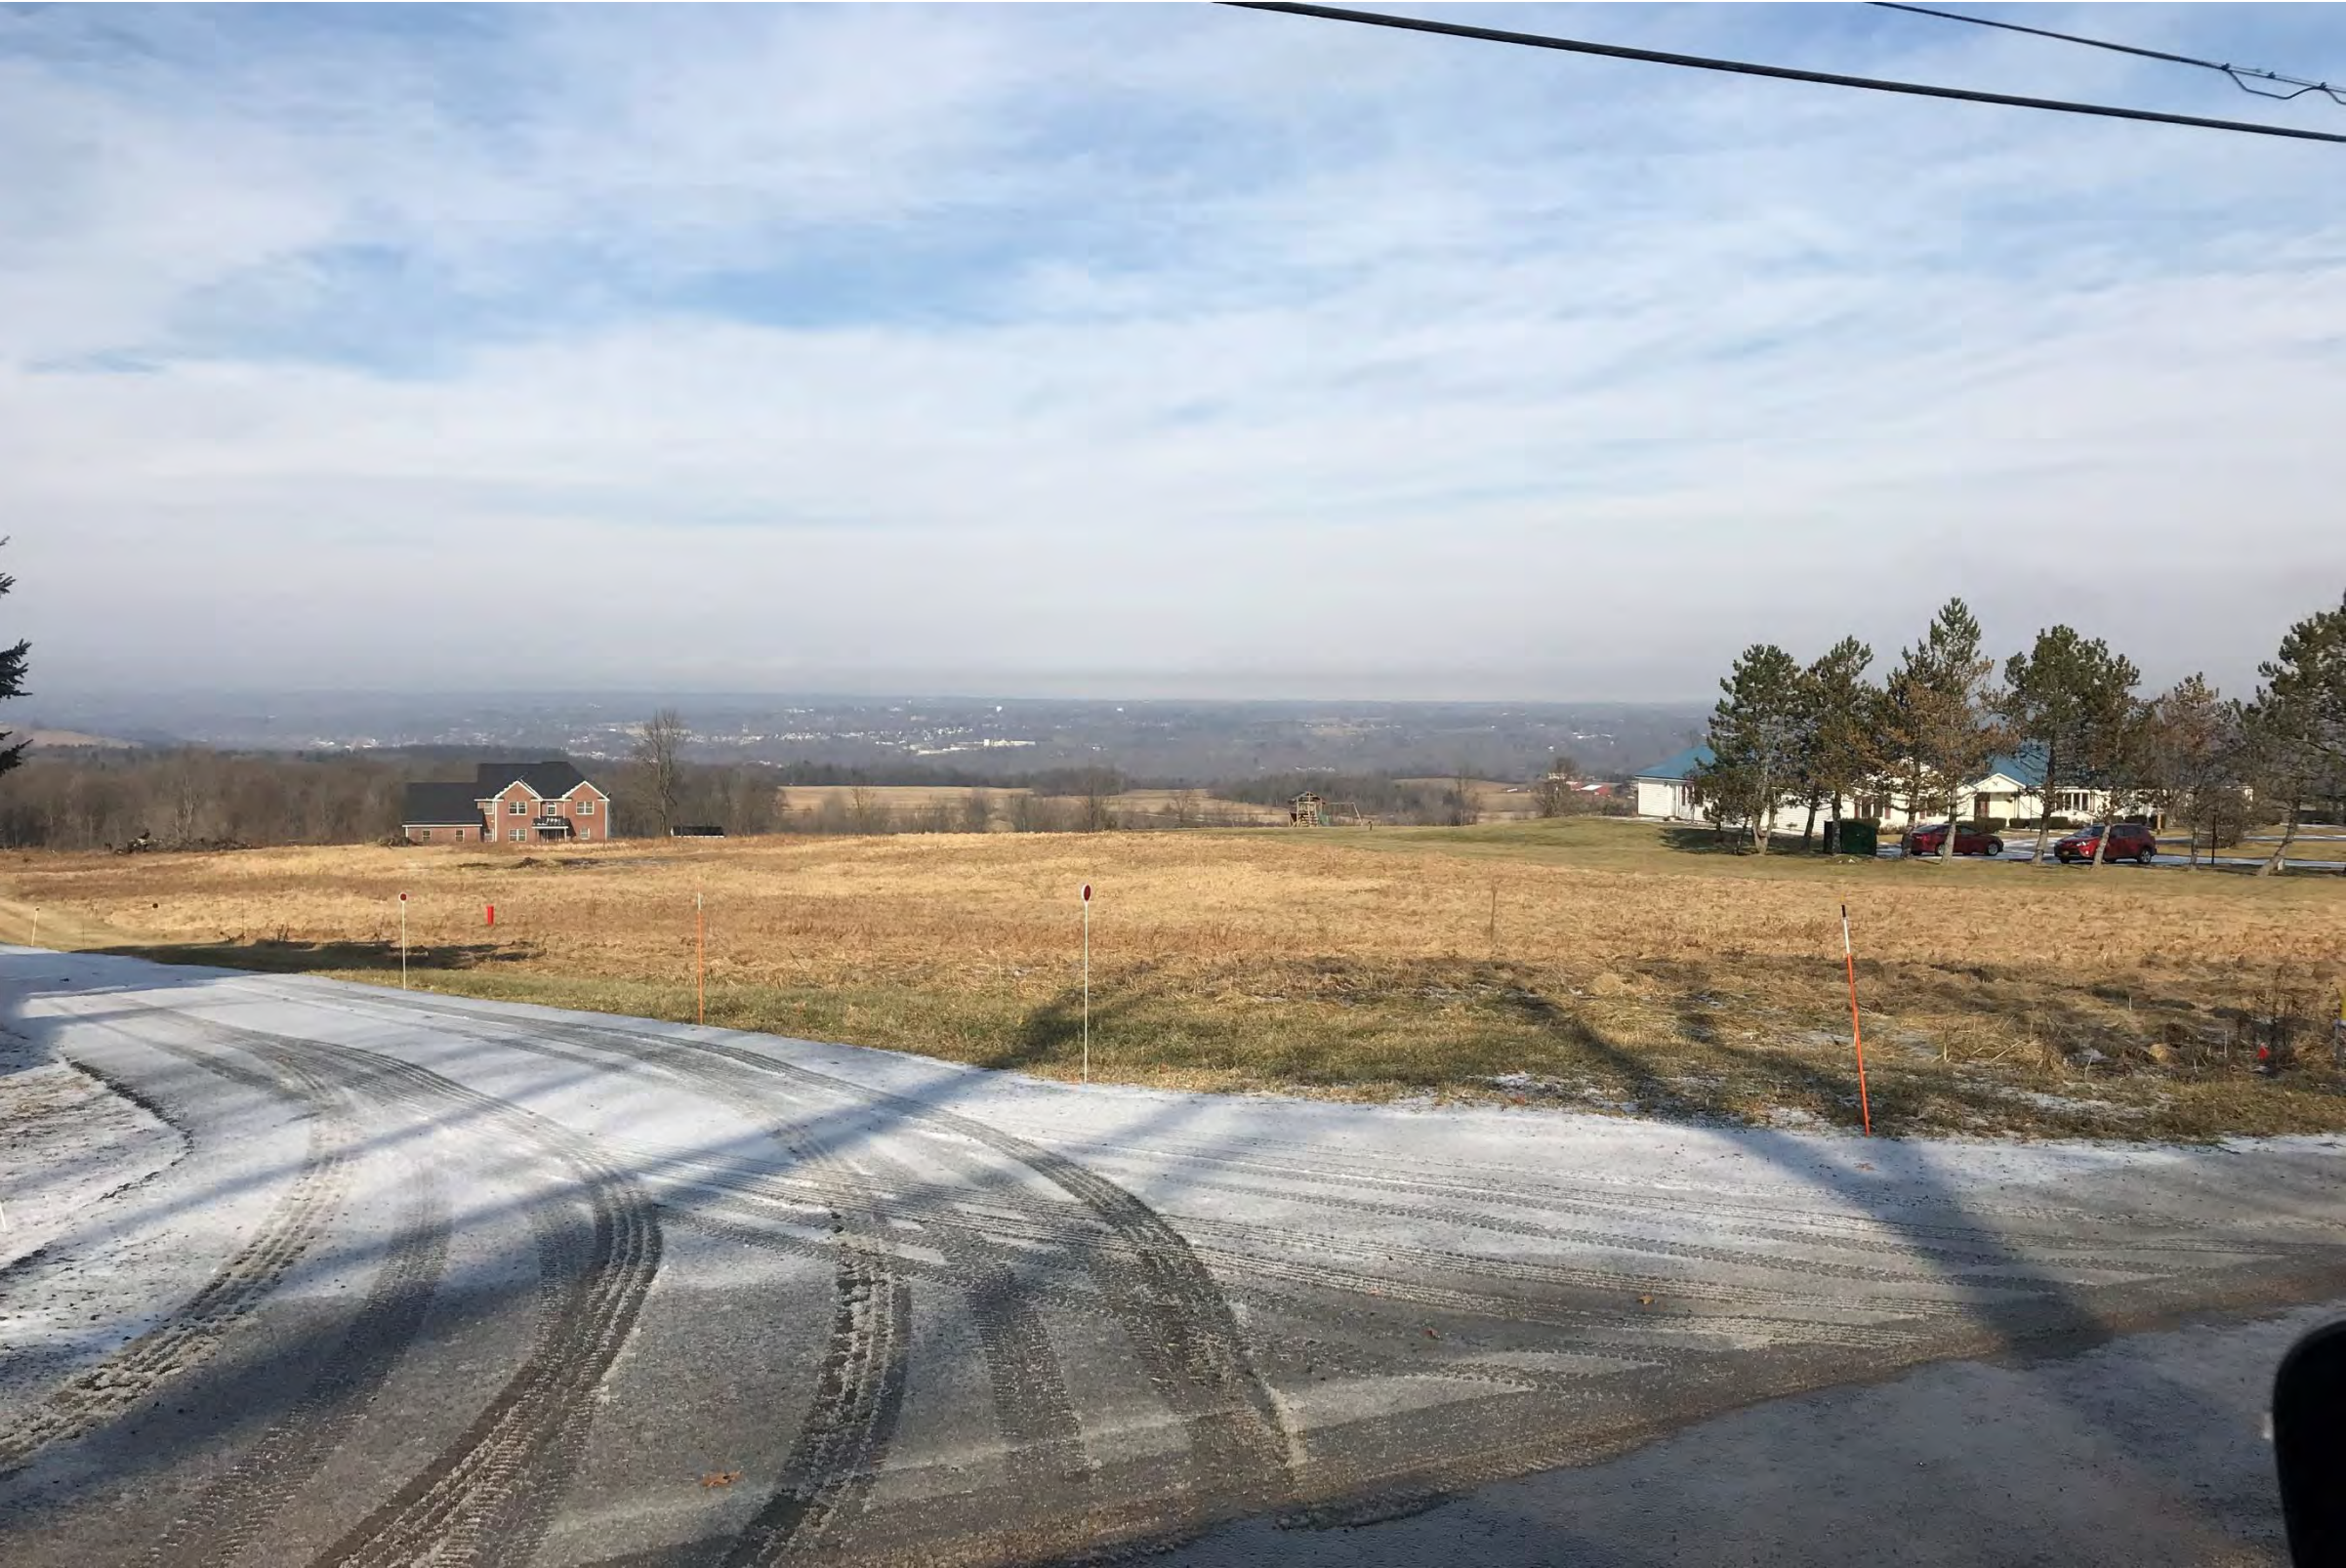
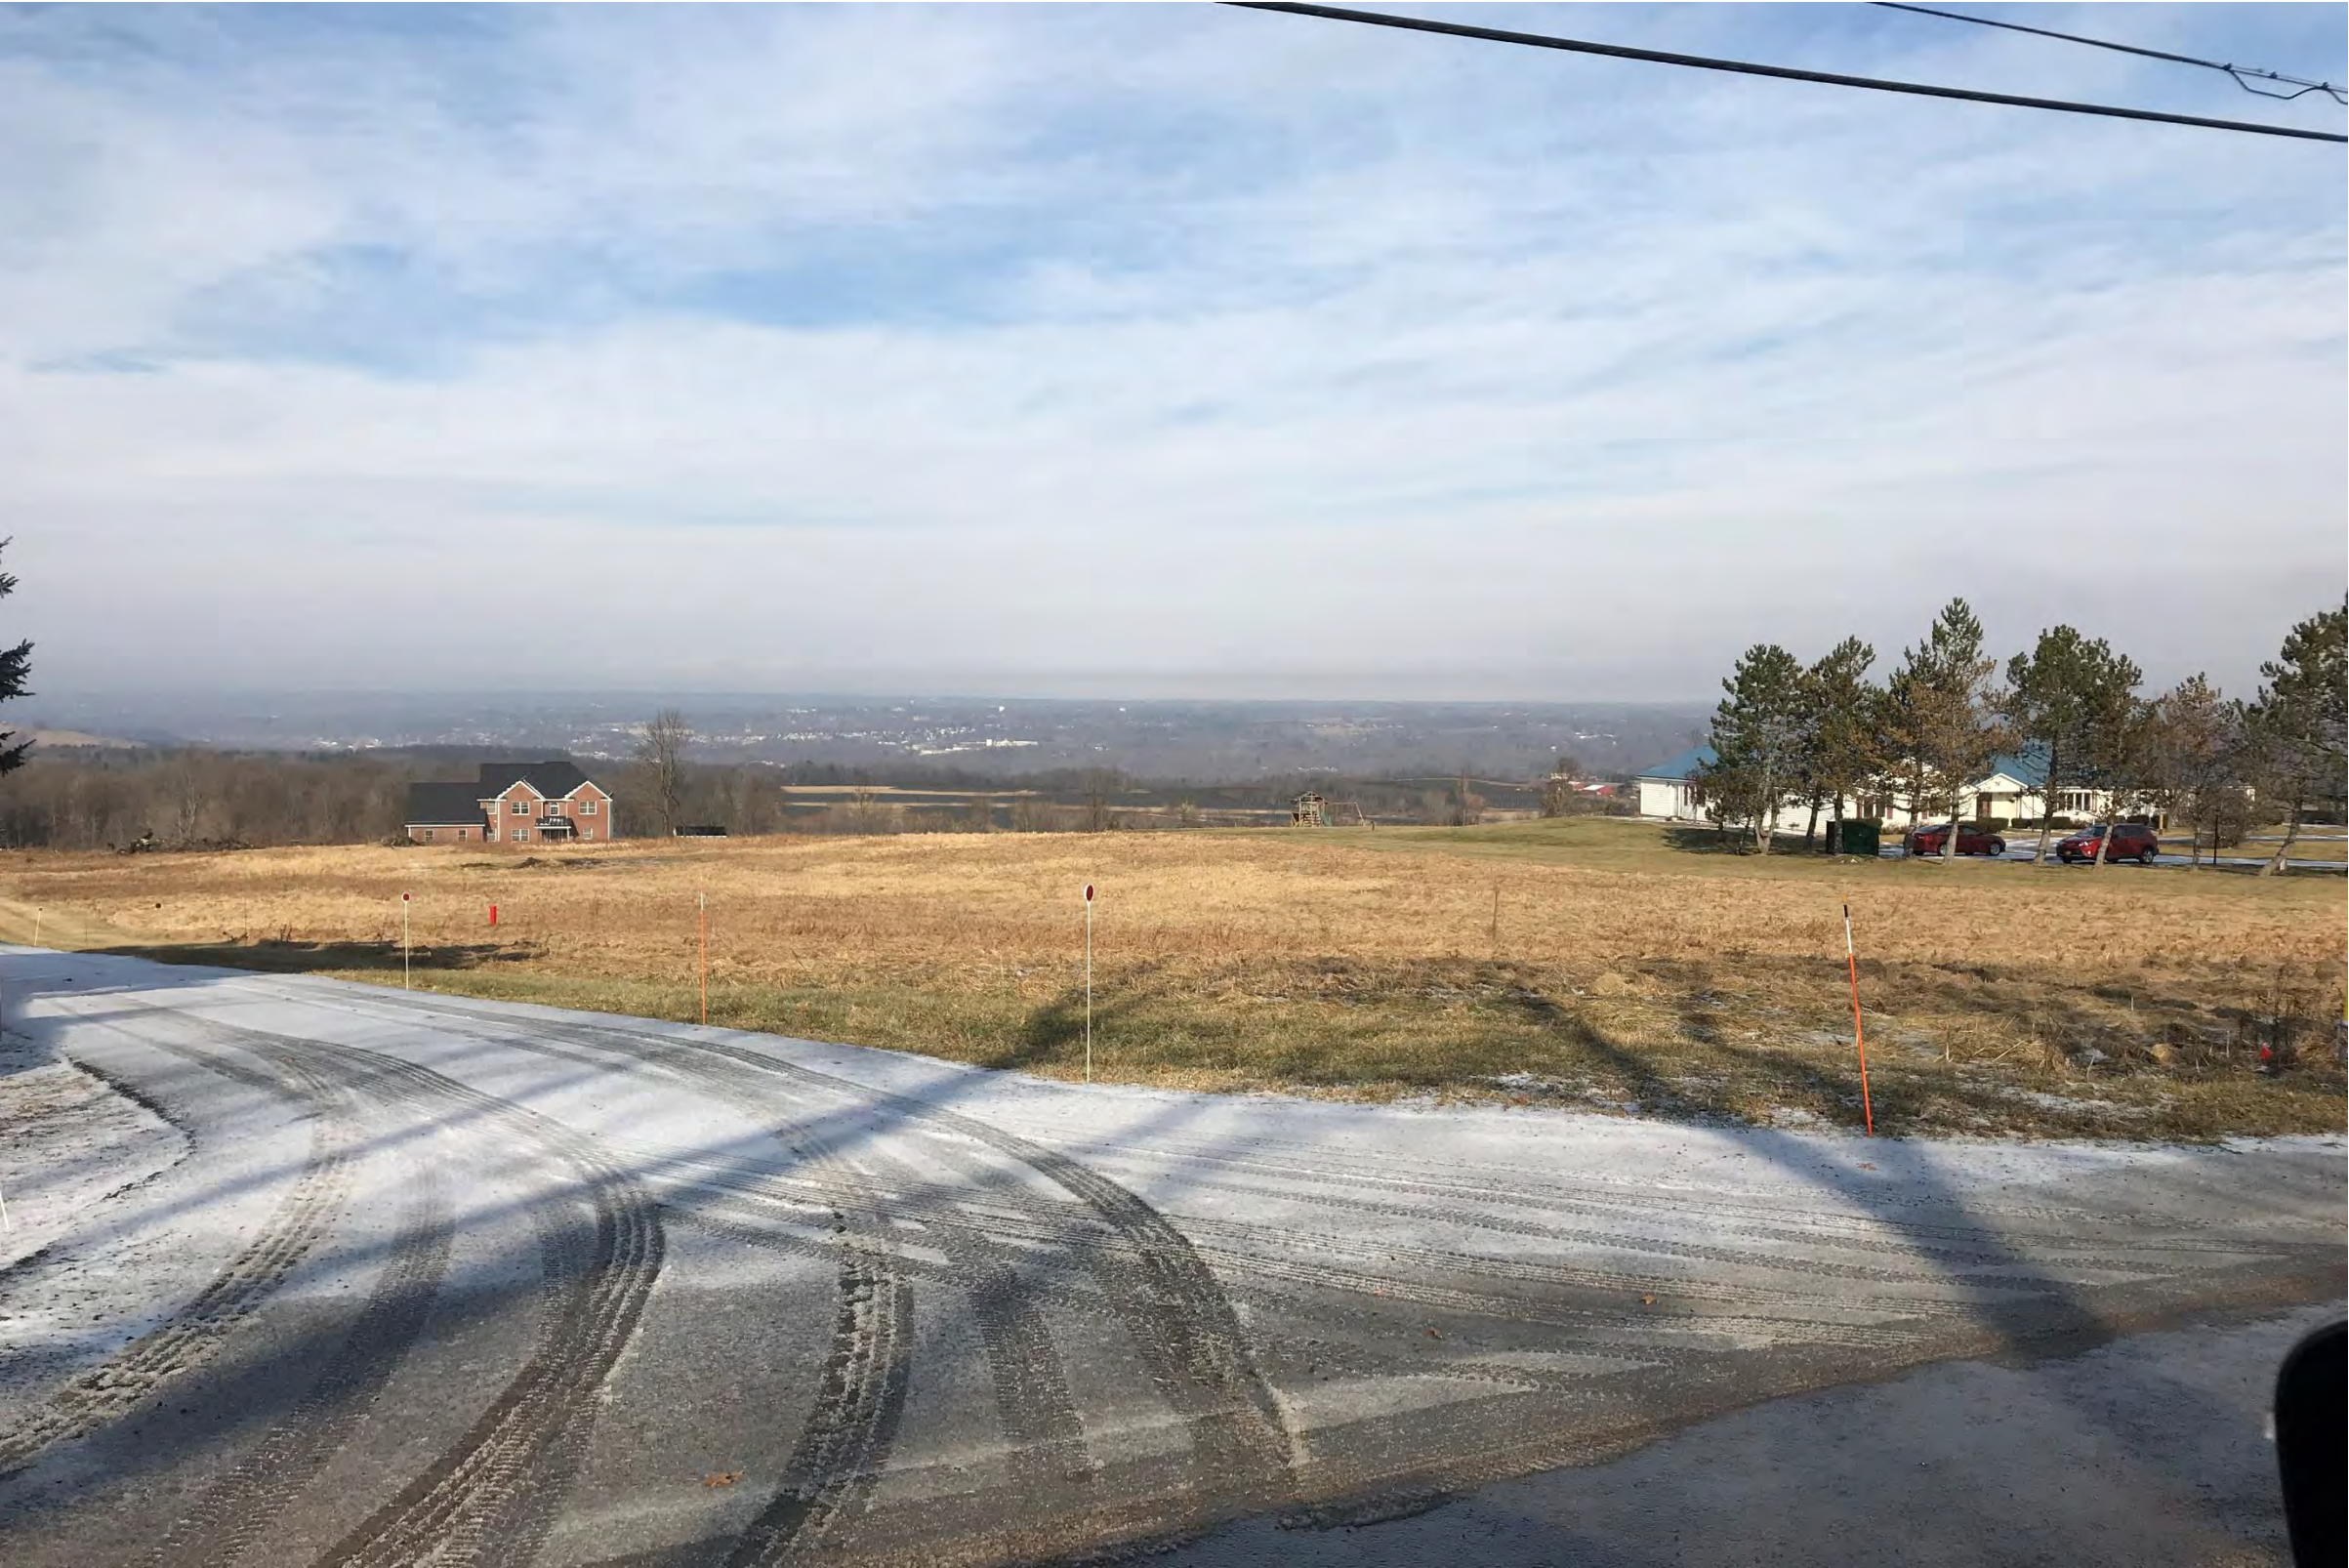
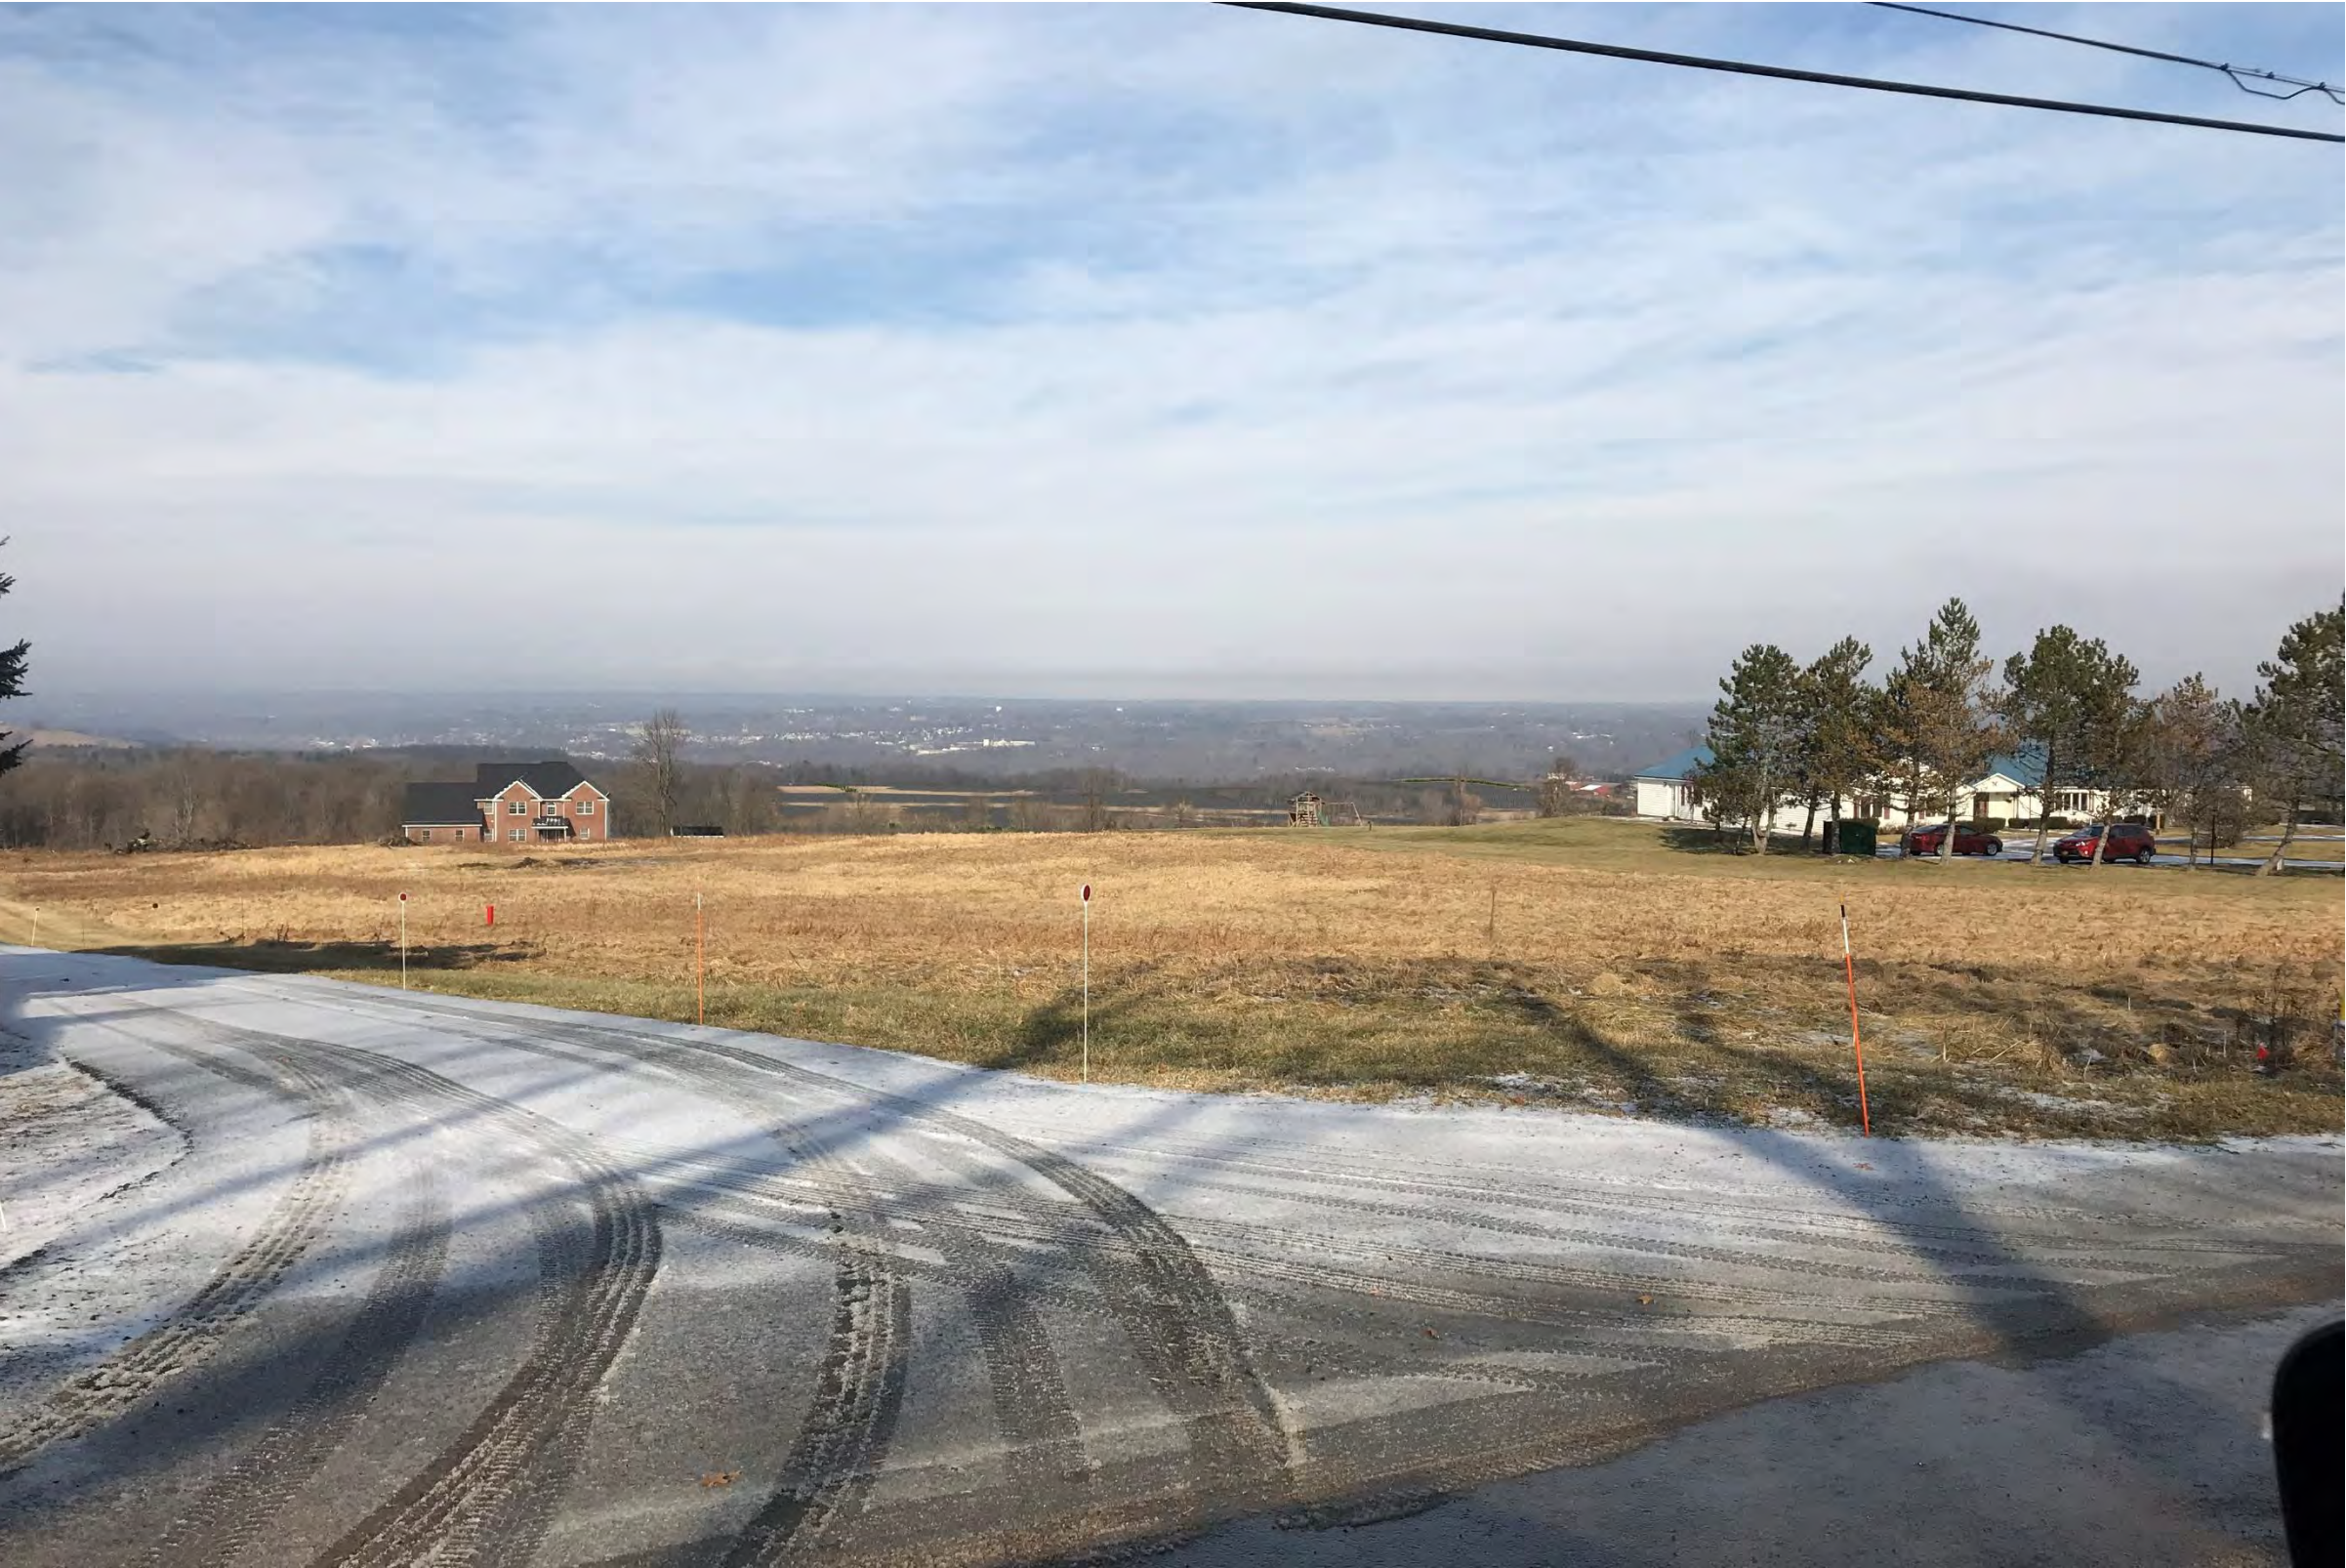
Viewpoint Coordinates in	585781.37 E
NY State Plane East	1477259.07 N
Viewpoint Location	Bulls Head Rd
Viewer Elevation (ft msl)	842
Distance to Fenceline	0.7 miles
Direction of View	North
Date	28 mm
Time	1.8.2019/11:47am

High River Energy Center – Update for
Alternative Layout, Florida, New York
Visual Simulation of Project
May 2020

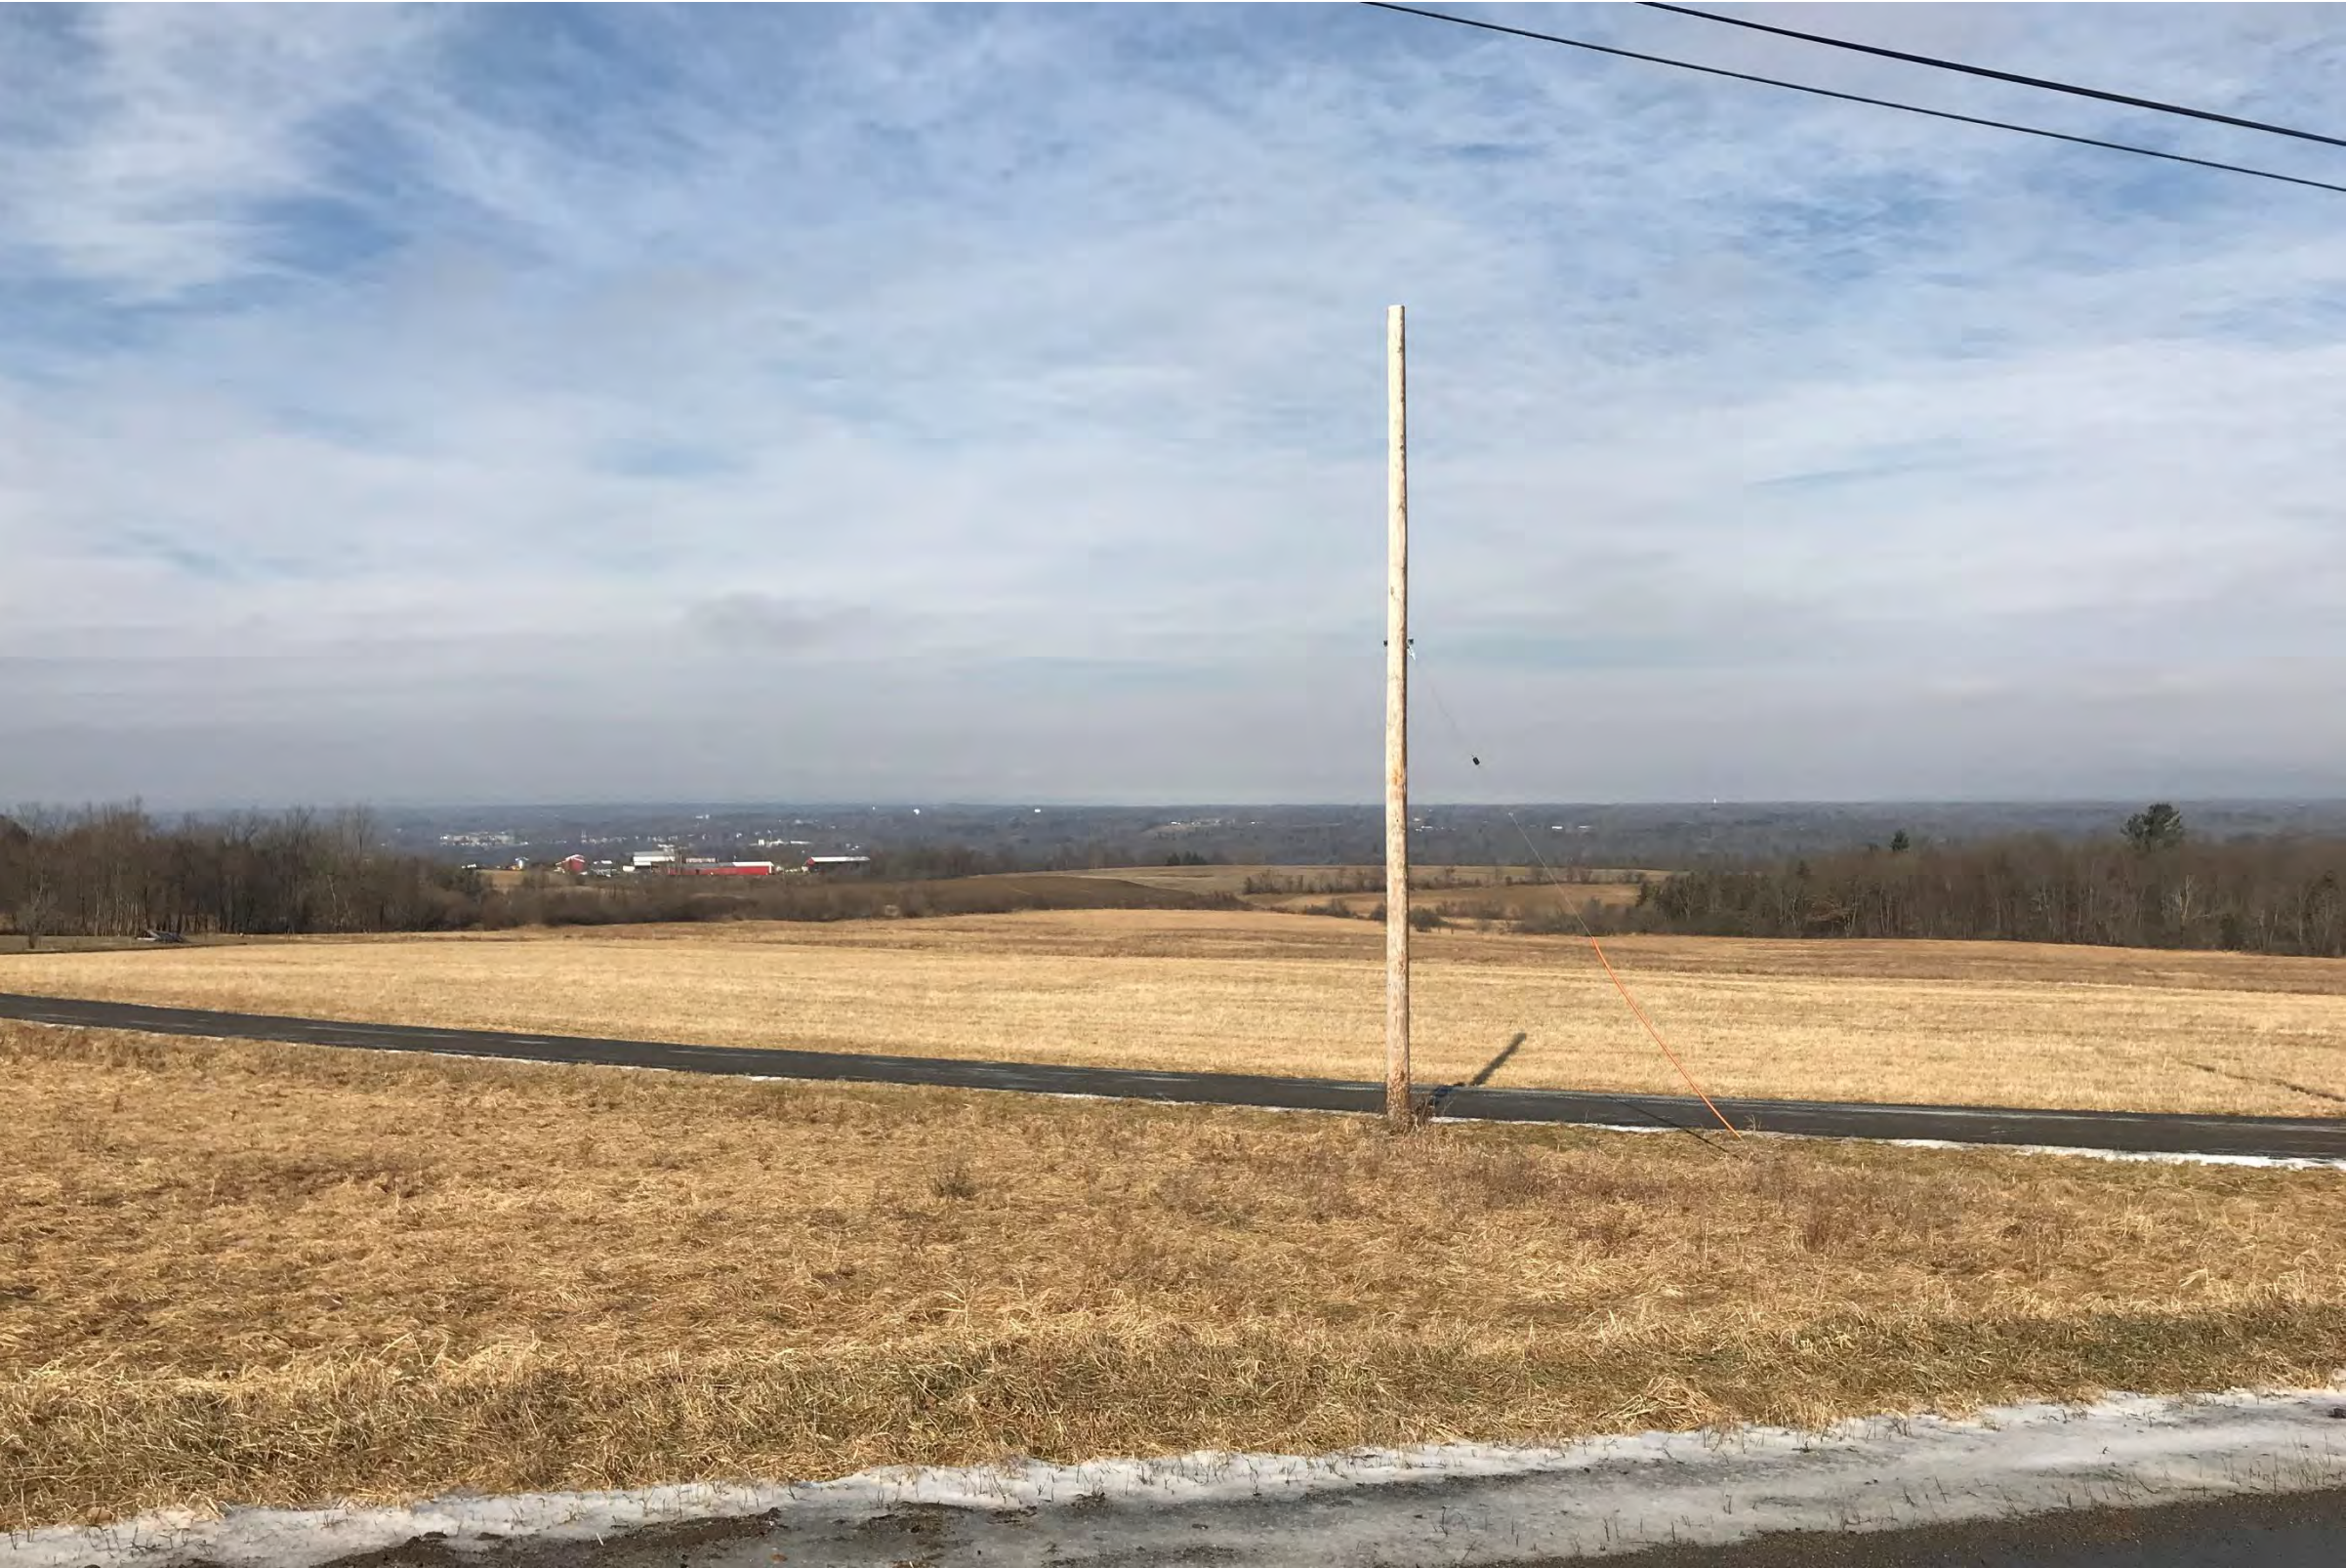
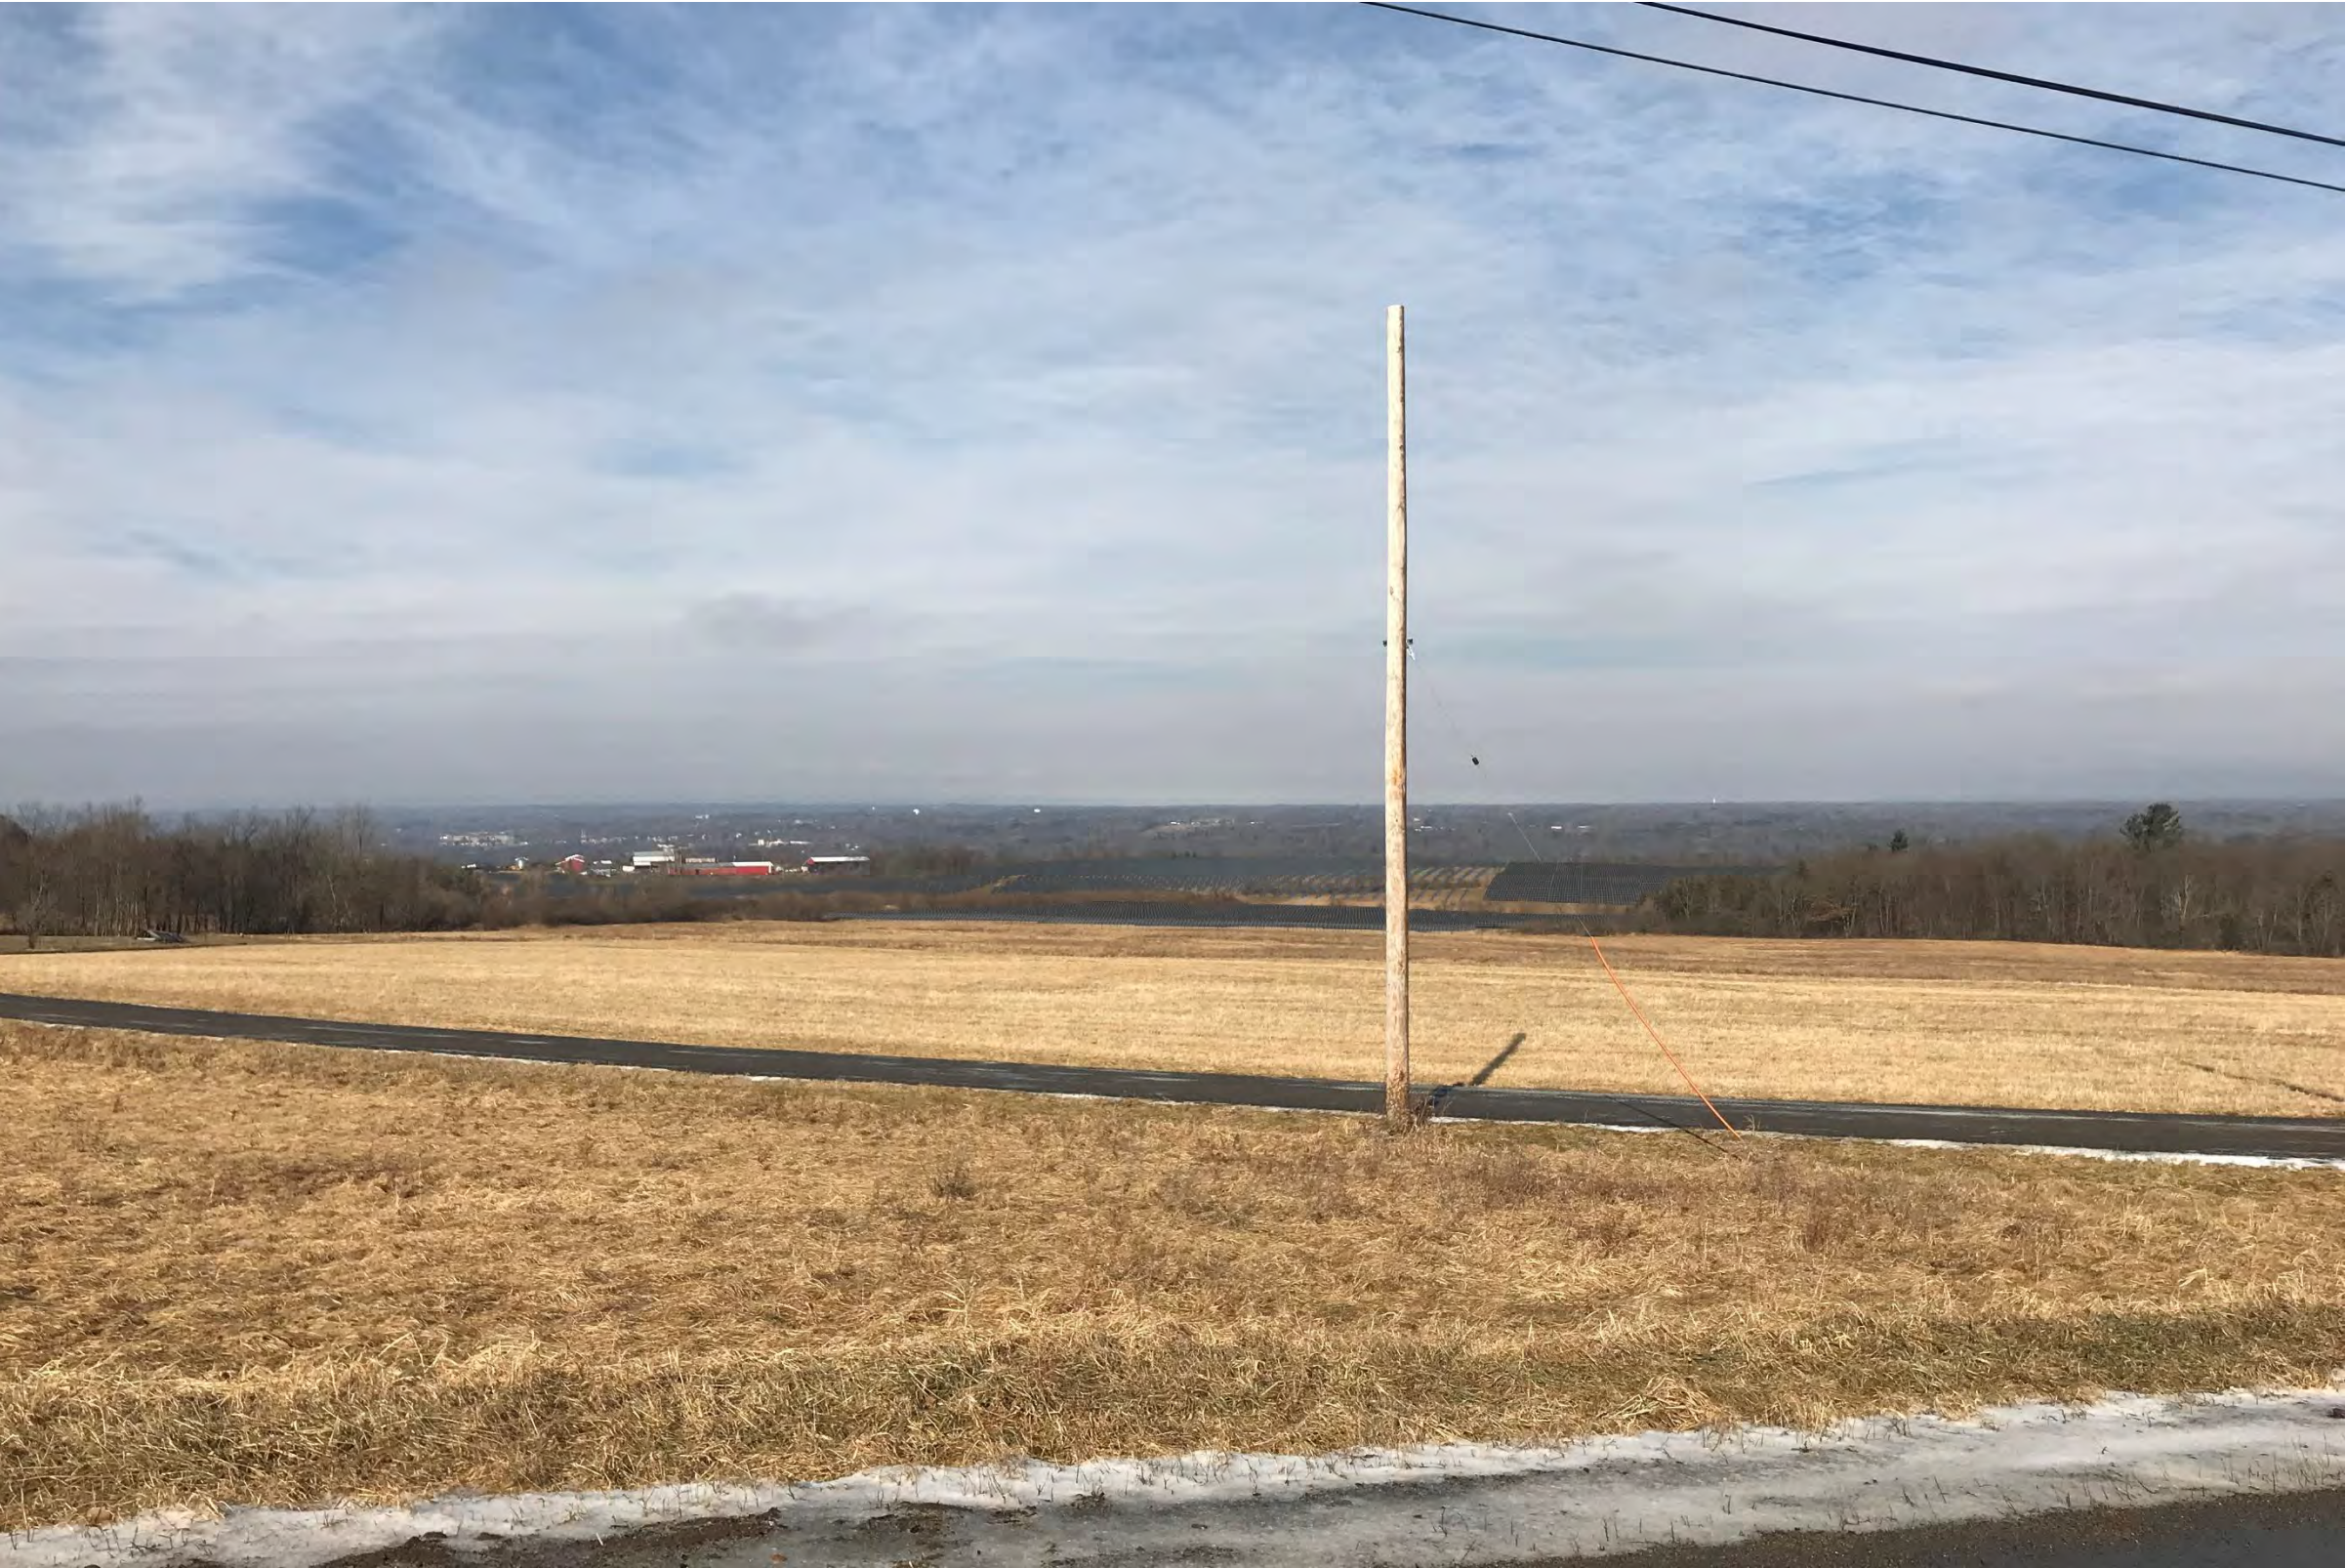
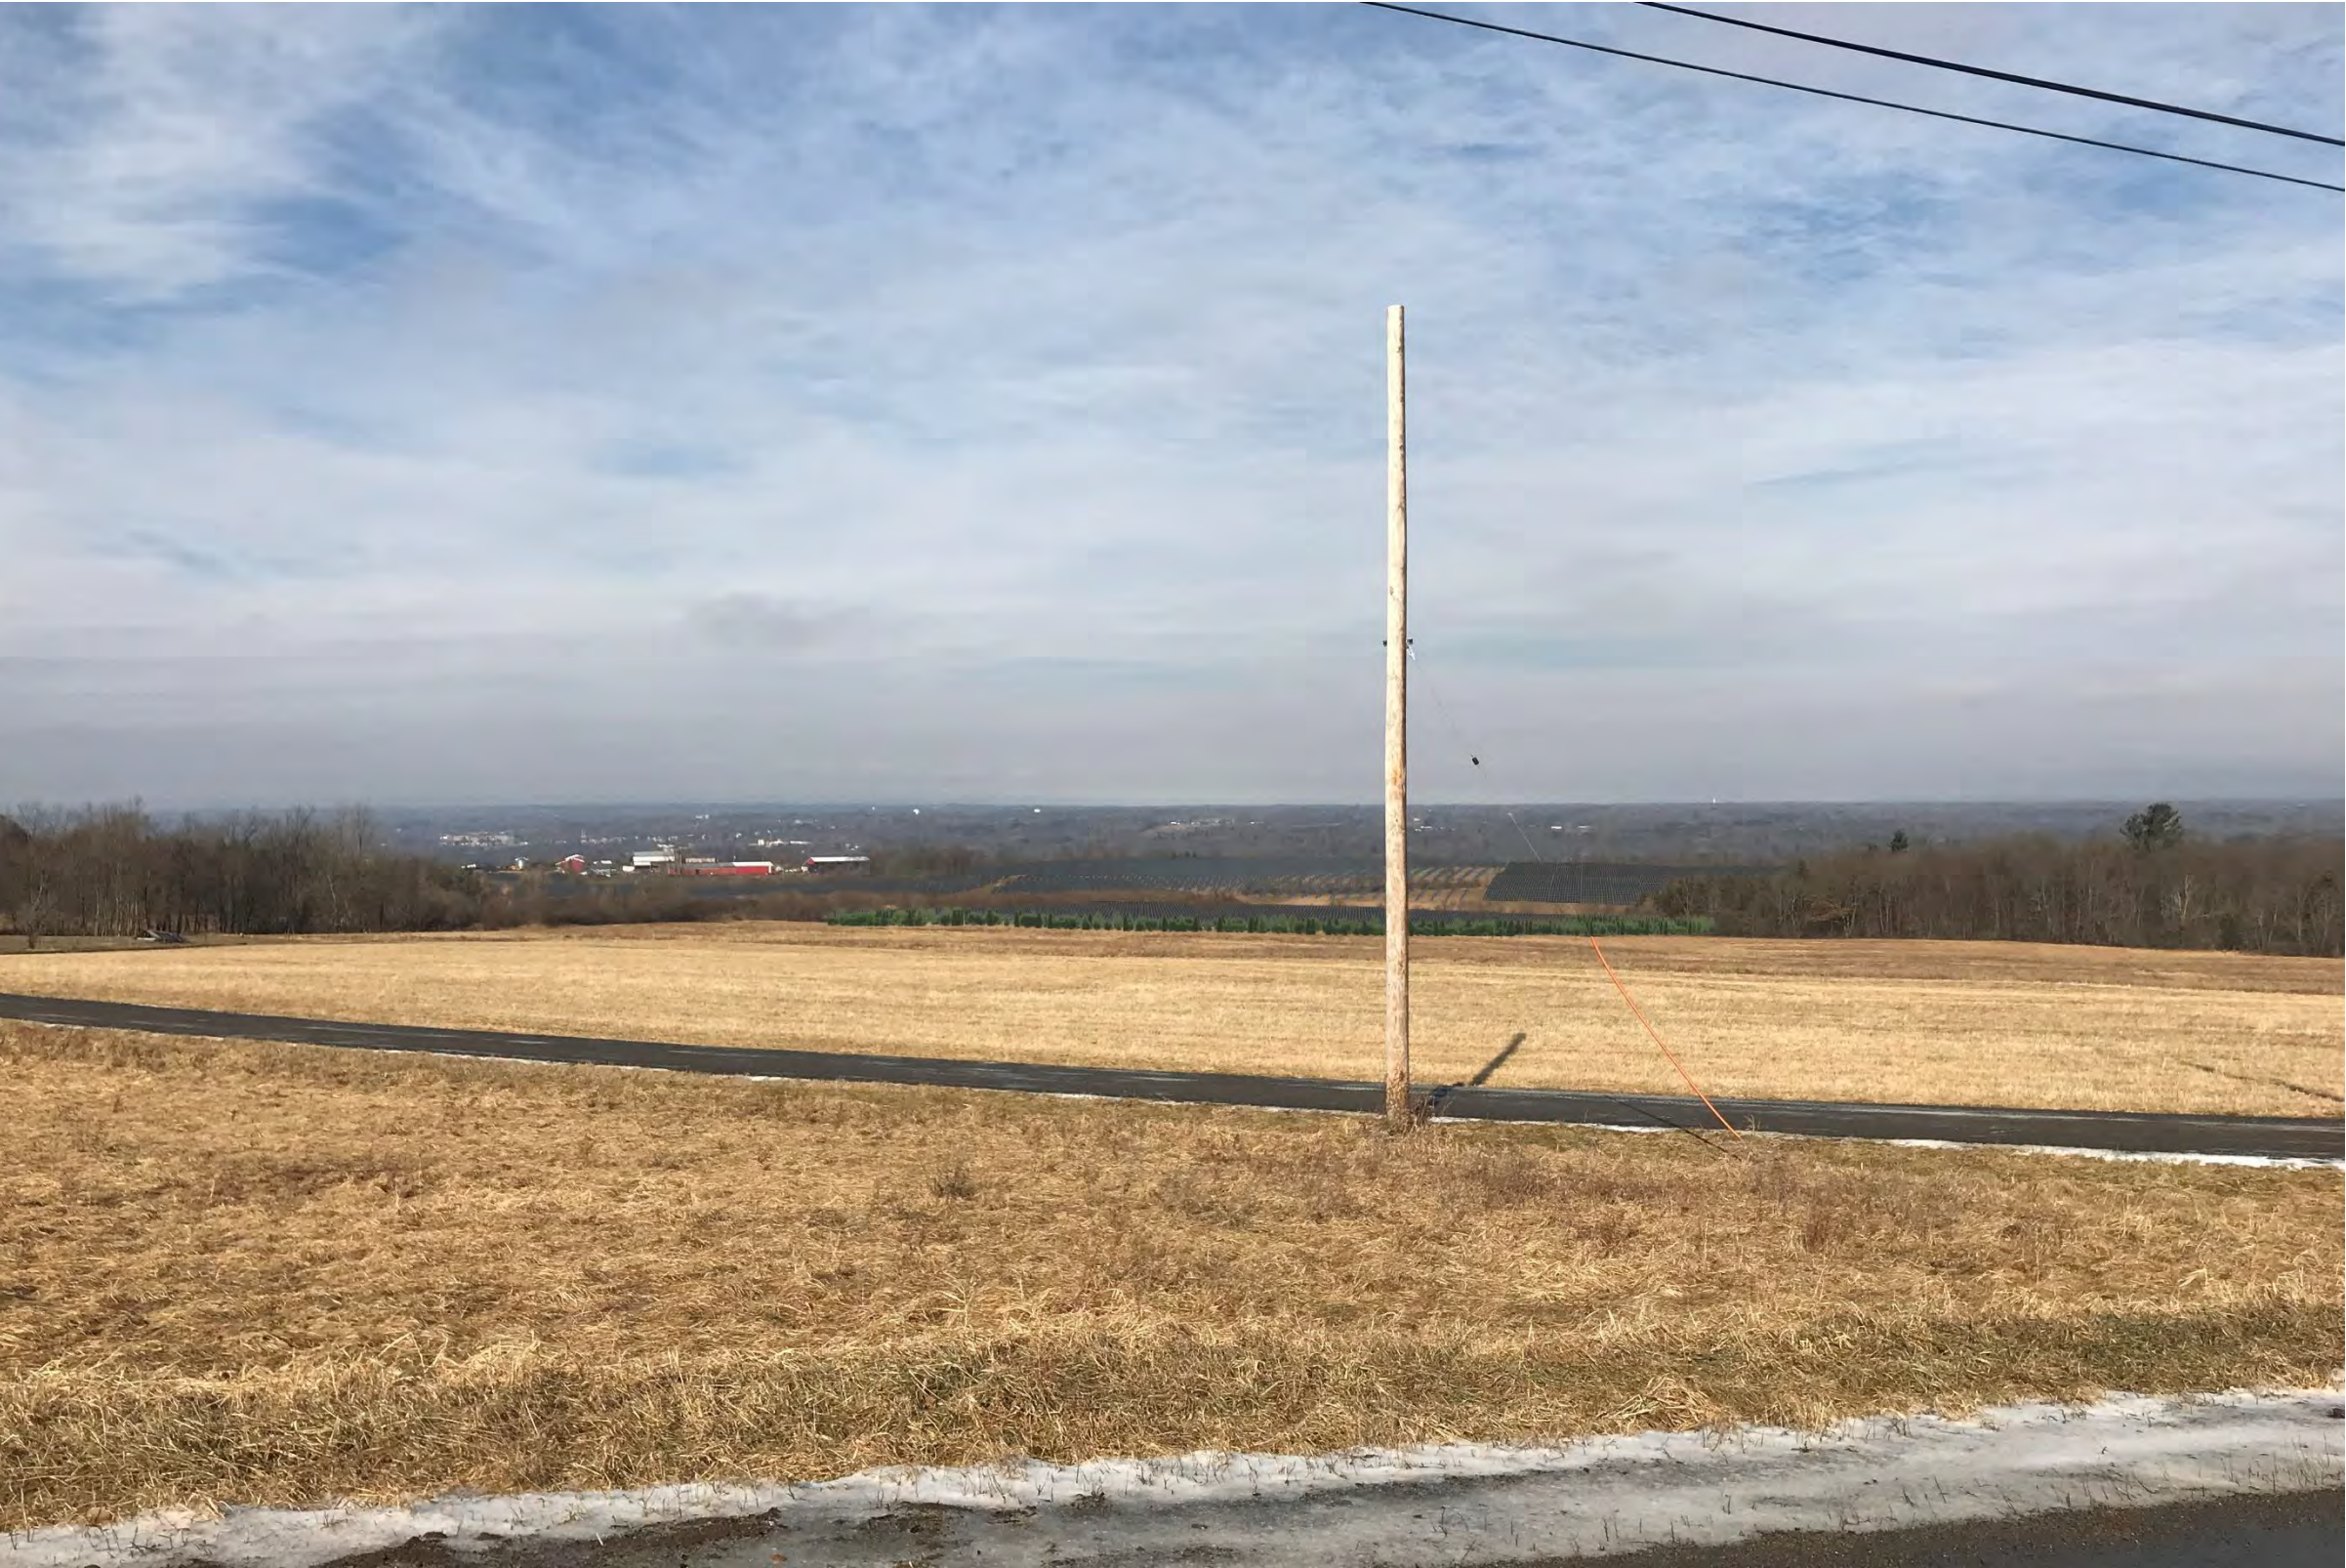
Viewpoint Coordinates in	588098.56
NY State Plane East	1479149.98
Viewpoint Location	Bulls Head Rd
Viewer Elevation (ft msl)	712
Distance to Fenceline	0.3 miles
Direction of View	North
Date	28 mm
Time	1.8.2019/12:05pm

High River Energy Center – Update for
Alternative Layout, Florida, New York
Visual Simulation of Project
May 2020
